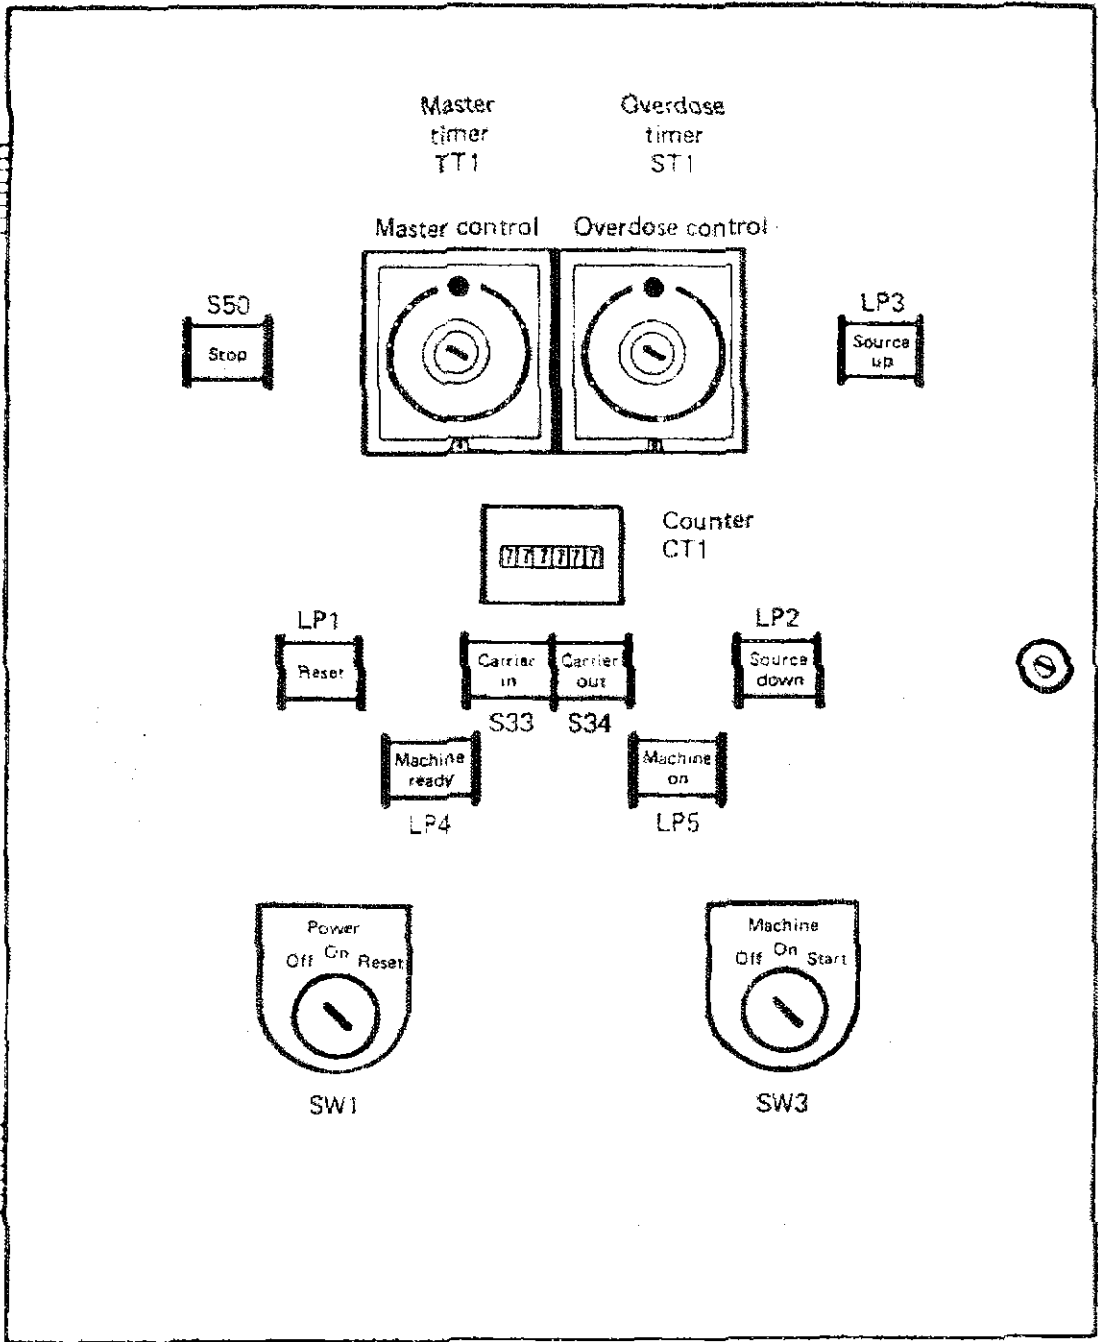
FIG. 9. The control panel of the JS6300 irradiator. (By courtesy of Nordion International Inc.)

Although Fig. 9 shows the panel as having illuminated legends, at the time of the accident the panel had no markings to indicate the significance of the controls or the warning lights. (However, the workers interviewed who were responsible for operating the controls were familiar with their functions.) In addition, a skylight above made it difficult to see whether the warning lights were on in the daytime.

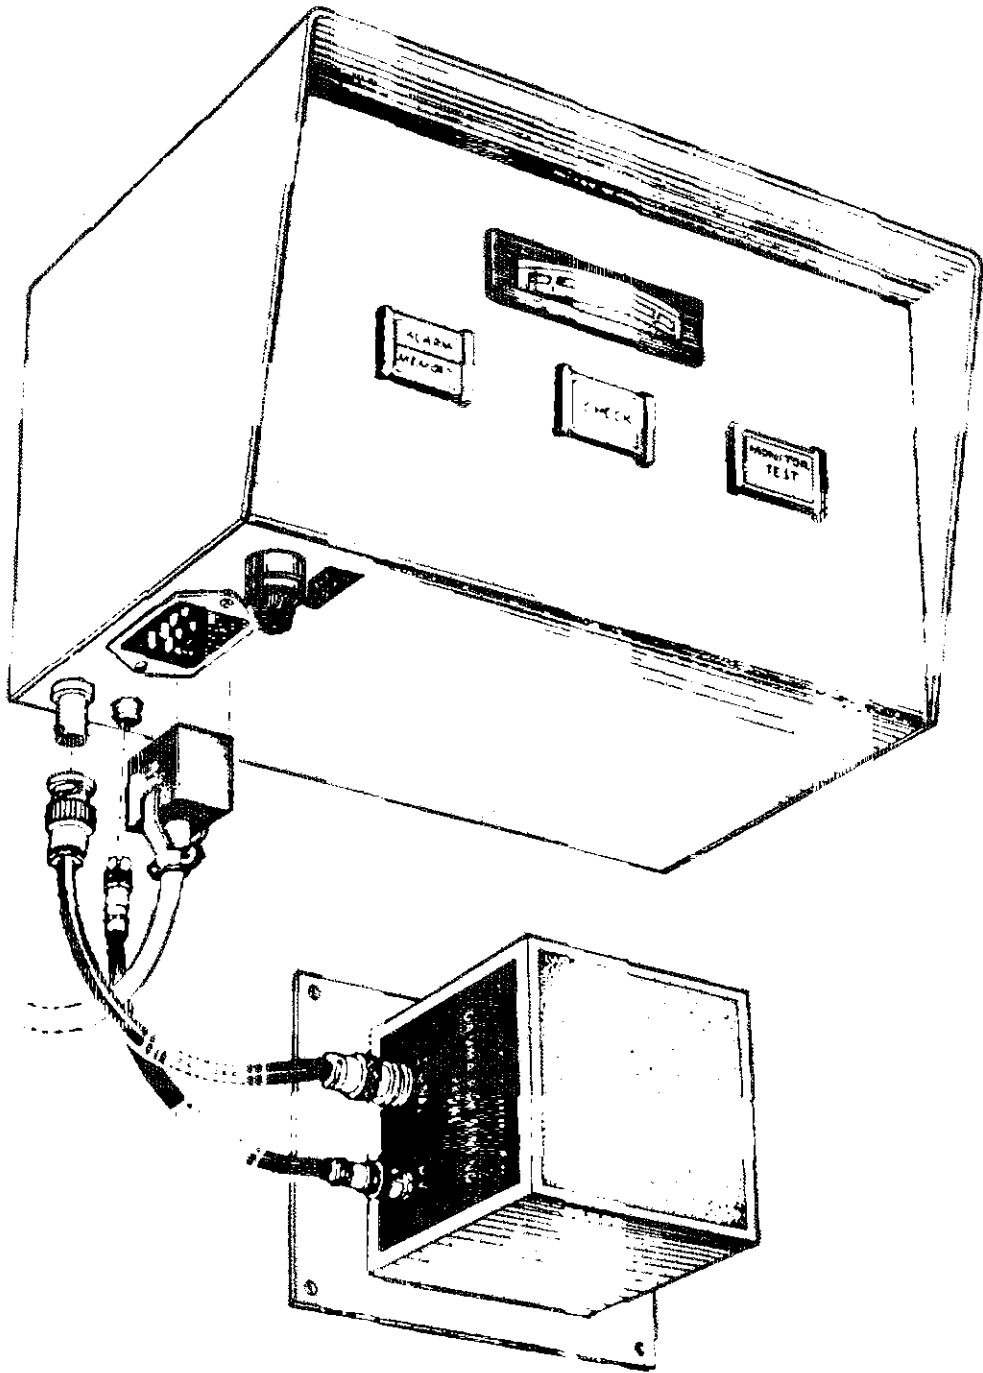
FIG. 10. The L118 wall mounted single probe monitor system. (By courtesy of Nordion International Inc.)

More than five years before the accident, the monitor probe had failed and the probe assembly had been removed. Its cabling remained. Removal of the monitor probe should have disabled the irradiator. However, it was discovered that access could be gained to the radiation room by depressing the monitor test switch and repeatedly cycling the buttons on the panel of the radiation monitor. This method of gaining access became the 'usual' procedure. The access door had not been maintained and had become badly fitting, with the result that it could also be opened by force or by using the blade of a knife to slip the catch (see Photographs 5 and 6). Thus one major safety feature of the design was bypassed.

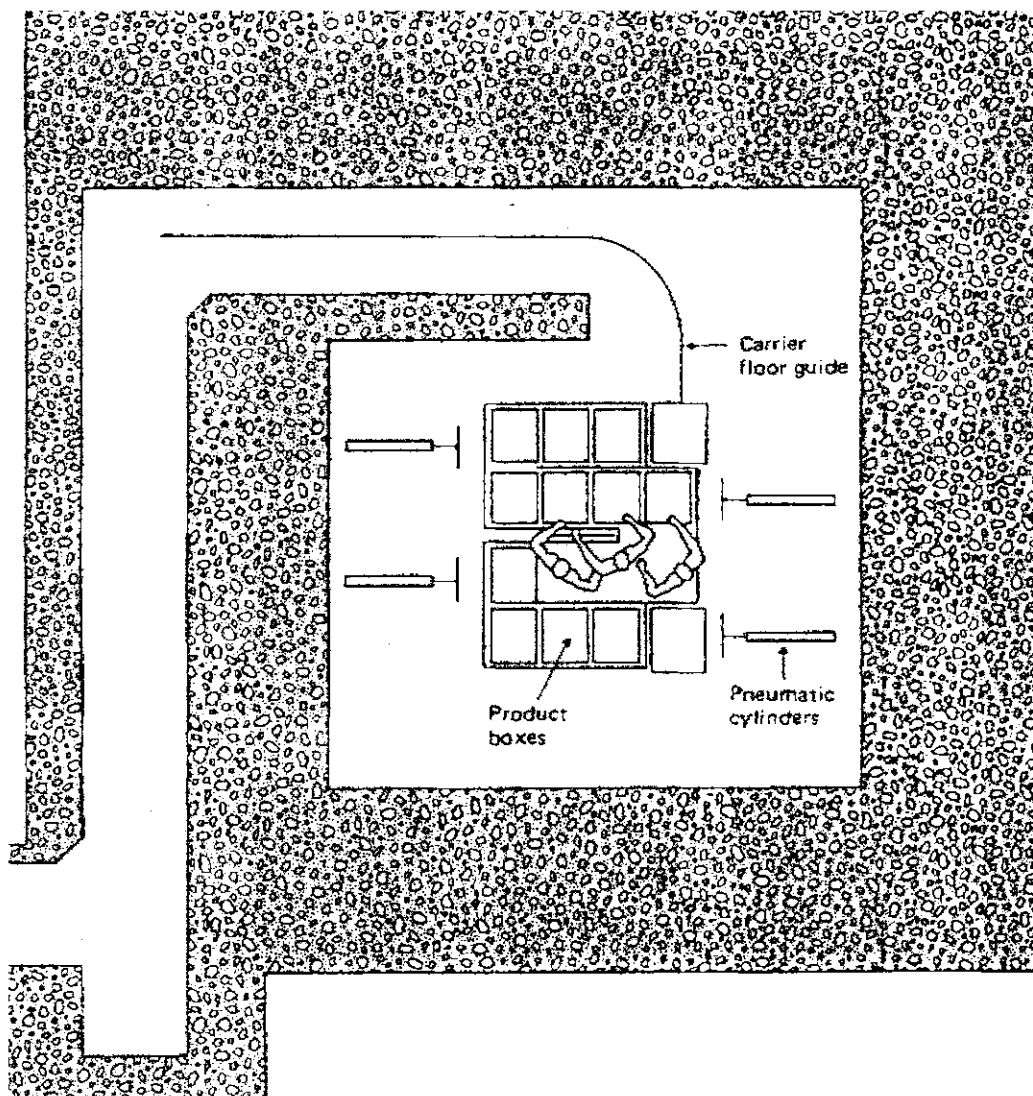
FIG. 12. Plan view of the positions of Workers A, B and C in the radiation room during the accident. (Source: REAC/TS.)

Shortly afterwards, at about 03:00, Worker A returned with Workers B and C, from another department, who had no experience of the irradiation facility. On being asked about any hazard, Worker A assured the others that there was no danger since the machine was switched off. The three men entered the radiation room and proceeded to remove product boxes from the third row on the upper level (adjacent to the source) so that the source rack could be freed from above (see Figs 12 and 13).

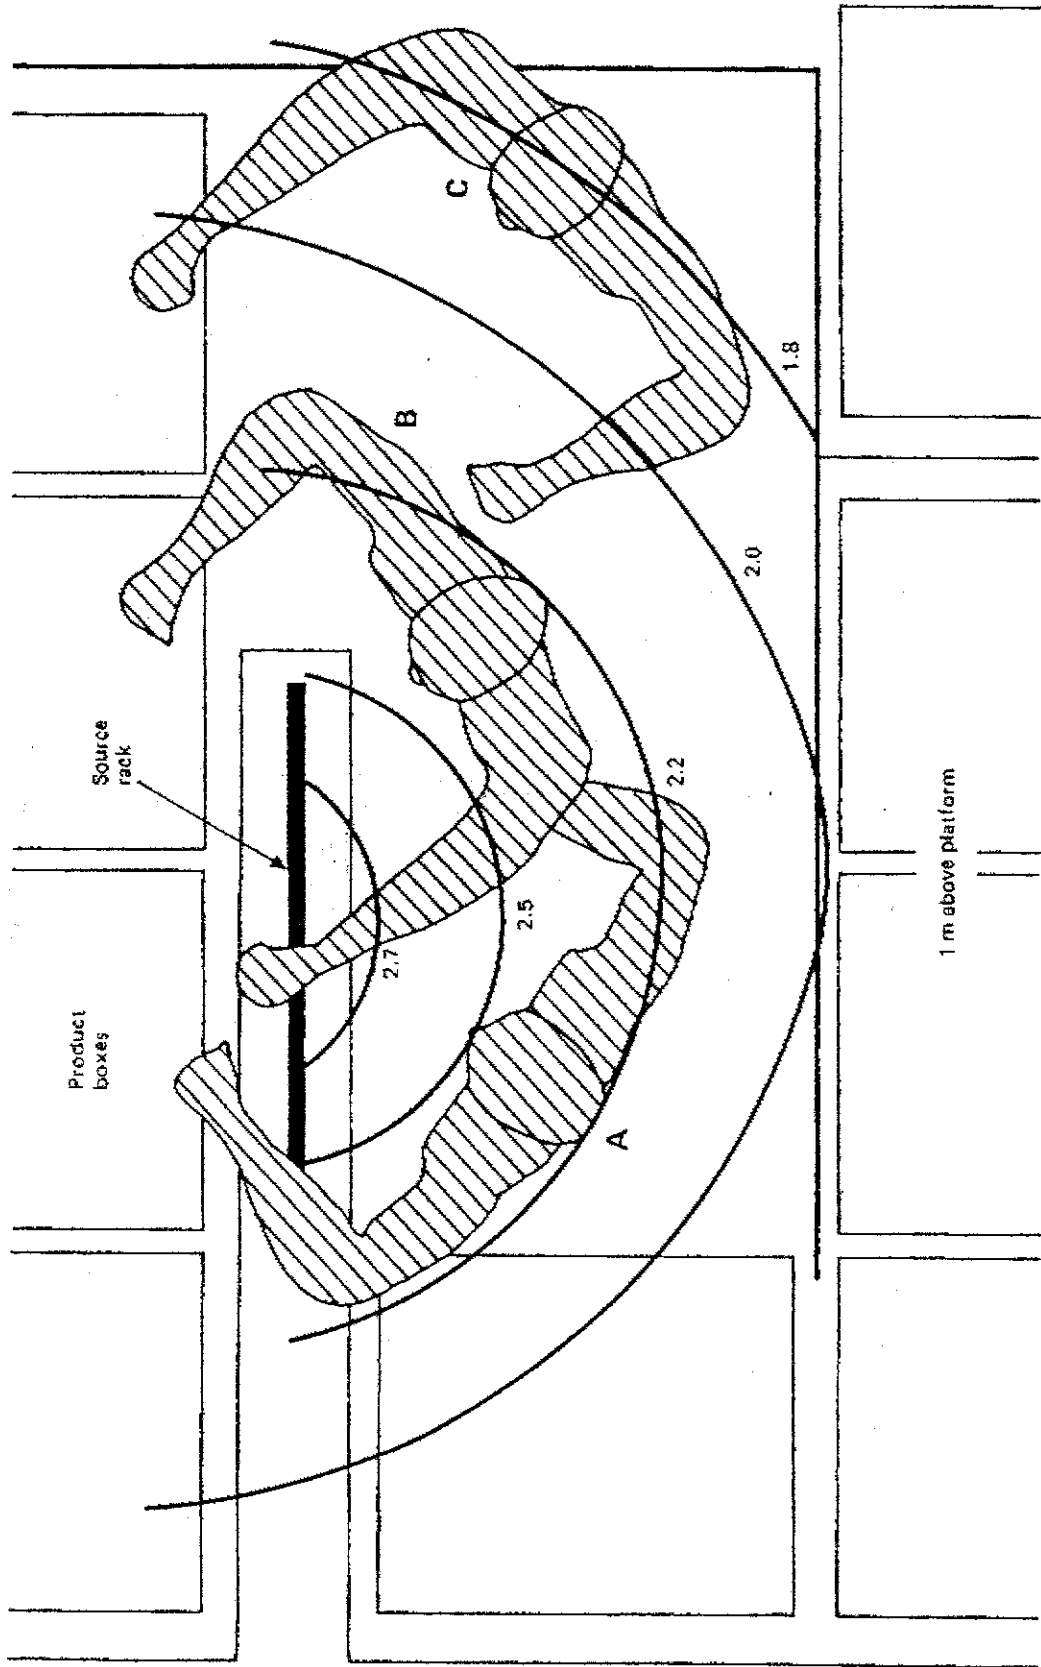
FIG. 13. Plan view of the positions in relation to the source rack of Workers A, B and C during the accident with dose rate contours in $\text{Gy} \cdot \text{min}^{-1}$. (Source: REAC/T.S.)

The next phase of the accident was probably when the three workers sustained the largest share of their doses. They would have been moving, but the positions and dose rate contours shown in Figs 13-15 can be taken as indicative of the patterns of exposure. In order to free the source rack they first had to raise it (a mass of about 60 kg) by all three pulling on the hoist cable. Eventually the three men were standing broadly in line on the upper level (Fig. 16). Worker A was in a crouching position with his legs slightly apart and his right leg forward directly in front of the rack. To his right, Worker B had his left leg nearer the source. (The leading leg of each man
