4.3. FURTHER EXPOSURES AT THE FACILITY: THE SECOND EVENT

5. THE RESPONSE TO THE ACCIDENT

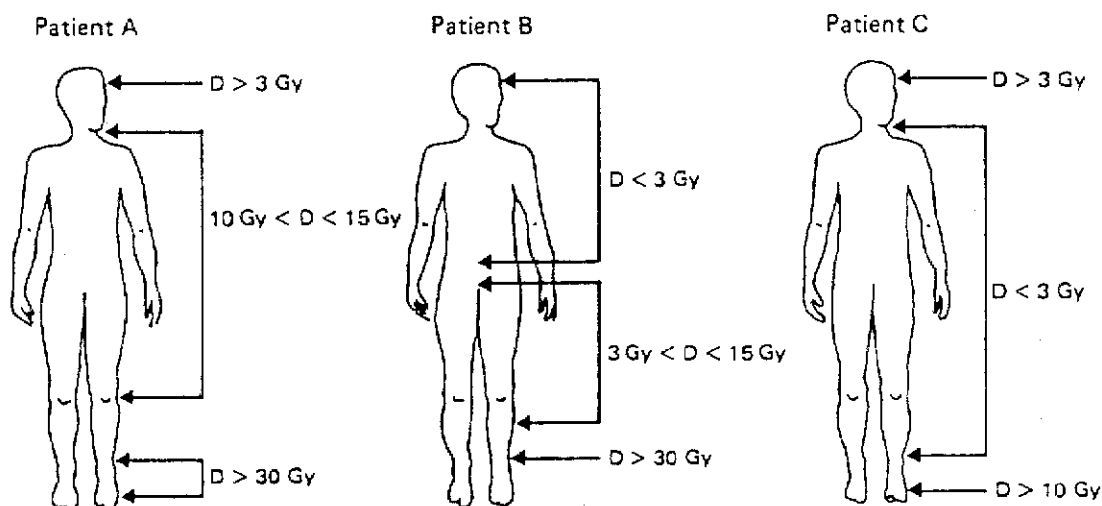
Patient A: 8.1 Gy

Patient B: 3.7 Gy

Patient C: 2.9 Gy.

FIG. 17. Patients A, B and C: doses D incurred by different parts of the body. (Source: REAC/TS.)
