# **THE 1974 LANDSLIDE IN CENTRAL PART OF PERU**

**By: Miguel Luis Estrada Mendoza**

Japan-Peru Center for Earthquake Engineering Research

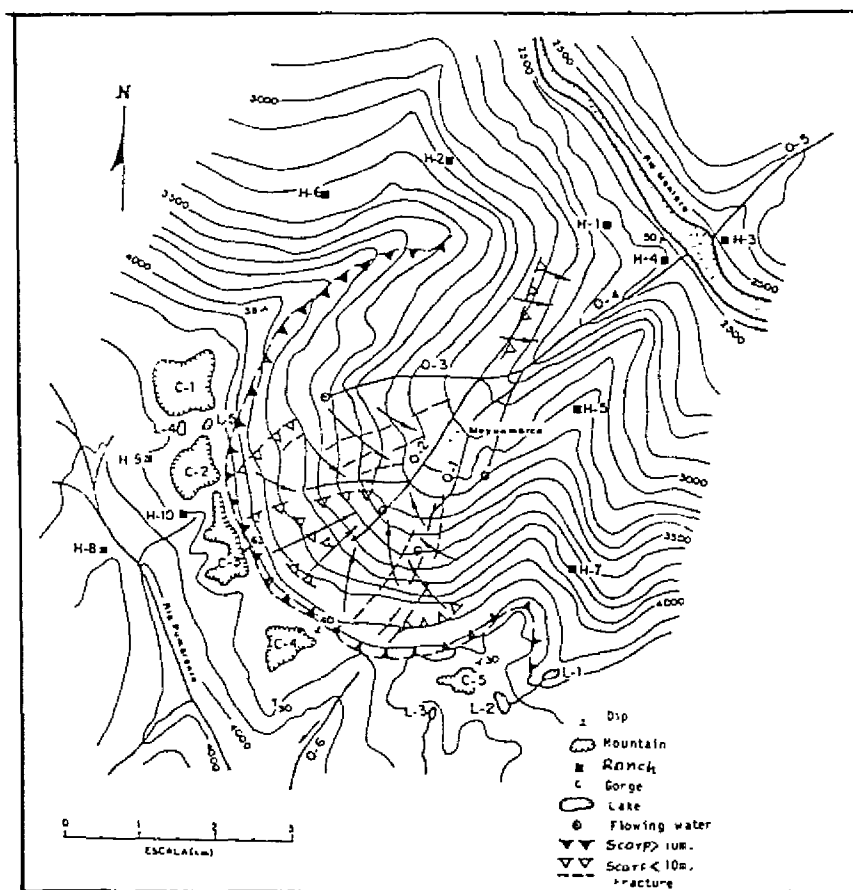
Fig. 6 - Topography characteristics before landslide of Mayunmarca.

The landslide occurred on April 25, 1974 at 9:00 p.m. The Fig. 6 shows topography characteristics before landslide and the Fig. 7 shows plant view of landslide zone. Mayunmarca town was buried and Huaccoto and Ccochacay haciendas too. Vibration caused by landslide movement were transmitted as seismic wave and were recorded by many seismic stations, registering 3 minutes of movement duration. From there was possible to calculate the velocity which was approximately 140 km/h covering 7 to 8 km. The debris flow dammed the river completely, which was dried down stream without filtration, up to the undamming at June 6, after 42 days occurred the slide.

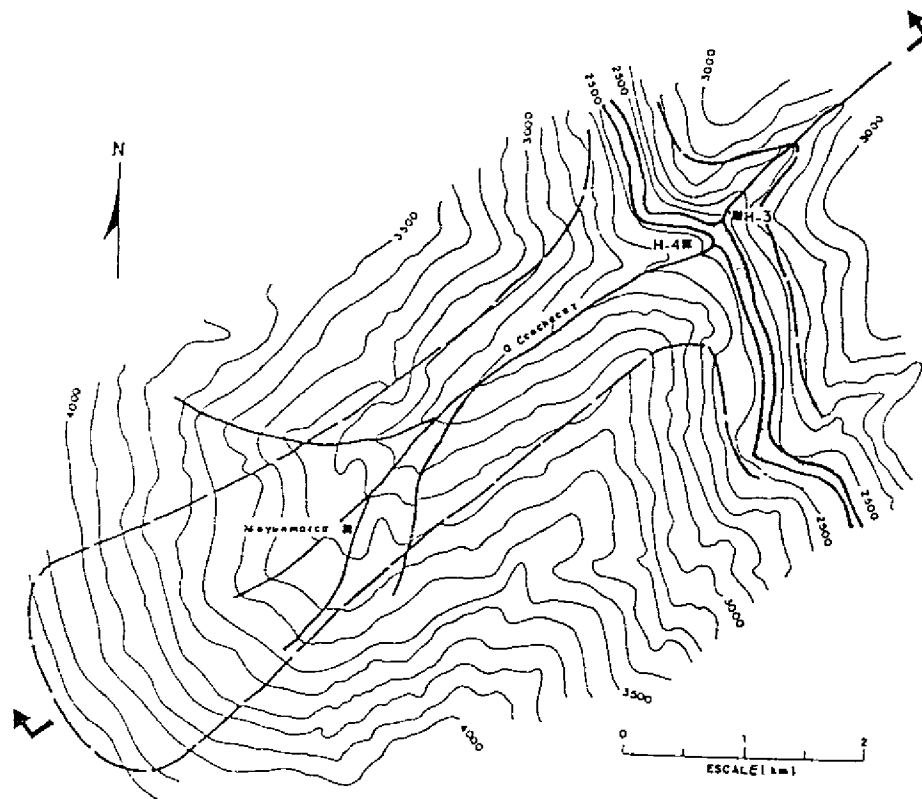
Fig. 8 Map of Landslide Area

Total volume of material sliced	$1.6 \times 10^9 \text{ m}^3$
Volume which dammed the river	$1.3 \times 10^9 \text{ m}^3$
Remaining material on the valley	$0.3 \times 10^9 \text{ m}^3$
Scarp length	7.5 km
Scarp height	1.9 km
Slide time	3 min
Slide velocity	140 km/hr

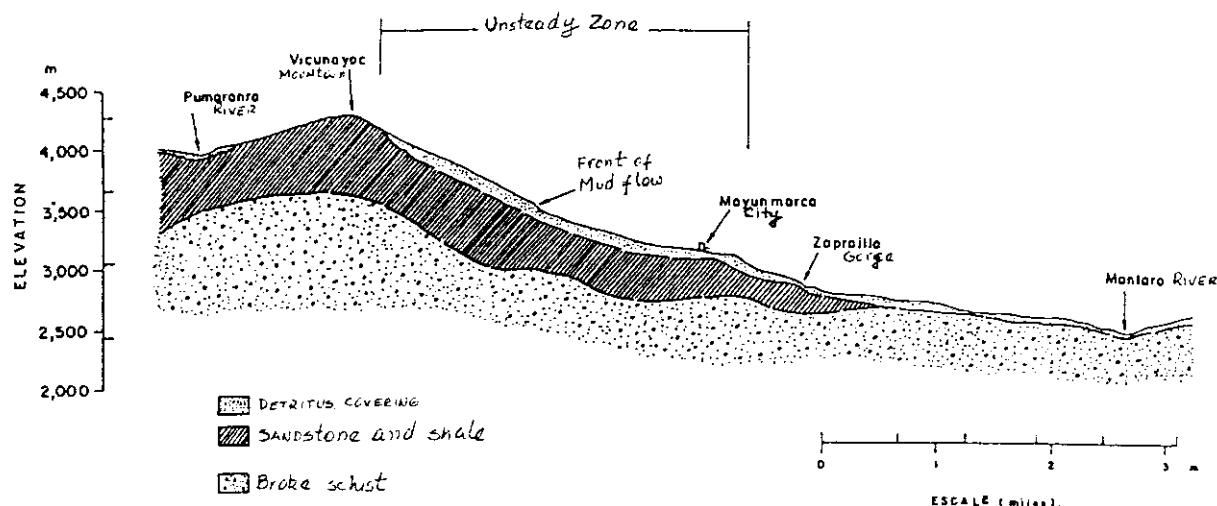
Fig. 9 Cross Section of Landslide Area Before the Landslide

- 3.- The hard rainfall at the region, occurred in October and March, making the material loses its strength.
- 4.- The slope of material is parallel to the main slope to Mantaro river direction.
- 5.- The material slope and cuaternary material with slope from 45 to 60 degrees.
- 6.- The water level.

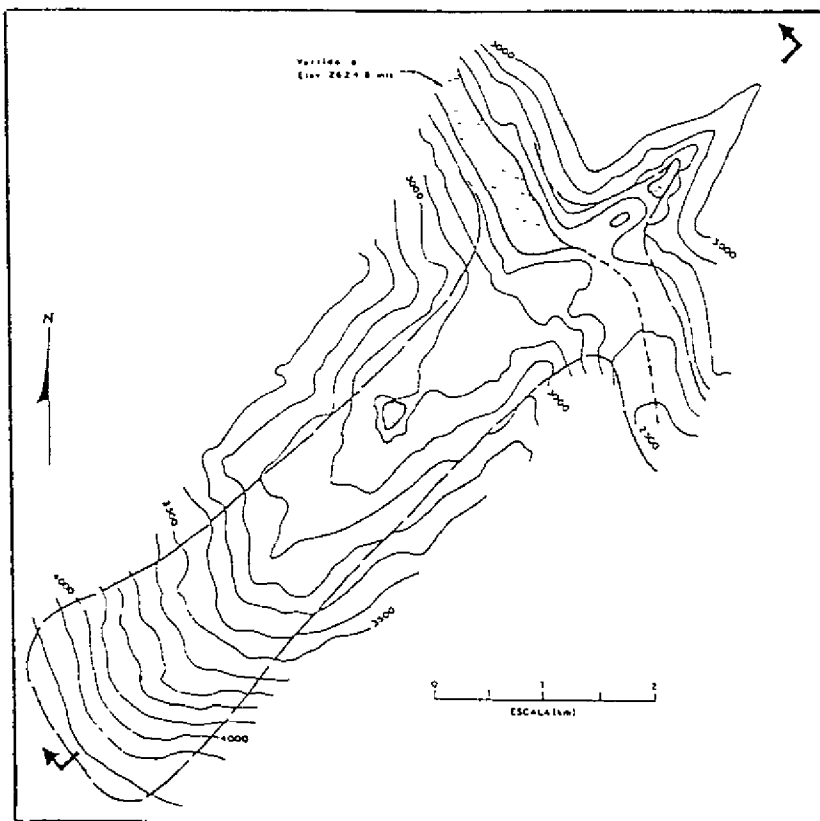
Fig. 10 Map of  
Landslide Area  
a f t e r o f  
Landslide.

Debris height which blocked the river	170 m
Debris length which blocked the river	3.8 km
Debris comb width	1.0 km
