# 6. FIRE

## FIRE SPREAD IN A DENSELY BUILT-UP SETTLEMENT

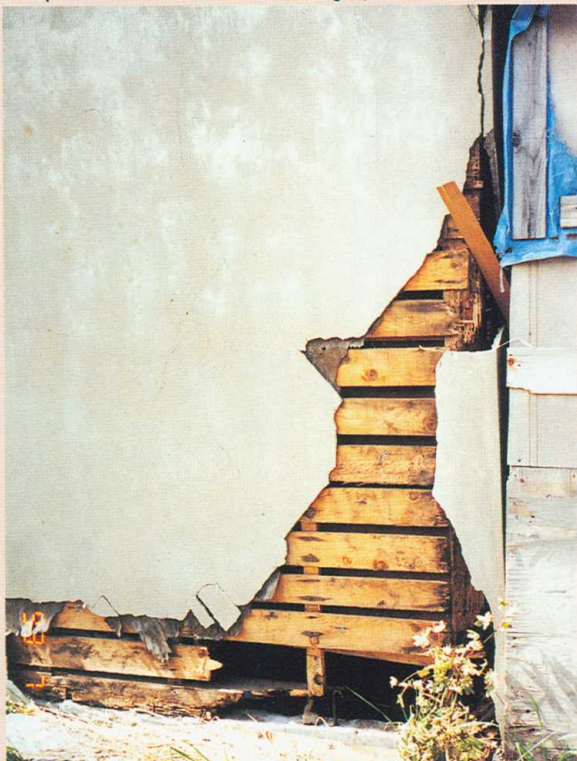
Fire preventive construction flaming up due to fire brands

In the highland over the cliff, some wooden houses were built with mortar and wire mesh construction to cover up the external walls of timber structures. In general, this type of construction is regarded as a fire preventive construction specified in the Building Standard Law. The UNCRD investigation team, however, discovered a house with its mortar covering fallen down due to the tremors and the exposed timber structure had actually caught fire brands and partially flamed up. (photo left)

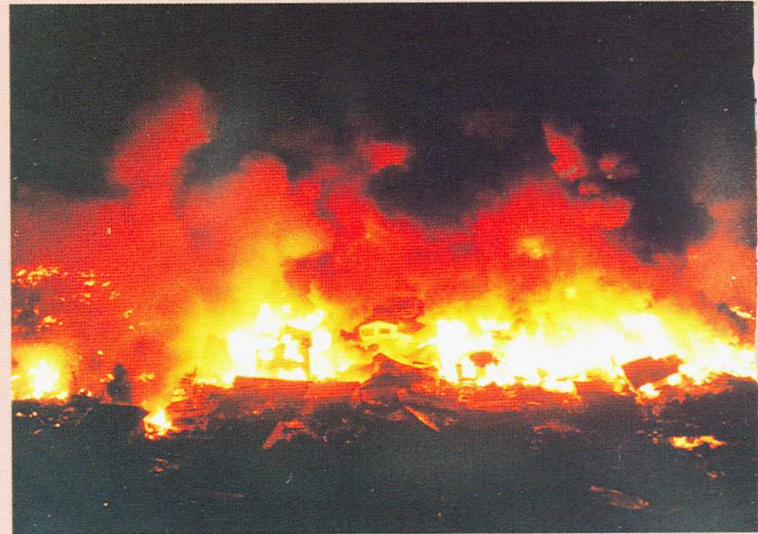
Fire spreading in Aonae community at approximately 02:00 (from helicopter of Maritime Safety Agency, 100 m above sea level)

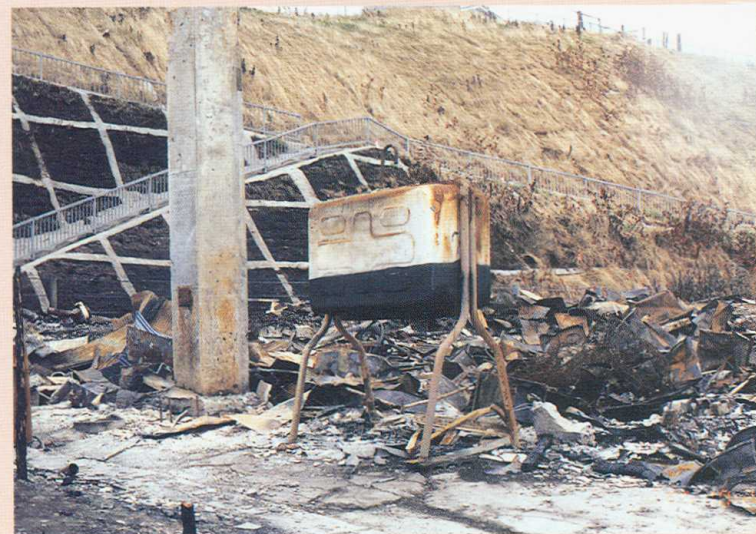
Ruins of fire; only chimney and kerosene tank standing; staircase for emergency climb up cliff
