The San Salvador earthquake of 10th October 1986

Julian Bommer*

The authors carried out an investigative mission to San Salvador between 20th October and 3rd November 1986, under the auspices of the Earthquake Engineering Field Investigation Team (EEFIT). The mission was funded by Rendel Palmer & Tritton and the Science and Engineering Research Council.

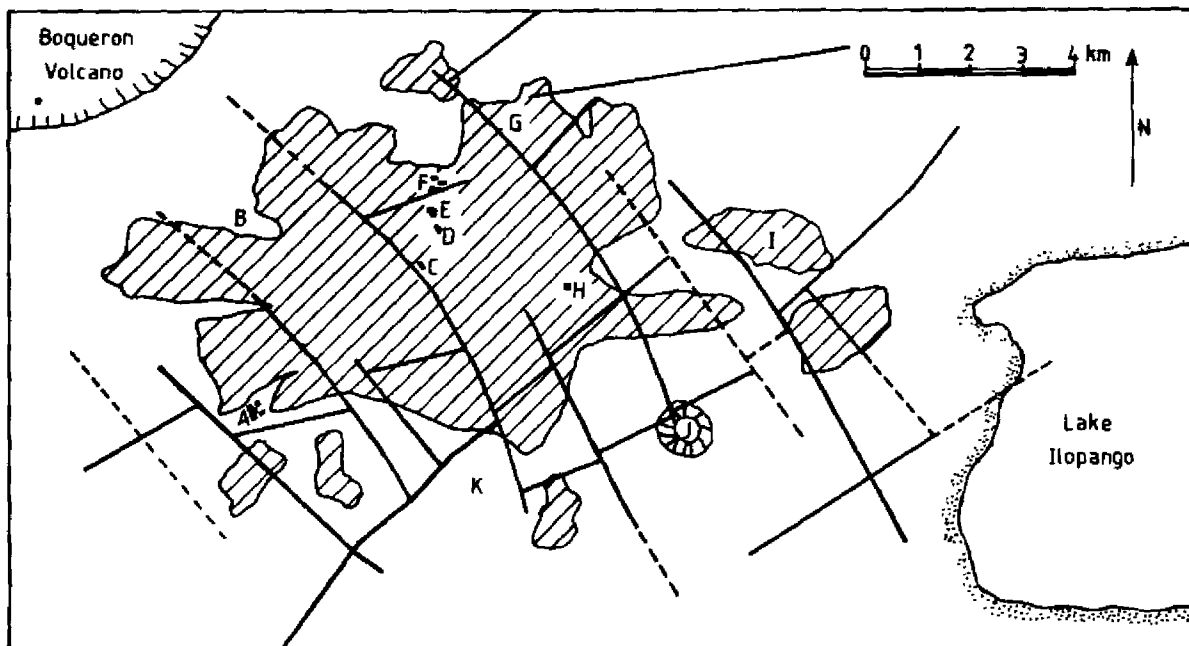
Fig. 1. Geological faults in San Salvador area. — fault; - - - presumed fault; (A) Catholic University; (B) San Antonio Abad; (C) Externado de San Jose; (D) U.S. Embassy; (E) Benjamin Bloom Hospital; (F) National University; (G) Mejicanos; (H) La Constancia Brewery; (I) Soyapango; (J) Cerro de San Jacinto; (K) Las Brisas.

It is known that the geology of the San Salvador area is heavily faulted, the predominant trend being north-west to south-east crossed perpendicularly by smaller faults. Figure 1 shows the geological faults identified by a German geological team (Schmidt-Thome, 1975) working in conjunction with El Salvador's National Geographic Institute which produced a geological map of the area on a scale of 1:100,000 in 1978.

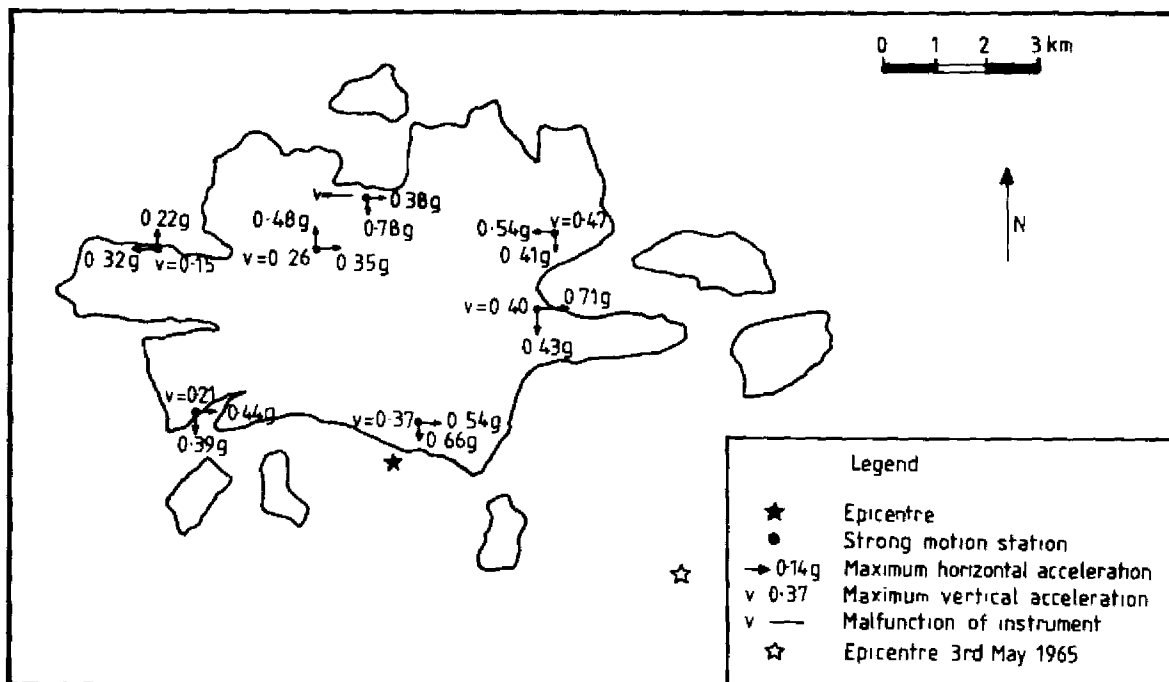
Fig. 2. Peak ground accelerations during 10th October earthquake in San Salvador.
