EARTHQUAKE DAMAGE

ENGINEERED STRUCTURES

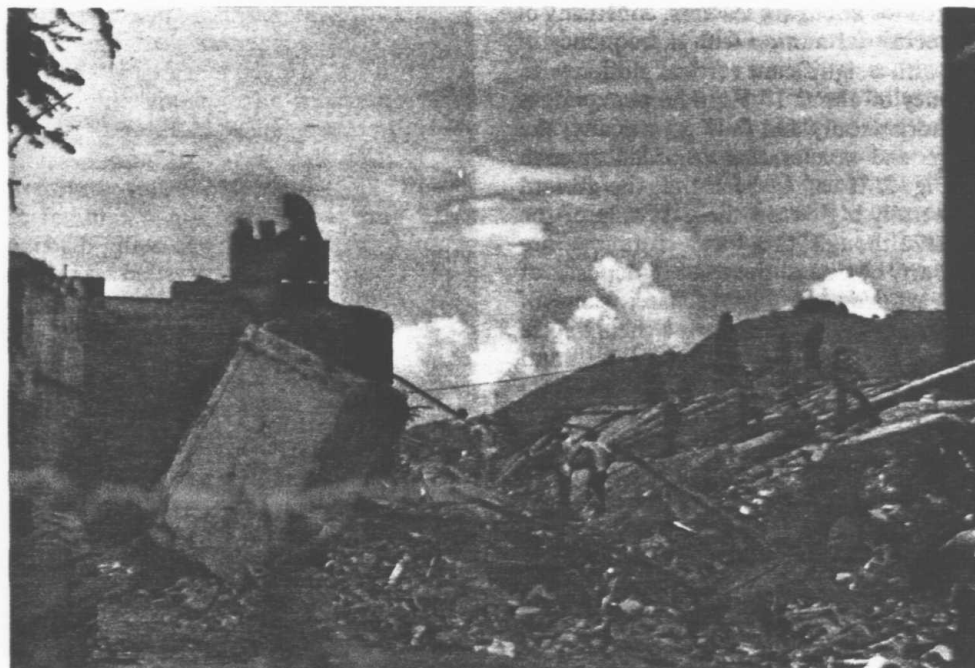
Fig. 3. Remains of Ruben Dario Building.

Another building that was damaged in 1965 and repaired and then failed in the 1986 earthquake was the Hotel San Salvador. The same is true of the Ruben Dario building which has caused considerable controversy since it was apparently condemned to demolition after the 1965 earthquake.* Immediately after the 10th October disaster
