DAMAGE TO SOLID WASTE MANAGEMENT SYSTEMS AND THEIR RECONSTRUCTION IN THE EARTHQUAKE-STRICKEN AREA

HYOGO NANBU EARTHQUAKE - DAMAGE TO SEWERAGE SYSTEMS

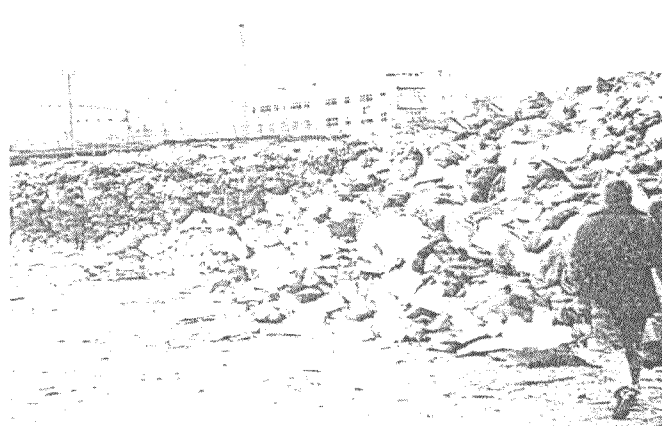
Photo 2 Depot of Demolition Waste, Kobe City

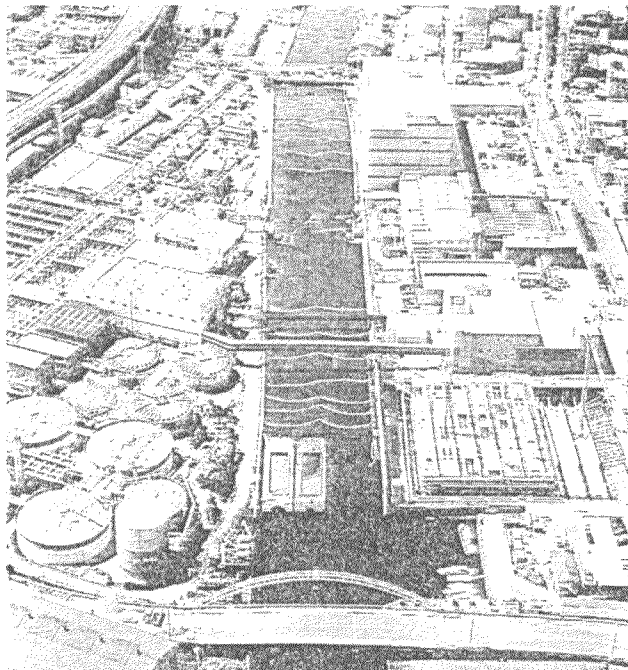
The Higashinada Wastewater Treatment Plant in Kobe city was severely damaged. The plant is located on reclaimed land next to a canal. Because of liquefaction and lateral ground deformation, the buildings and facilities, as well as pressure pipes which connect the treatment plant and the pumping station on the other side of the canal, were damaged and lost of treatment functions. Because it was expected that repair work would take a long time, authorities partitioned the canal so that the canal serves as a sedimentation tank. From February 6 to the end of April, wastewater was treated in this temporary sedimentation tank. On March 19, partitions were added to prevent a short-circuit. A facility for coagulation was added on March 28 in order to improve effluent quality. On the first of May, the plant recovered secondary treatment functions (activated sludge treatment) through temporary repair work.

Photo 1 Higashinada Wastewater Treatment Plant and Adjacent Canal Which Is Partitioned to Serve as a Temporary Sedimentation Tank

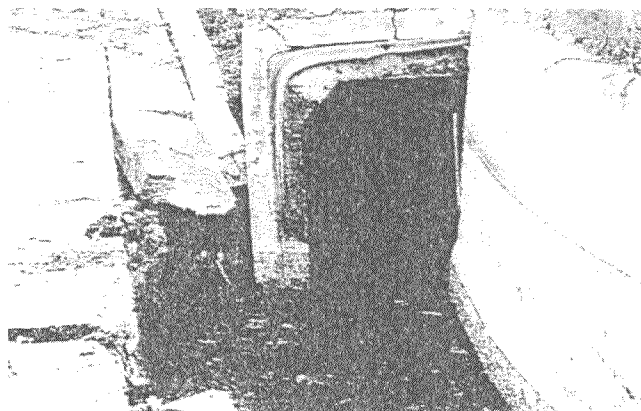
Photo 3 Aqueduct in Higashinada Wastewater Treatment Plant (Aqueduct is broken at a joint.)

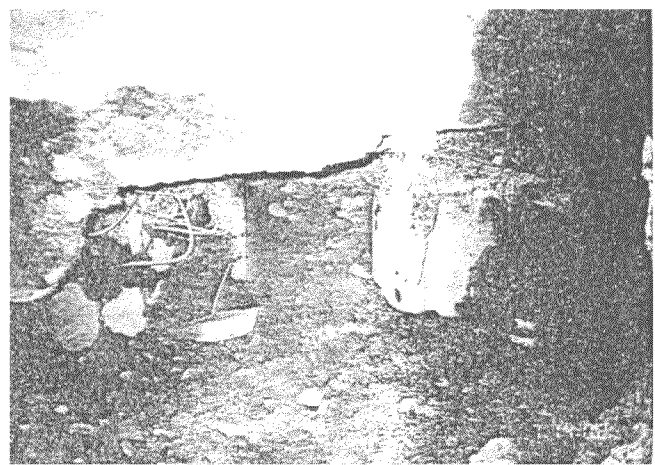
An intensive investigation has been done on Higashinada Wastewater Treatment Plant. It has been found that pile foundations are broken under several

buildings including the administration building and part of the wastewater treatment facilities. In one part of the treatment facility in particular, 40% of the pile foundations are estimated to be broken. These structures are scheduled to be rebuilt. It will take four or five years to complete.

Photo 2 Pile Foundation at the Administration Building at Higashinada Wastewater Treatment Plant
