CHAPTER 5

SAND LIQUEFACTION IN THE CENTRAL VALLEY INDUCED BY THE 1990 EARTHQUAKE

5.1 The 1990 liquefaction and historical records

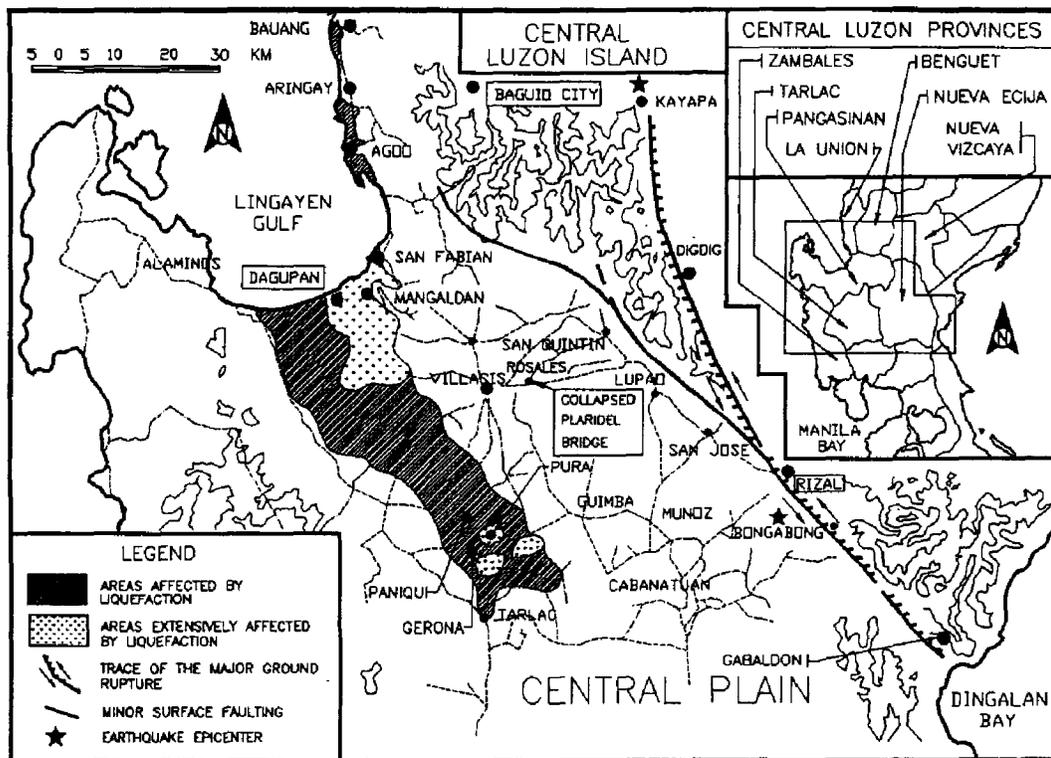
Reconnaissance studies made after the quake showed that liquefaction-related phenomena such as sand boils, fountains, lateral spreading, cracks, fissures and differential settlement had been induced in various areas and isolated spots in the Central Plain west of the major and minor ground ruptures (Fig. 5.1). In addition to the catastrophic damage caused in Dagupan City in the Gulf of Lingayen, liquefaction also affected San Fernando in La Union Province and severely damaged Agoo and Aringay.

Fig. 5.1 - Sand liquefaction in the Central Plain and the Agoo-Bauang area (adapted from Punongbayan and Umbal, 1990).

Extensive liquefaction also explains the severe damage suffered by the road connecting Dagupan City to San Fabian through Mangaldan (Fig. 5.1). The rigid pavement of this road was deformed into an undulating strip several hundreds of meters in length with subsidence of the shoulder on the seaward side (both sides in some cases) ranging from 30 cm to 100 cm. Such behavior, which was also reported in Niigata, is attributable to the fact that the embankment under the rigid pavement acted as a floating shield preventing upward dissipation of the accumulated pore water pressure underneath. As a consequence of this local condition the pore pressure was dissipated along the foot-slopes of the shoulders on both sides of the road, thus resulting in the separation and sinking of the body of the shoulders. For a few months after the quake the cement concrete pavement exhibited marked waviness with a period of about 25 m.

The coastal road directly linking Dagupan City and San Fabian suffered the most severe damage. In some sections it was affected by multiple longitudinal cracks (10-30 m long and 50-90 cm wide) while in other zones the road embankment split into tilted blocks topped by portions of pavement still in place.

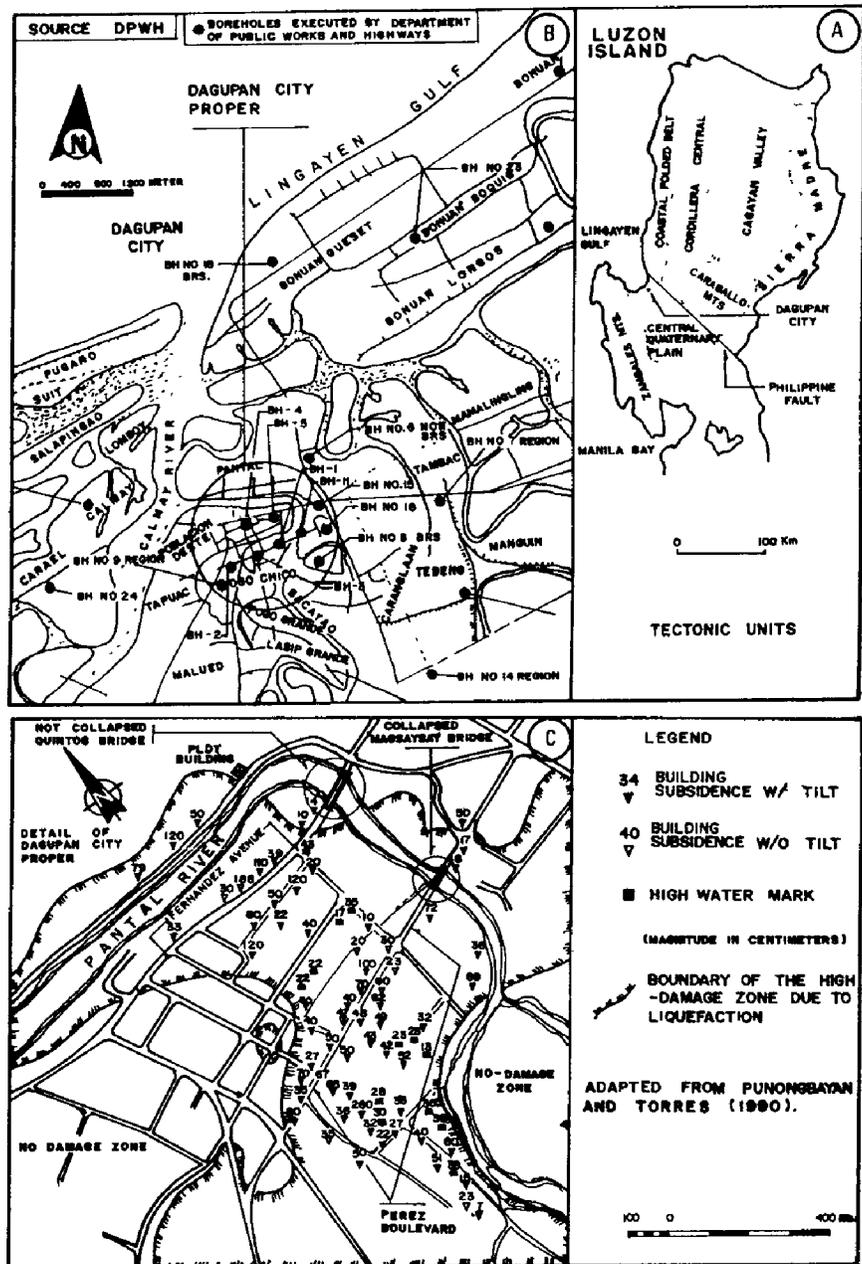
The most impressive liquefaction occurred in the commercial area of Dagupan City (Fig. 5.2), which is crossed by two major roads, Perez Blvd. and Fernandez Ave. Many buildings, bridges, road platforms and pavements, as well as electrical and sewerage systems suffered structural damage (top sketch).

Fig. 5.2 – Tectonic units in Luzon (A), overview of Dagupan City (B) and details of tilt and subsidence of major buildings in Dagupan City Proper (C). Adapted from Punongbayan and Torres, 1990.

Figure 5.2 shows: sketch A) a map of the major tectonic units in Luzon, sketch B) the liquefied area in Dagupan City and the two most affected roads in the city proper, namely Perez Blvd. and Fernandez Avenue, sketch C) the detail of the area severely affected by liquefaction with data on building subsidence and tilt, and the location of the major city bridges (circled) on the Pantal River. The

location of the PLDT building, which did not suffer any damage, is indicated northwest of the undamaged Quintos Bridge (sketch C).

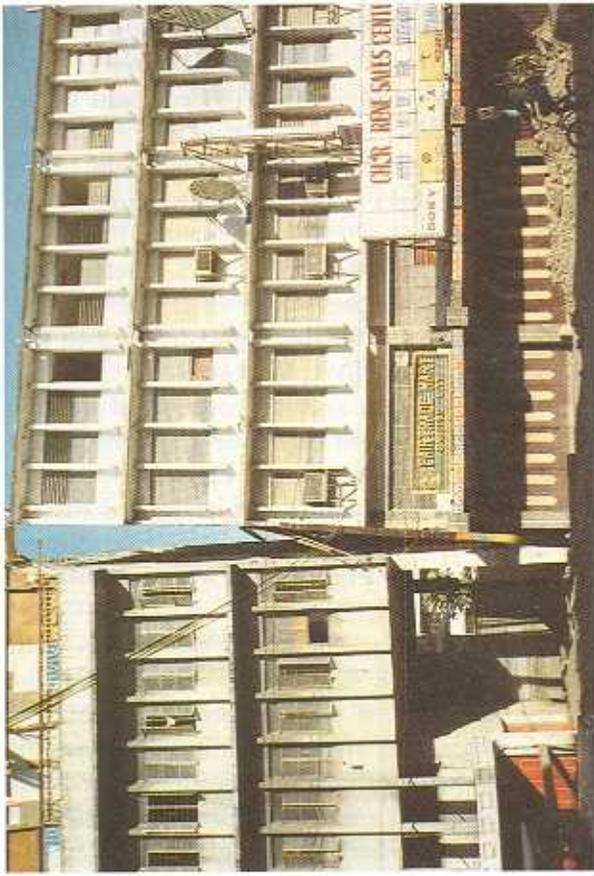
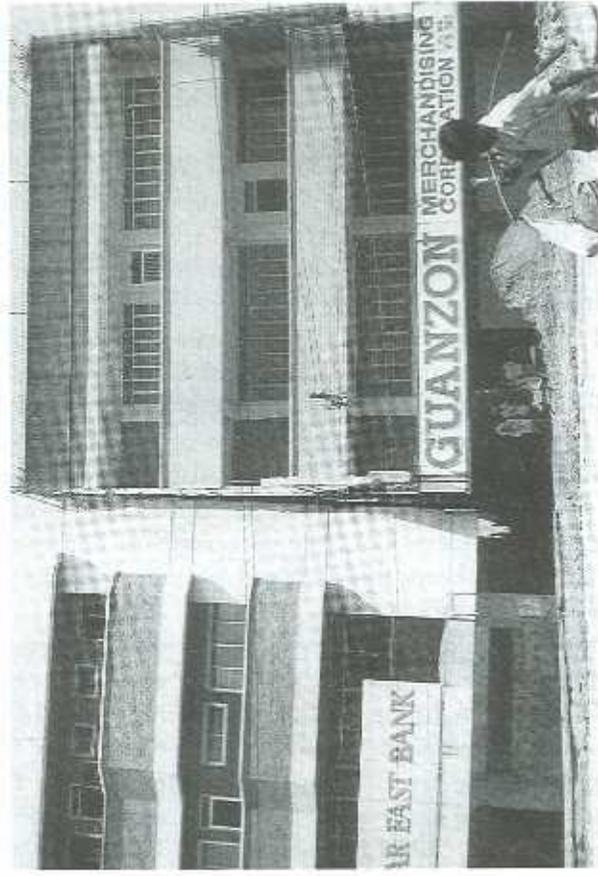
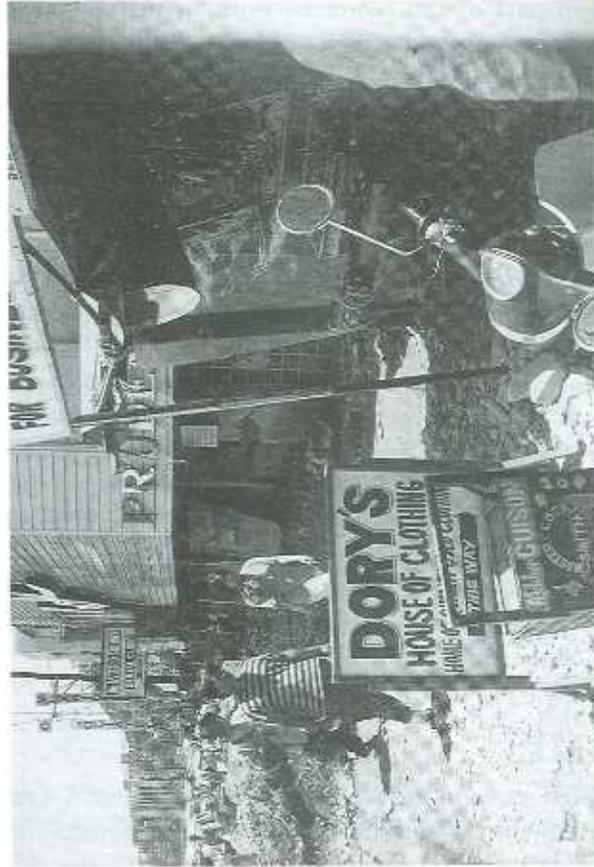
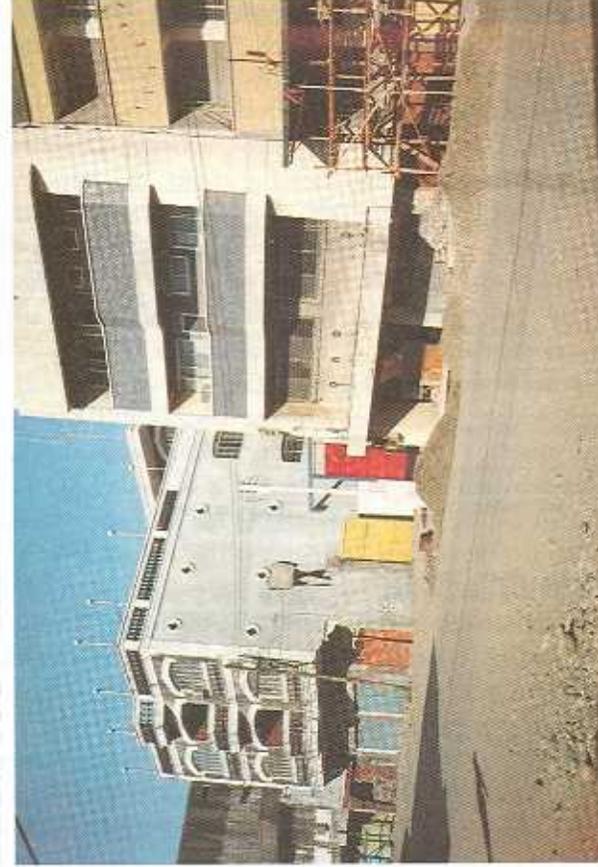
In Fernandez Ave. contiguous buildings underwent quasi-uniform sinking and moderate tilting for hundreds of meters on both sides of the road (Fig. 5.3, top). Figure 5.3, bottom, illustrates oblique and front views of new, well-kept buildings which suffered severe subsidence (140-180 cm) and tilting in Perez Blvd.

Fig. 5.3 – Quasi-uniform sinking (150 cm) of contiguous buildings (top left) and uneven sinking and tilting (top right) on Fernandez Ave. Sunk and tilted buildings on Perez Blvd. (bottom), oblique and front views, with a differential settlement of 140-180 cm.

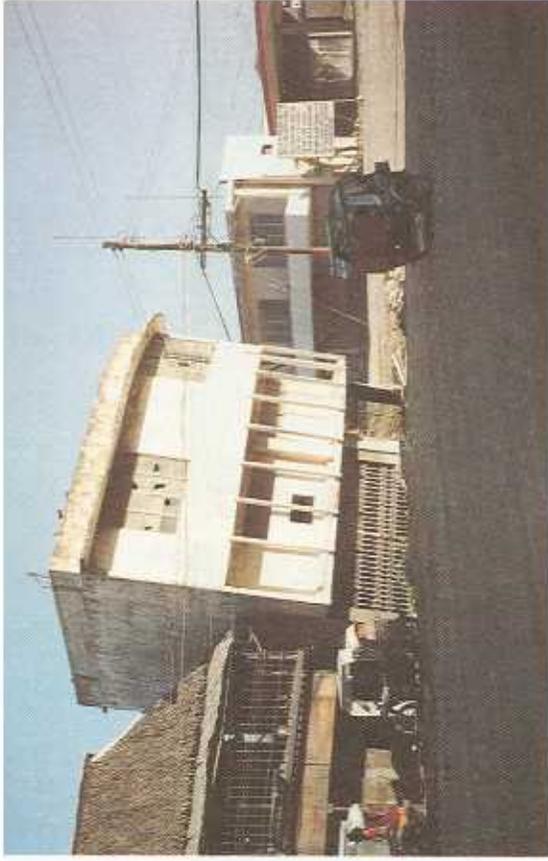
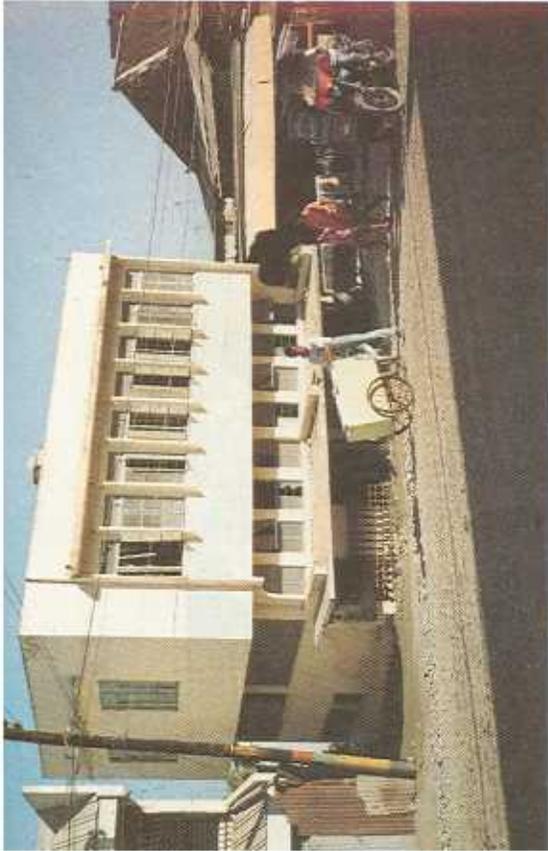
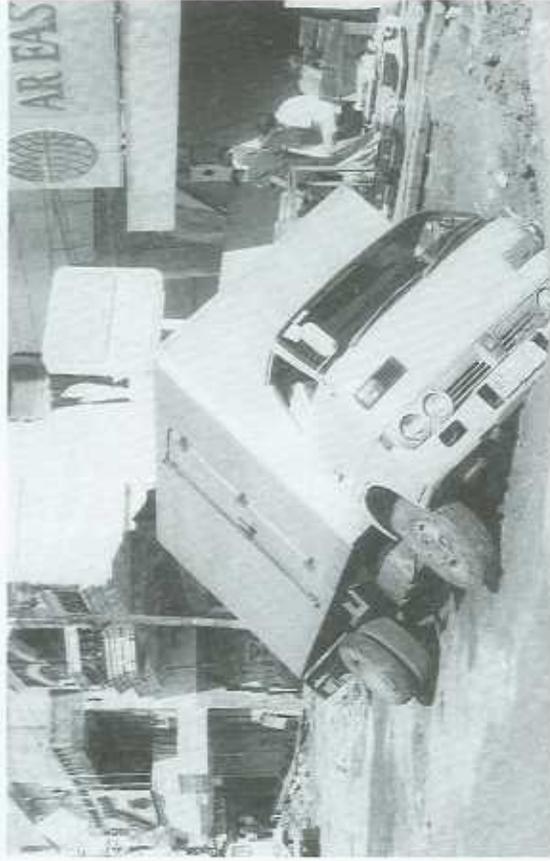
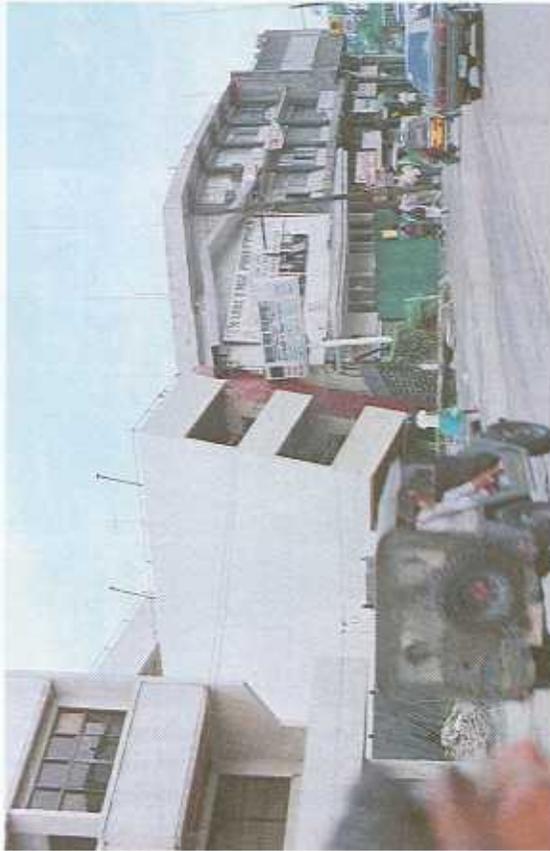
The lack of lateral support from adjacent structures was an essential factor for the severe tilting in Perez Blvd. of two isolated buildings (Fig. 5.4, top) in close sequence (non-uniform sinking 80-150 cm and tilting 12-14 degrees).

The most spectacular case, however, occurred in Perez Blvd. (Fig. 5.4 bottom, left), where tilting was estimated to amount to 15 degrees. The complete rotation and collapse of the structure was prevented by the next-door building. Heavy damage in general occurred in the area between the two major streets in Dagupan City proper, and some houses collapsed in Perez Blvd. Market.

Roads in Dagupan were catastrophically affected by sand liquefaction and the consequent bulging was the major cause of the destruction of the rigid pavement. The swelling of city streets was due to the light weight of the road structure compared with the heavier nature of the buildings. Figure 5.4, bottom right, shows a small truck which has sunk into the roadside due to road bulging and associated subsidence of the shoulders. Concrete pavements of houses and courtyards were disrupted almost everywhere.

Repeated visits to Dagupan City between 4 and 8 months after the earthquake showed that some buildings which first tilted during the July 1990 tremor continued to tilt for months finally being declared unsafe. This means that, under the unbalanced weight of already inclined structures, continuous uneven sinking persisted for a considerable period. A number of heavy structures affected by sinking and tilting were responsible for damage to nearby buildings. In some cases they leaned against them and in others they influenced the behavior of their foundations.

Fig. 5.4 ~ Isolated consecutive buildings on Perez Blvd. which suffered 150 cm differential settlement towards the roadside (top). The tilting continued for months after the quake. Isolated tall building in Perez Blvd. (bottom left) with 15 degrees tilt due to severe foundation failure. Further rotation and collapse of the structure was prevented by the house next door. Truck sunk into the roadside (bottom right) due to road bulging and subsidence of the shoulder because of liquefaction (Courtesy of R. Panongbayan).

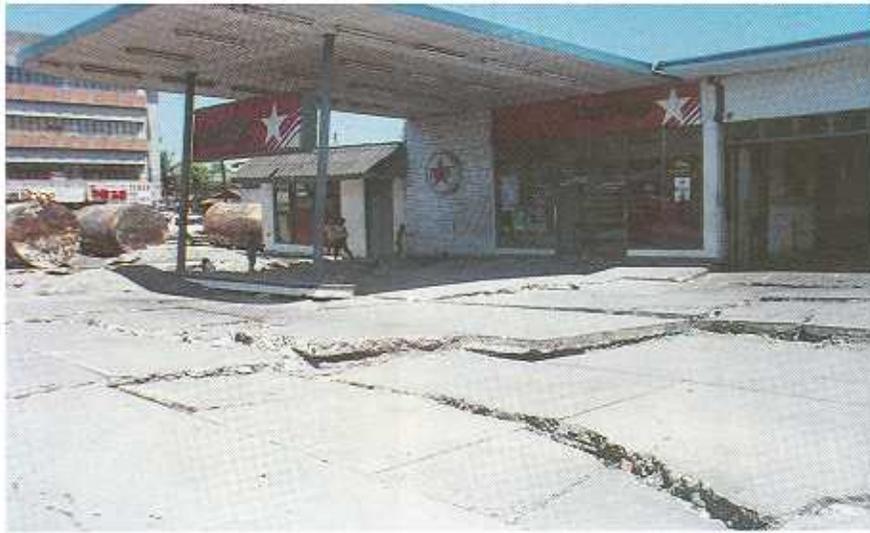
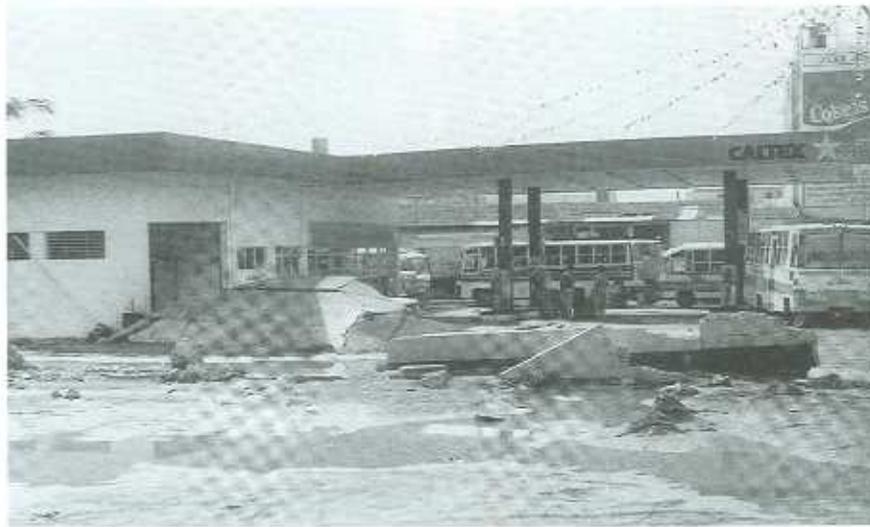
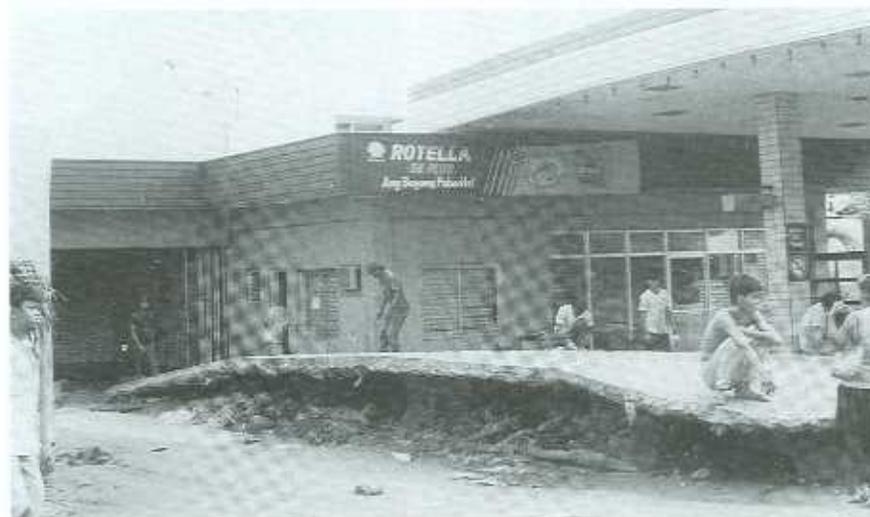
Figure 5.5 shows the damaged pavement of the gasoline station on Perez Blvd. where the underground fuel tanks floated up.

Fig. 5.5 – View of the gasoline Station on Perez Blvd. (near the collapsed Magsaysay Bridge) where the cement concrete pavement was entirely disrupted by liquefaction and, locally, by the buried tanks floating up. Details of the upheaval of the pavement (center and bottom) due to the floating of tanks (Courtesy of R Punongbayan)

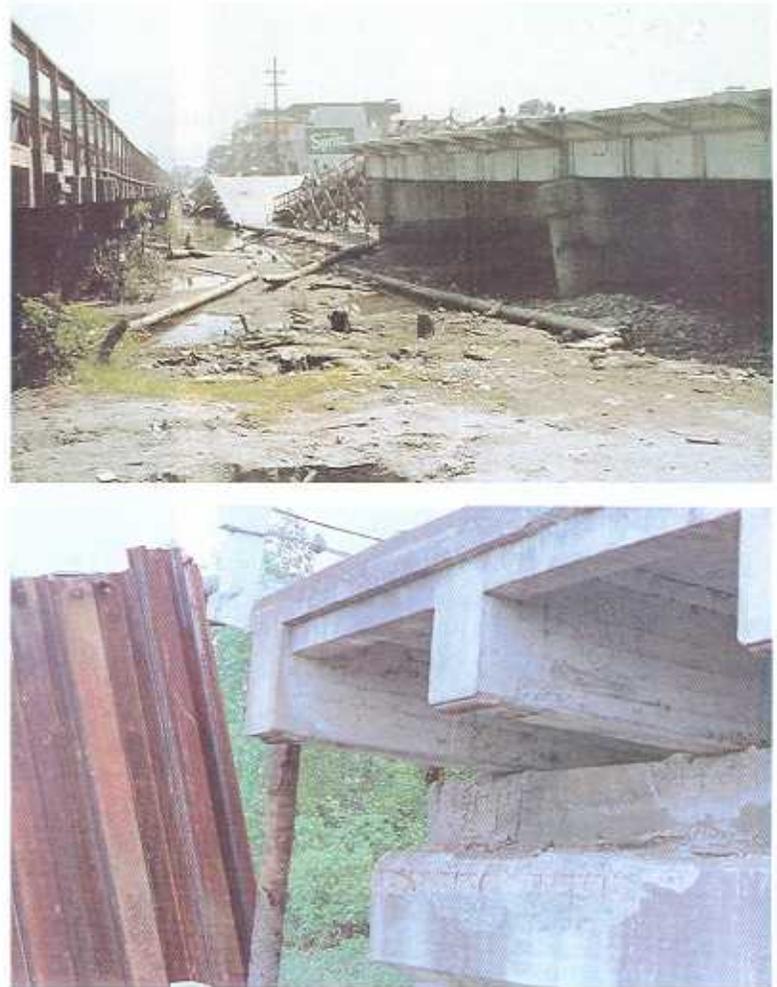
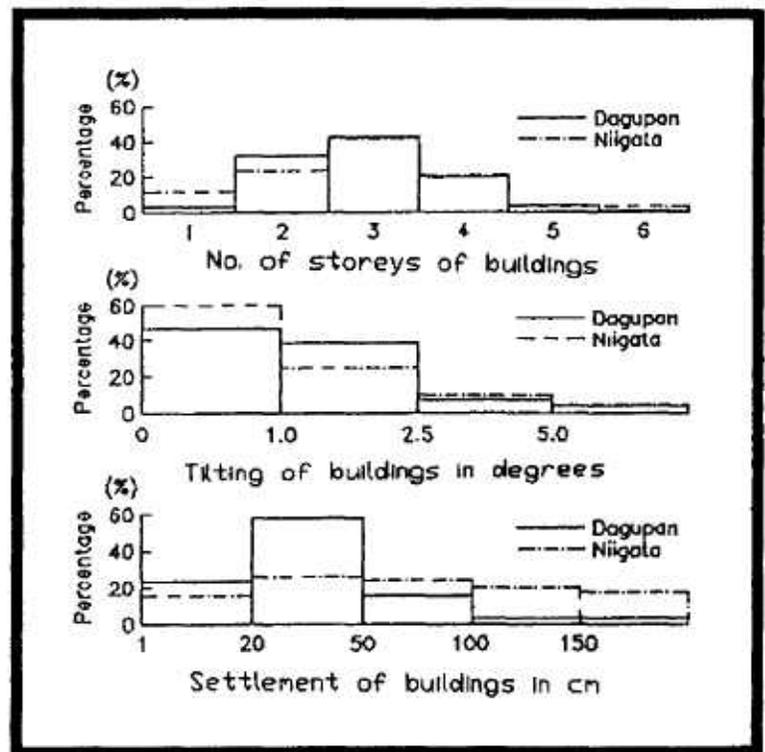
Statistics for the City (Tokimatsu, Midorikawa and Tamura, 1991) as of July 31, 1990, indicate that 200 commercial and residential buildings were totally damaged and over 400 buildings partly damaged. More than 1,200 houses were destroyed beyond repair and about 6,000 houses partially collapsed. Figure 5.7 shows the damage statistics for about 120 reinforced concrete buildings in the area affected by the quake compared with the ones for Niigata as a result of the 1964 earthquake.

Over 90% of buildings were sampled between Fernandez Ave. and Perez Blvd. Only a few had piled foundations and about half of them tilted more than 1 degree in the liquefied zone. Figure 5.7 shows that both Dagupan City and Niigata were affected by similar damage. Differential settlement and lateral displacement of foundations in both cases were the major causes of failure.

Fig. 5.7 – Comparison of damage in Dagupan City during the 1990 quake with that in Niigata (Japan) as a result of the 1964 earthquake (Tokimatsu et al., 1991)

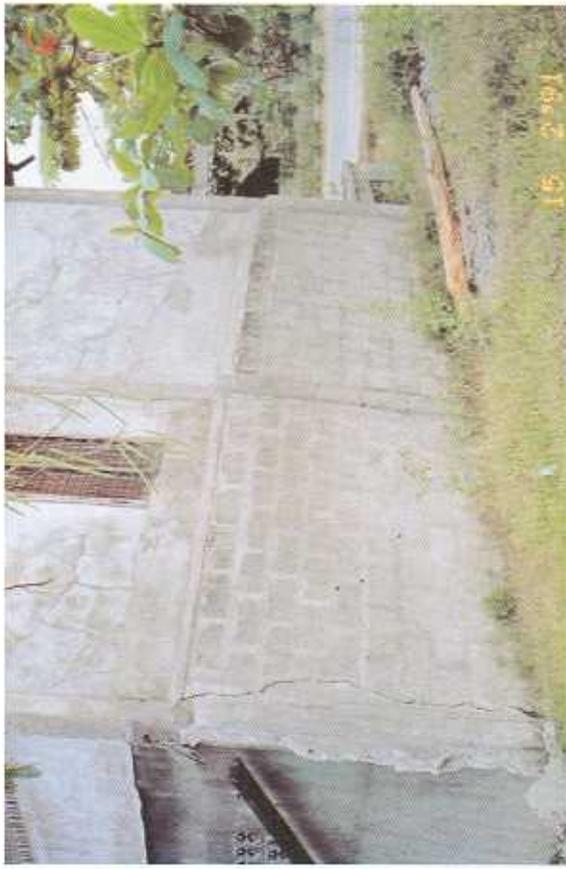
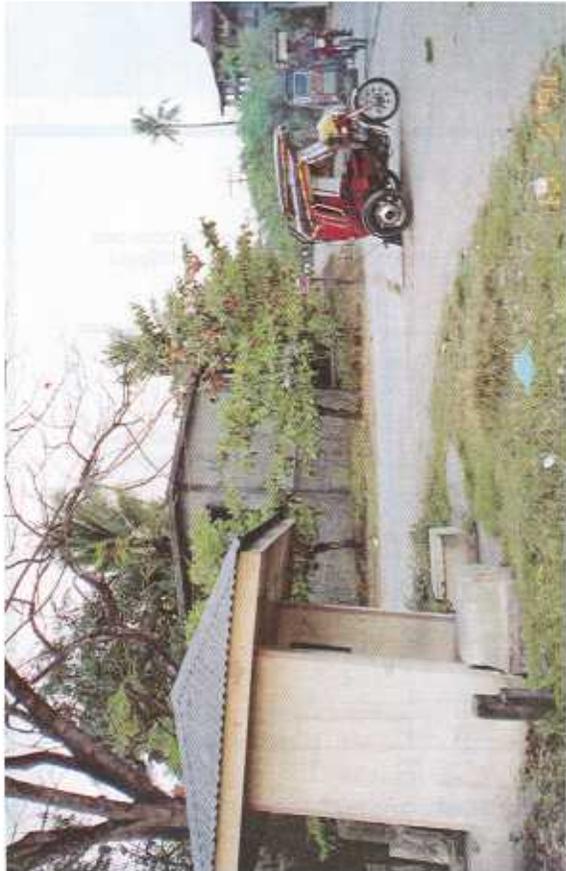
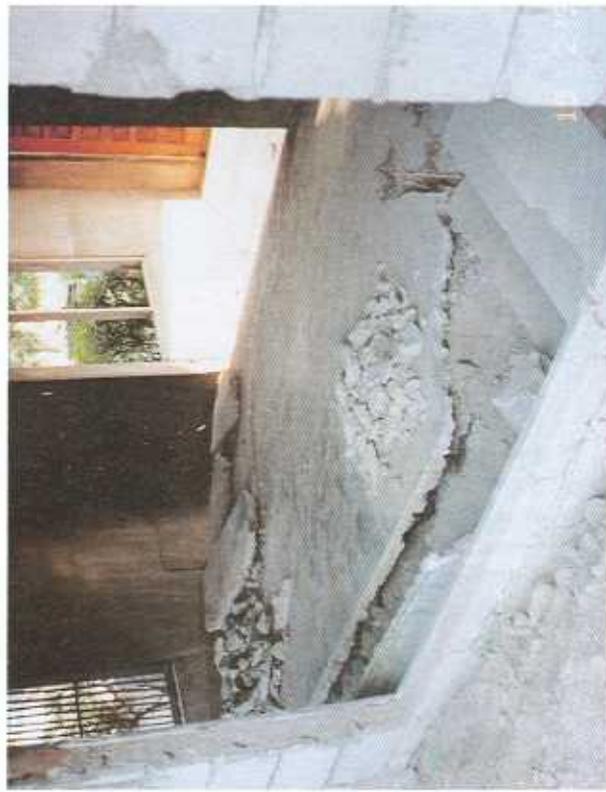
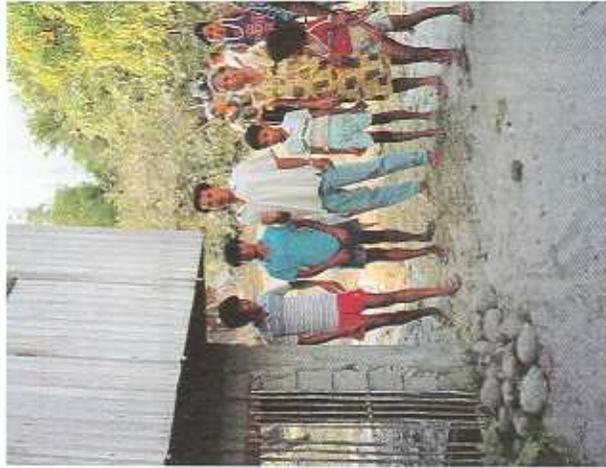
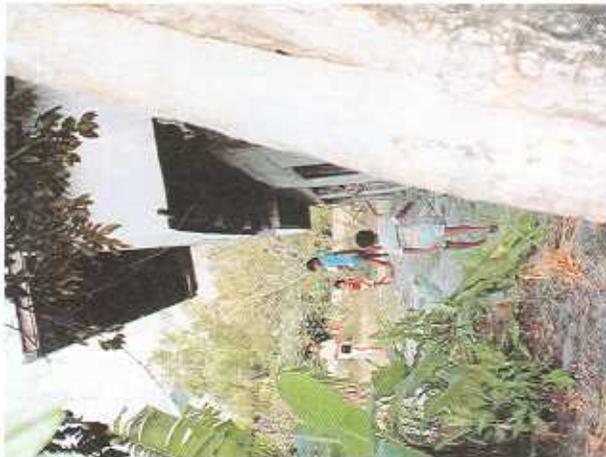
Fig. 5.8 – Tilted houses in Pura City Proper (top). Isolated house outside Pura City with over 1.3 m of uneven settlement, and tilting and the bulging of the pavement inside the house (bottom).

The liquefaction of soils hinders the propagation of highly destructive shear waves. Thus, the damage to buildings and structures in general was mainly due to tilting and huge differential settlement, there being only a few signs of cracks, the concrete framework often remaining intact. Figure 5.8 shows some typical examples of tilting and differential settlement associated with the July 1990 earthquake. The road network was entirely disrupted, with long embankment undulations, longitudinal cracks and separation of shoulders.

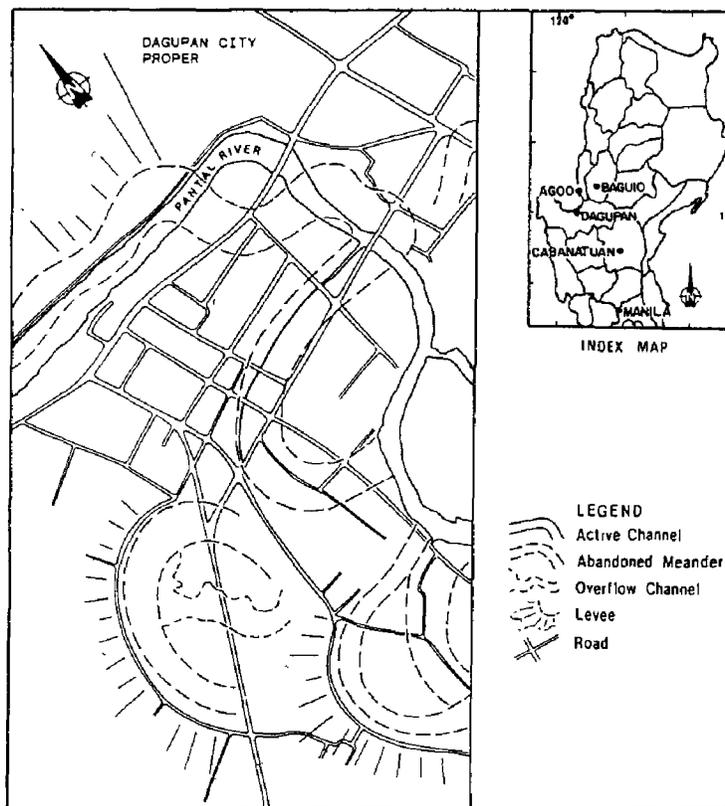
Fig. 5.9 – Abandoned channels of Pantal River in Dagupan City Proper. The meandering of the river, during its Quaternary migrations, and the related deposition of fine sediments coincide quite well with the location of areas severely affected by liquefaction and high structural damage (Punongbayan and Torres, 1990).

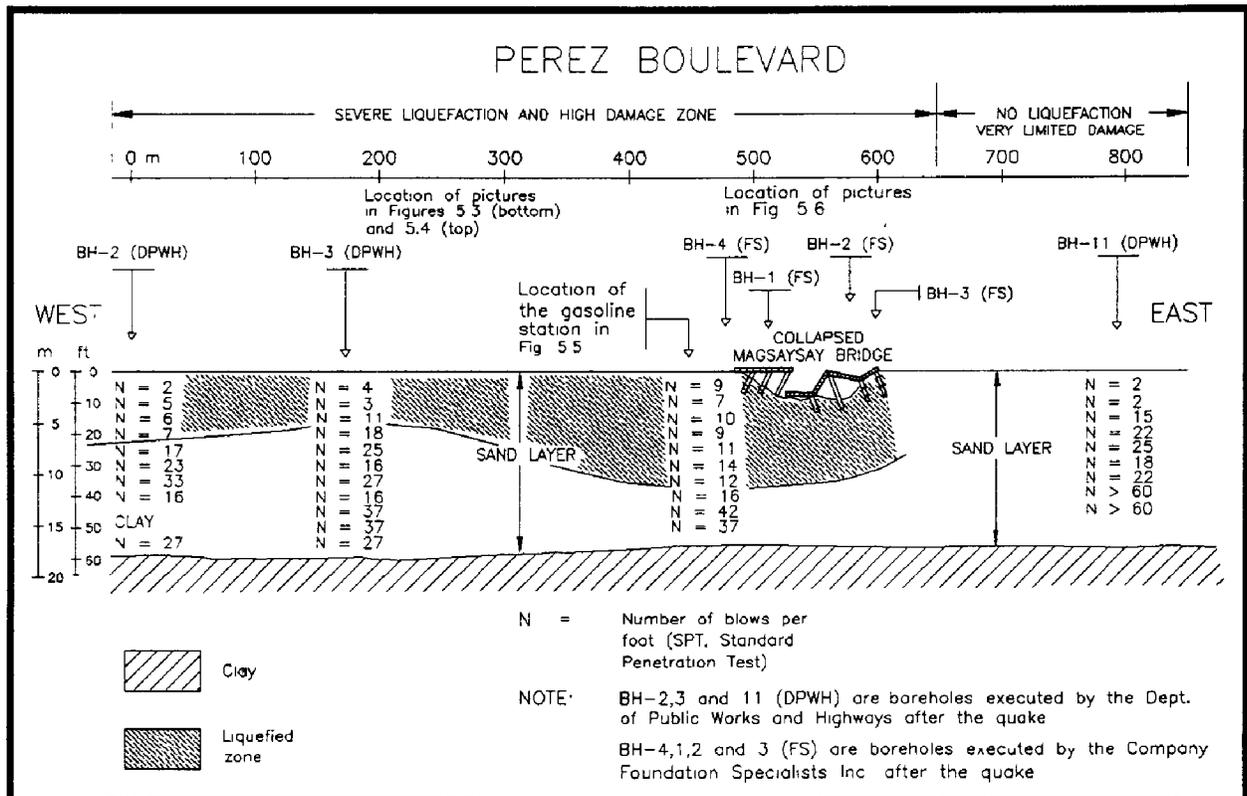
Fig. 5.10 – Cross-section along Perez Blvd. where the major damage and the most impressive liquefaction effects occurred. Shown in the section are SPT (Standard Penetration Test) data and the layer which underwent liquefaction during the quake.

In terms of safety factors it was found that F_1 was less than 1 for the top layer at the Magsaysay Bridge site and mainly greater than 1 for the same stratum at the PLDT Building.

In conclusion, the entire layer from ground surface down to a depth of 7 to 10 meters underwent liquefaction along a 600 m long cross-section in Perez Blvd. during the quake (Fig. 5.10). Severe damage involved most buildings in this area, several of them being affected by considerable uneven settlement and spectacular tilting. It is worthwhile to recall that the collapsed Magsaysay Bridge is located very near the gasoline Station where buried tanks floated up and the structural damage was most severe.

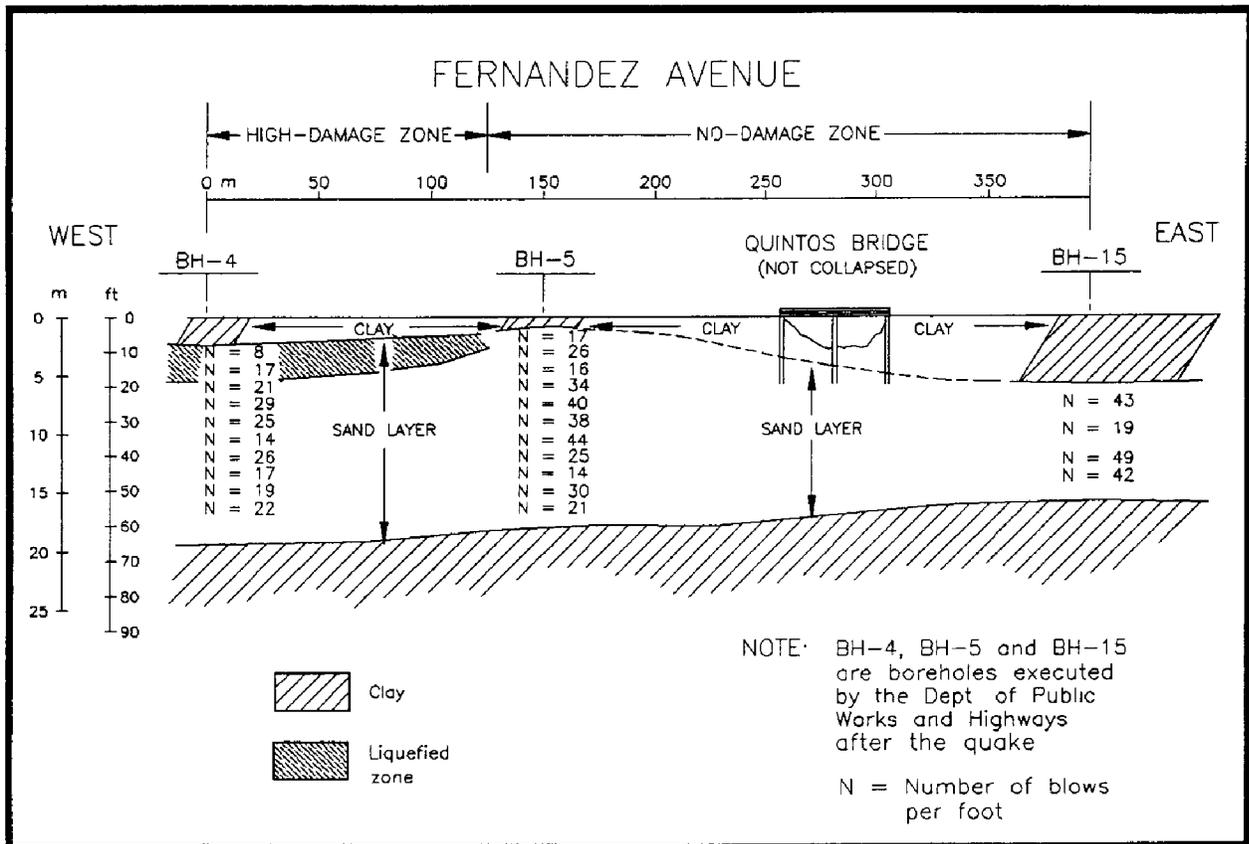
Fig. 5.11 – Cross-section along Fernandez Avenue. Roadside buildings along the high damage zone were affected by quasi-uniform sinking. The section shows SPT data and the layer affected by the liquefaction.

A thin liquefaction zone was identified along Fernandez Ave. (Fig. 5.11), where buildings mainly underwent a quasi-uniform settlement (90-120 cm).
