## SECTION 2

### WATER SYSTEM DAMAGE DUE TO PRIOR EARTHQUAKES

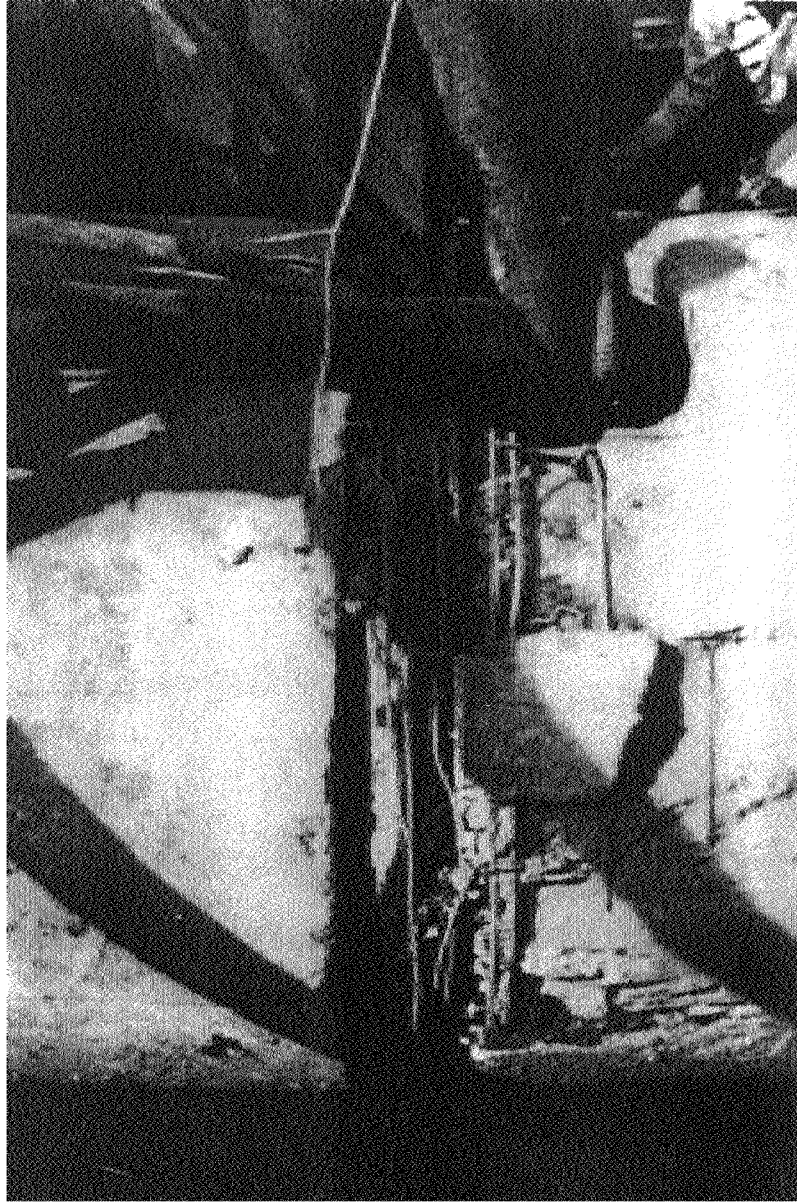
The 1979 Guerrero earthquake damaged a 72"φ buried reinforced concrete aqueduct at 10 locations along its 6 kilometer length in southeast Mexico City. Figures 2-2 and 2-3 show typical damage. Pipeline failures were mainly the result of tension and/or compression at joints. In order of incidence, the failures were due to compressional crushing at the bells, pull out accompanied in some instances by rotation at the joints. An evaluation of the damage indicates that the failures were due to a lack of flexibility in the system as opposed to a lack of strength, [1] and [2]. The repair method used consisted of either replacing the broken pipes or repairing the joints with a bolted steel collar. Unfortunately neither of these procedures improve the deformation characteristic (ie, flexibility) of the pipeline joints. Replacing the broken pipes theoretically returns the system to its pre-earthquake

FIGURE 2-2 Aqueduct Damage During 1979 Guerrero Earthquake

condition, hence leaving it vulnerable to future seismic damage. Repairing with a bolted steel collar has the effect of marginally reducing the overall flexibility of the system as a whole, and does not prevent damage at adjacent joints during future earthquakes.
