6.1.3. Analysis of Transmission Systems Damage

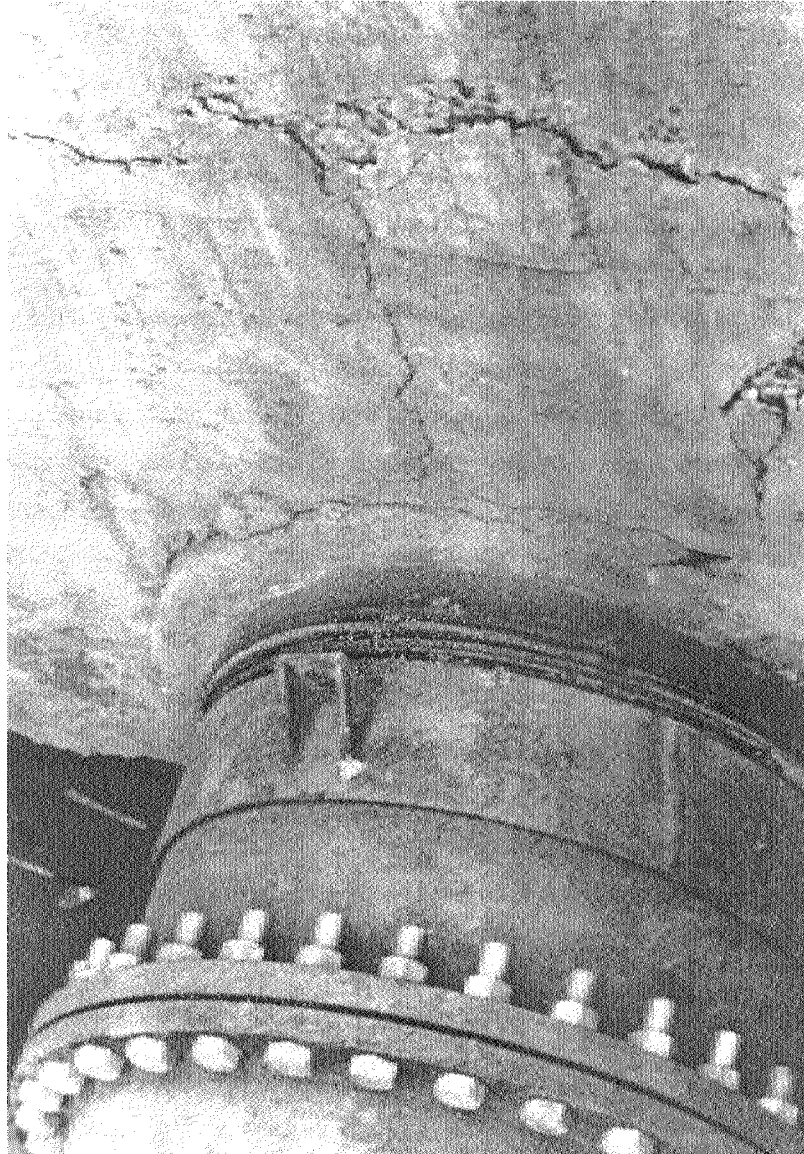
FIGURE 6-7 Cracking At A Valve Box Wall
