6.2 Distribution Systems Damage

6.2.1 Primary Distribution Pipelines in D.F.

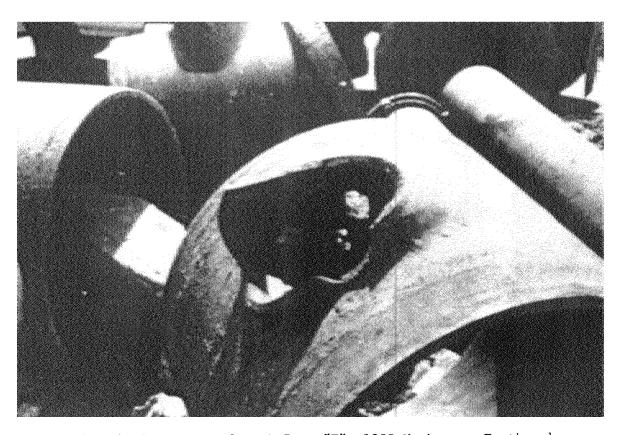
FIGURE 6-13 Fractured Cast Iron "T", 1985 Michoacan Earthquake
