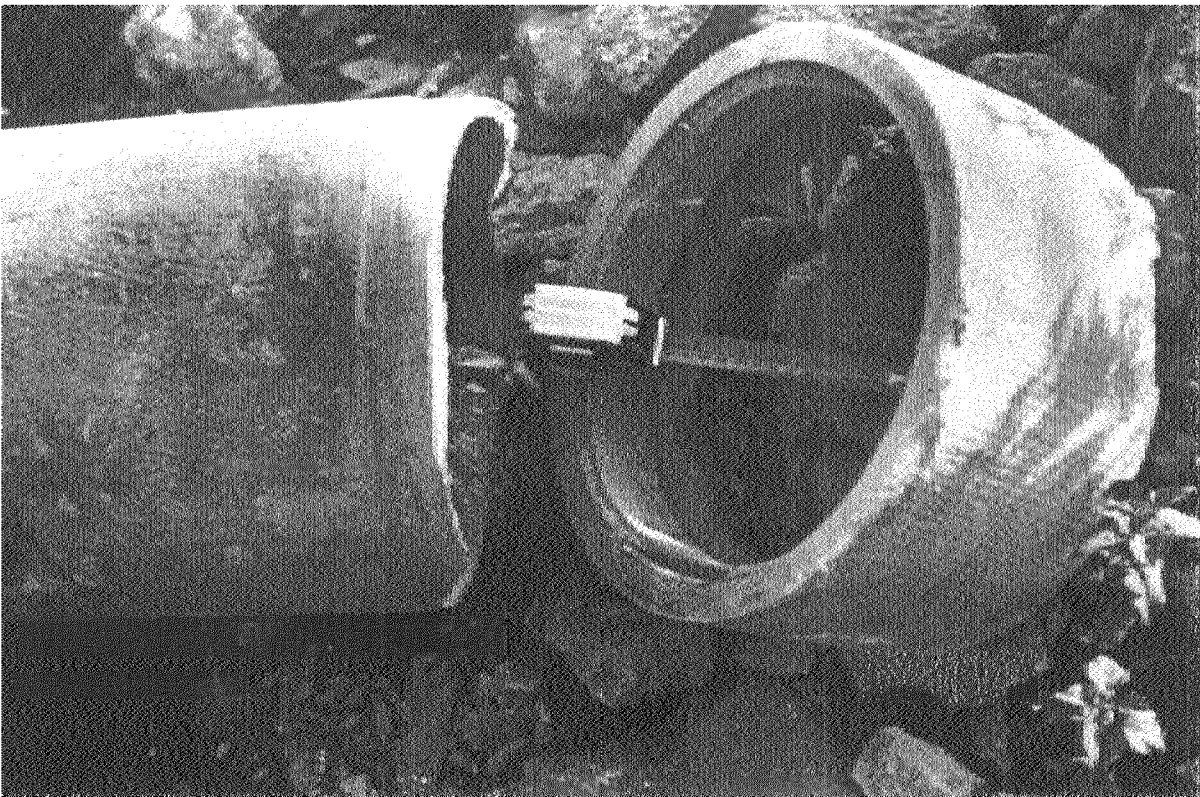
FIGURE 6-17 Break Near Joint Of An Asbestos Cement Pipe, 1985 Michoacan Earthquake
