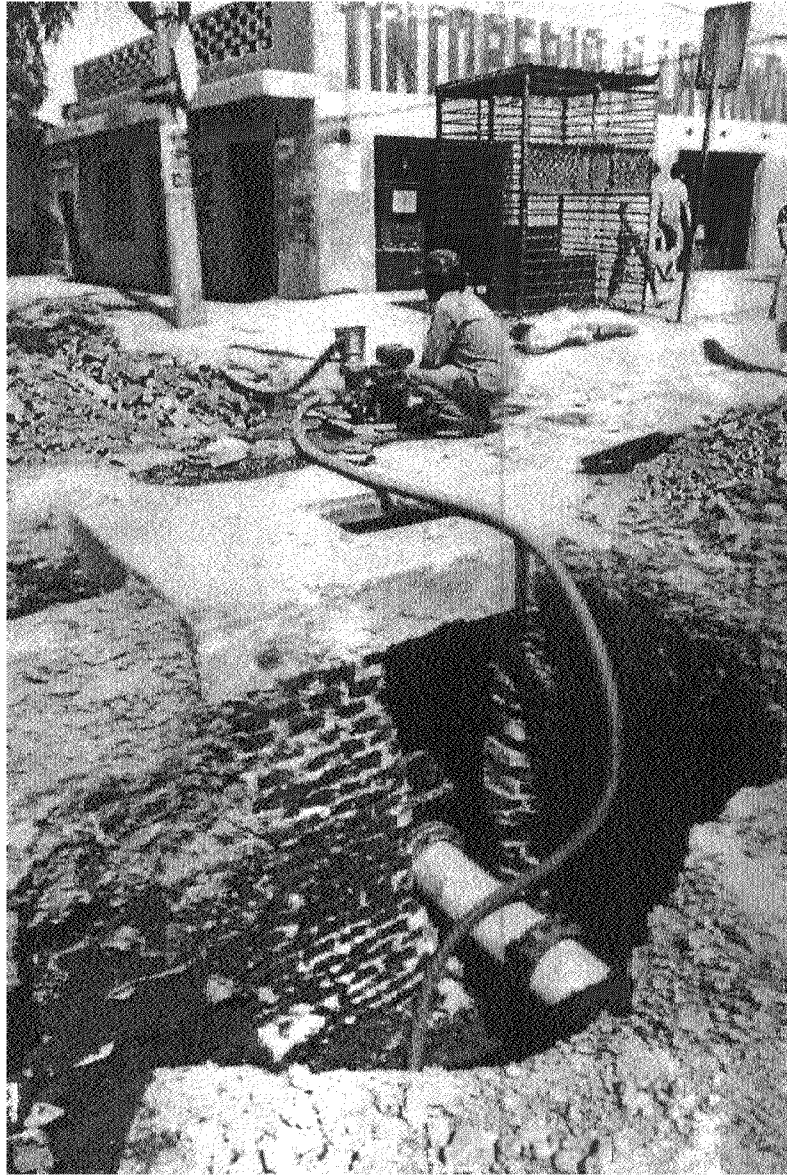
fixed points such as crossings, bends, 'T's', valve boxes etc., as shown in figure 6-18. Failures in the body of the pipes were less frequent and from discussion with engineers in charge of the repairs, these occurred along pipes already weakened by relative settlements which is common in all the urbanized areas of the Lake Zone. As may have occurred in the D.F, some of the failures may have occurred at the joints weakened by differential settlements. The failure rate for Ciudad Nezahualcoyotl was .831 breaks per km.

FIGURE 6-18 Repaired Leak At A Valve Box
