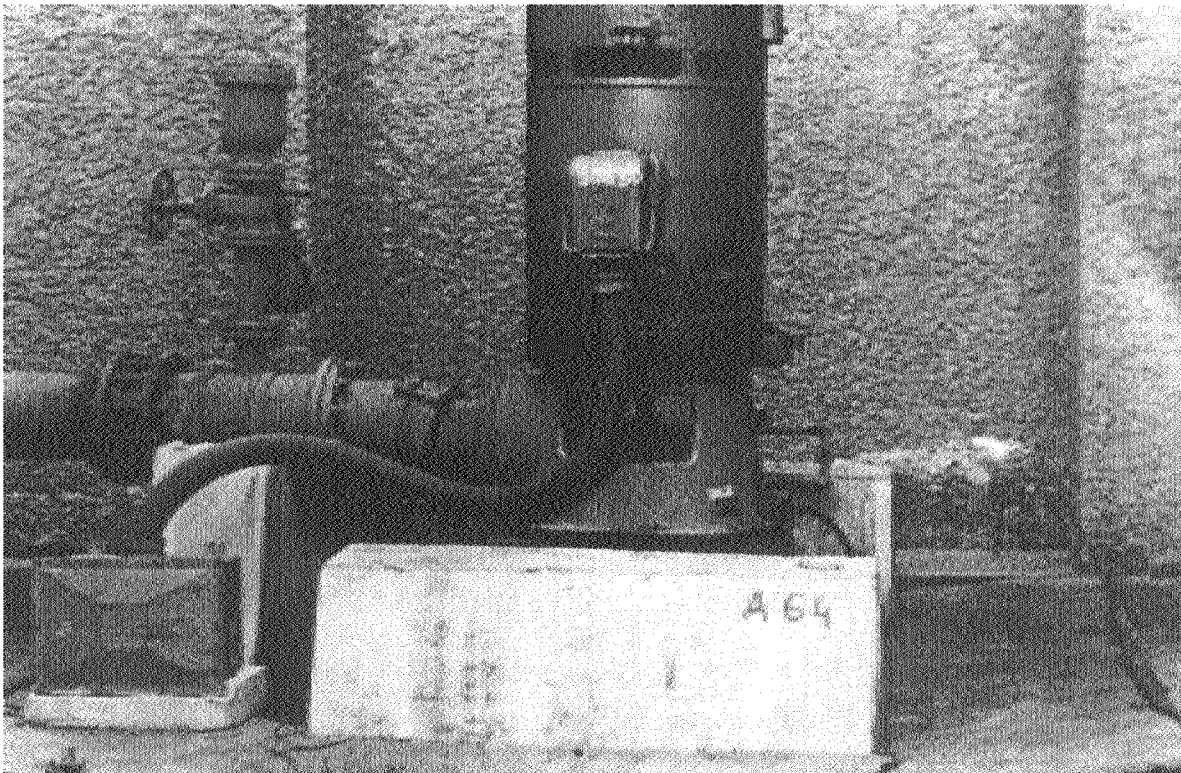
FIGURE 6-19 Well Damage At 'La Caldera' Tank, 1985 Michoacan Earthquake

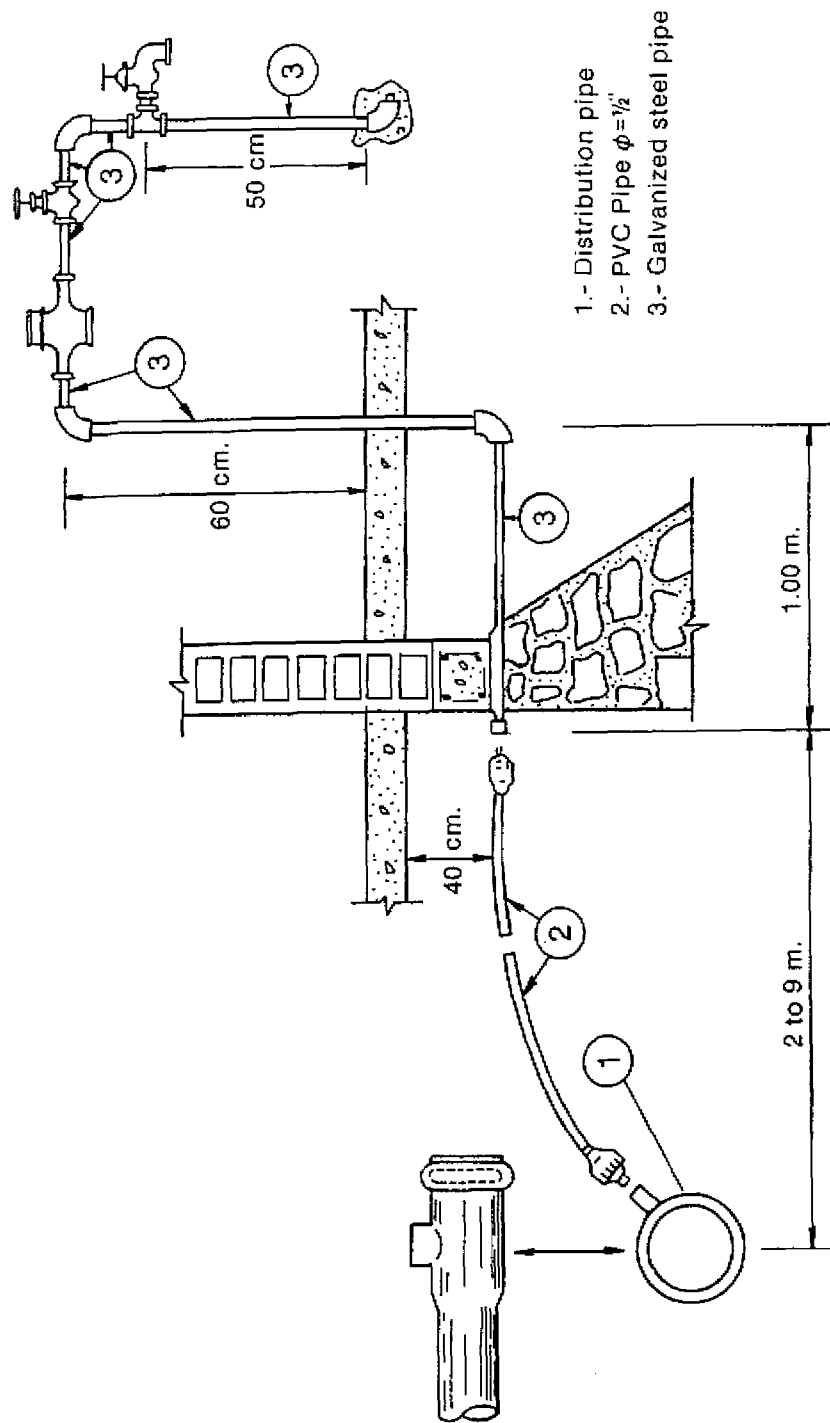
and also produced a relatively rigid connection at the street main service connection interface. On the other hand, service connections in the State of Mexico were made of plastic materials such as PVC. A typical flexible service connection that behaved successfully during the Michoacan earthquake is shown in figure 6-20.

Apparently the flexible service connections used in the State of Mexico were able to accommodate, without failure, the seismically induced ground deformation. Many of the more rigid service connections used in the Federal District typically broke at the service connection street main interconnection point when subject to similar intensities of ground deformation.

FIGURE 6-20 Typical Residential Service In The State Of Mexico (E.de.M.)

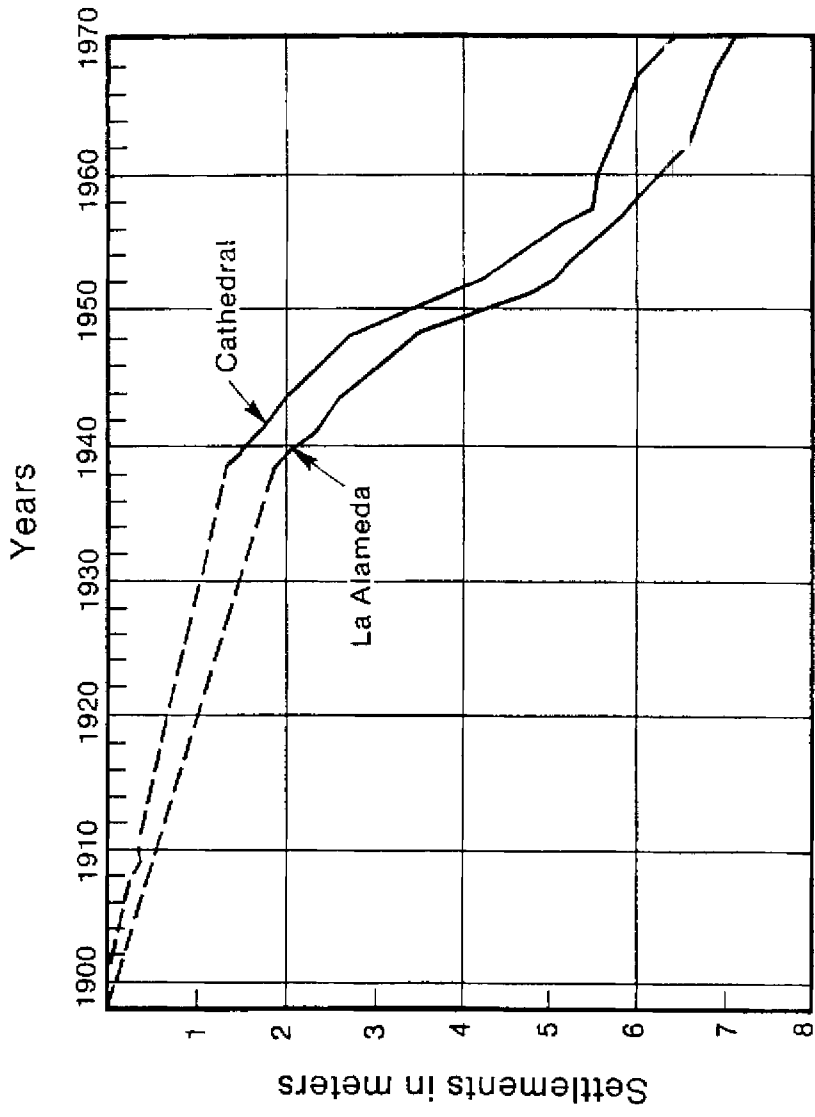
As mentioned in section 6.1.3, long term subsidence is a possible contributing factor to seismic damage experienced by the Mexico City water systems. This subsidence is due to the removal by pumping of subsurface water and is most pronounced in the older parts of the city. Ground settlement versus time for two sites in the older part of the city is shown in figure 6.21. Note that during the thirty year period from 1940 to 1970, the ground settled about 5 meters at these two sites.

FIGURE 6-21 Settlement Vs. Time For Two Sites In Mexico City (After [5])

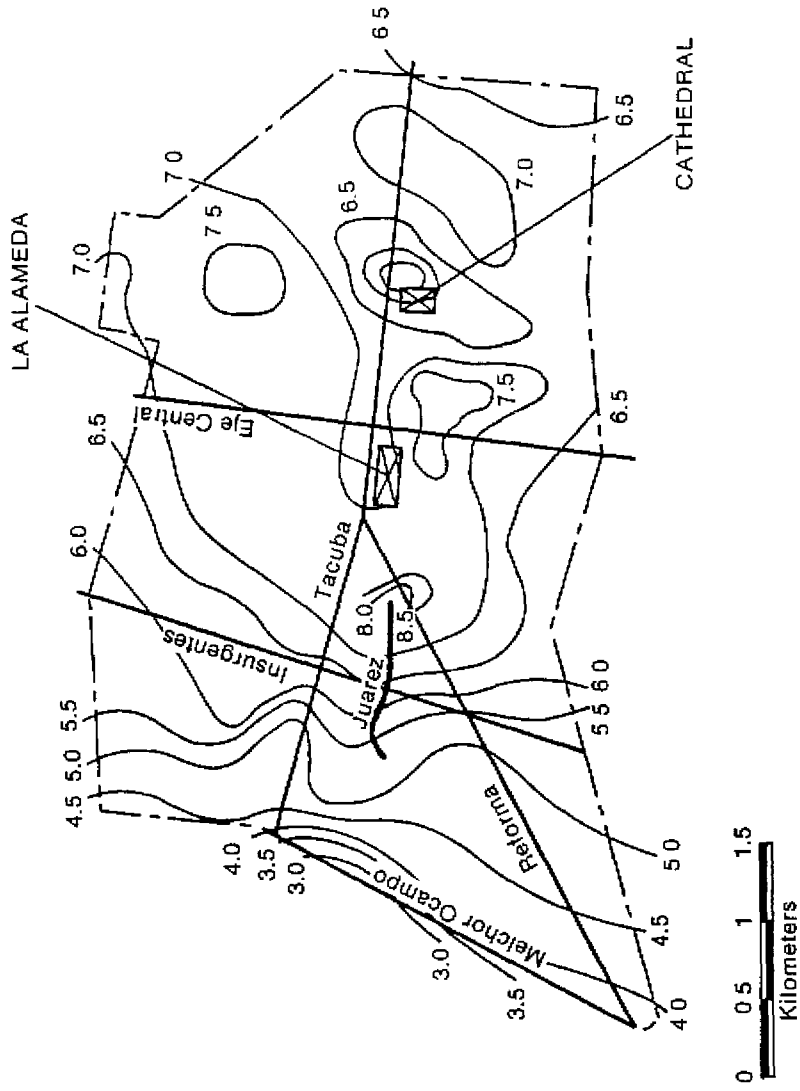
The settlement however was not uniform as shown by the equal subsidence contours in figure 6-22. In 1970 the settlement along Melchor Ocampo was between 3.0 and 3.5m. while the settlement along one section of Avenue Juarez was 8.5m. These two locations are separated by about 2000m. Assuming the 2 km separation distance between the Melchor Ocampo and the Ave. Juarez sites remained constant since the turn of the century, (ie since substantial subsidence began) the subsidence induced ground strain between the two sites would have been about 3.1×10^{-6} in 1970. This subsidence induced ground strain is illustrated in figure 6-23.

FIGURE 6-22 Contours Of Equal Subsidence In Old Mexico City As Of 1970 (After [5])

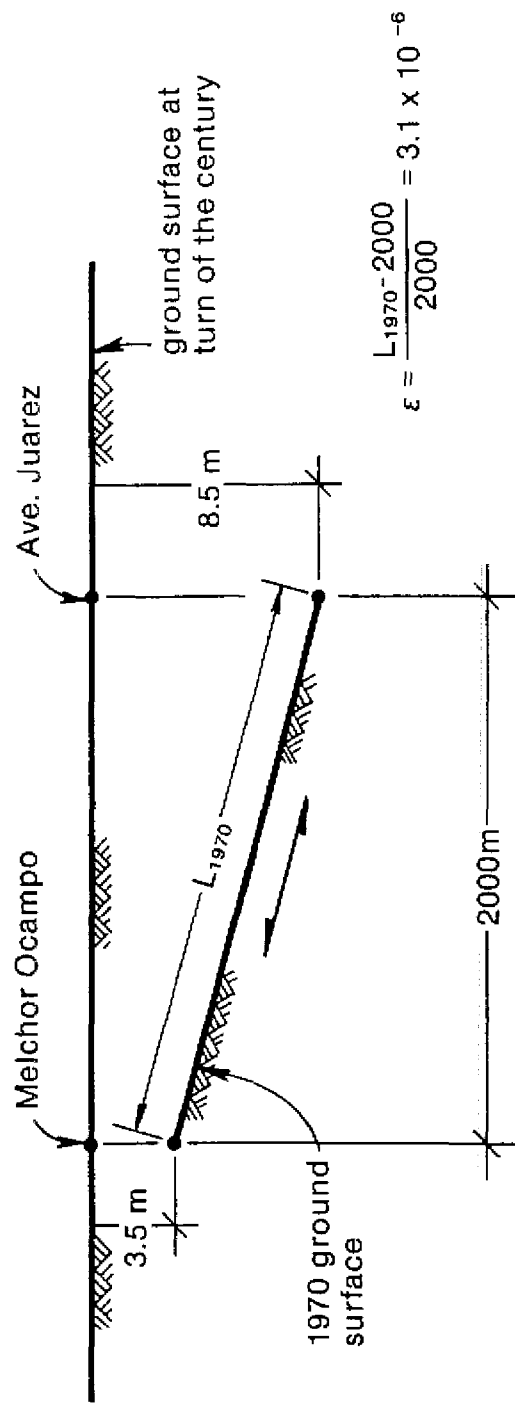
As will be shown in Section 7, the earthquake induced ground strain in the Lake Zone soils are estimated to be at least two orders of magnitude larger than the subsidence induced ground strain calculated above. Hence although subsidence surely caused deformation at the joints of the segmented water

FIGURE 6-23 Ground Strain In Old Mexico City Due To Subsidence As Of 1970

system piping of Mexico City, it appears to be a second order effect vis-a-vis seismic wave propagation effects.

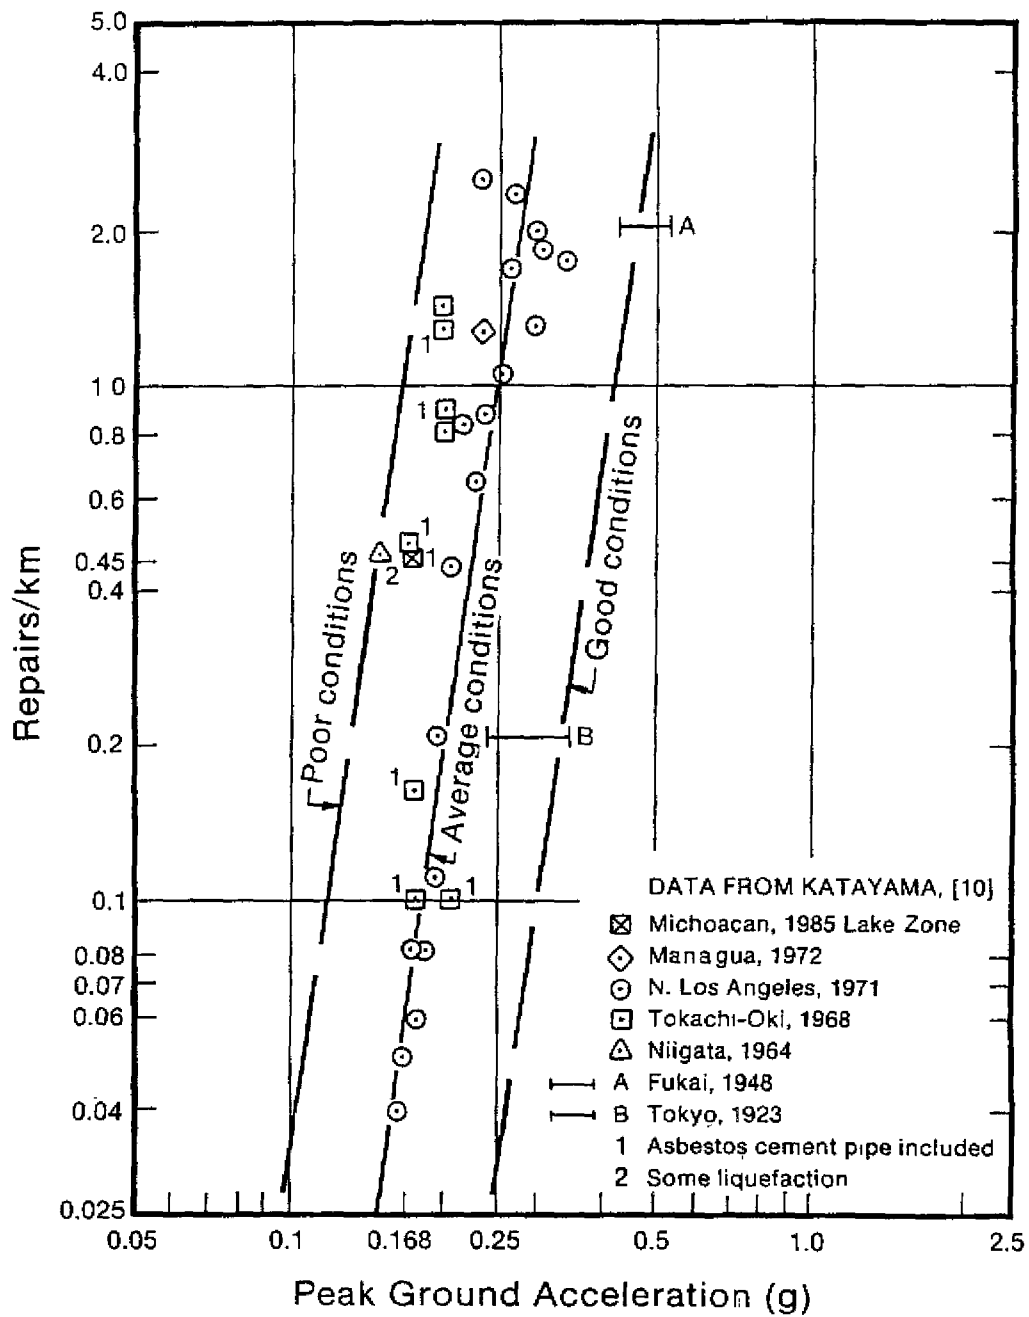
Figure 6-24 shows data on pipe repairs versus peak ground acceleration, presented by Bresko [9], and based on damage data gathered by Katayama, [10]. Mexico City data for the Lake Zone is included in this figure. It can be seen that data from Mexico City falls within the band of damage data of other major earthquakes. Bresko suggests, based on these data, that failure rates can be expressed in terms of maximum ground acceleration as

$$\log N = A + 6.39 \log a_{\max} \dots \dots \dots (6.1)$$

where N is the number of repairs per kilometer, a_{\max} is the maximum ground acceleration and, A is a function of factors such as soil conditions, pipe age, etc., and is defined as 4.75, 3.65 and 2.20 for poor, average and good conditions respectively.

FIGURE 6-24 Pipe Repairs Per Km. Vs. Peak Ground Acceleration For Lake Zone In Mexico City 1985 And Other Historic Earthquakes

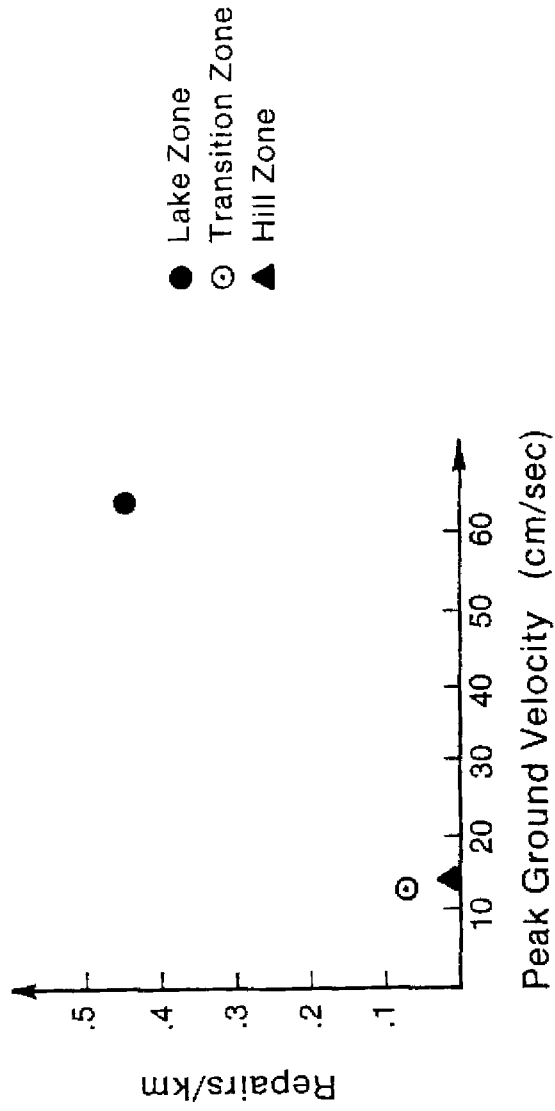
Theoretical analysis suggests that seismic wave propagation induced ground strain is proportional to peak ground velocity. Figure 6-25 presents the average damage ratios in Mexico City, per soil zone versus peak ground velocity. As one might expect, the peak ground velocities and damage ratios are high in the Lake Zone. However the damage ratio in the Transition Zone is somewhat higher than that in the Hill Zone although the peak ground velocities are comparable. This difference between Transition and Hill Zone damage ratios could be attributed to additional incoherence in ground motion in areas with changing soil types (such as the Transition Zone).

FIGURE 6-25 Damage Ratio Vs. Peak Ground Velocity, Mexico City 1985

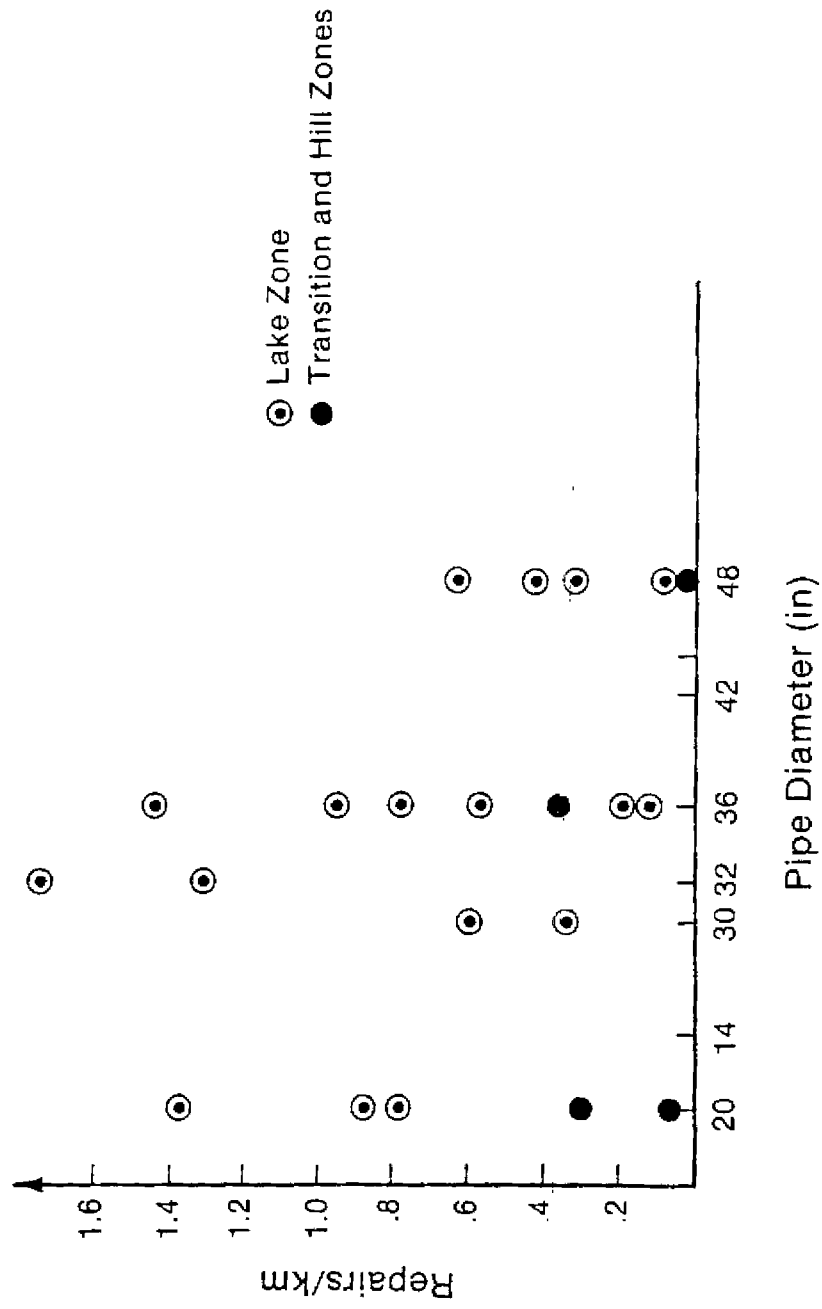
A graph of damage ratio for primary distribution piping vs pipe diameter is shown in figure 6-26. It may be observed that, as previously mentioned by Katayama [10] and others, damage ratio tends to be smaller as pipe diameter increases. Also, as expected, pipeline damage was larger in soft soils than in hard soils as may be observed from the data in table 6-VI.

FIGURE 6-26 Damage Ratio Vs. Pipe Diameter, Mexico City 1985
