### **Chapter 3**

#### **EARTHQUAKE EFFECTS TO URBAN AREAS AND LAND INSTABILITIES**

##### **3.1. Dominant Earthquake Effects in Baguio City**

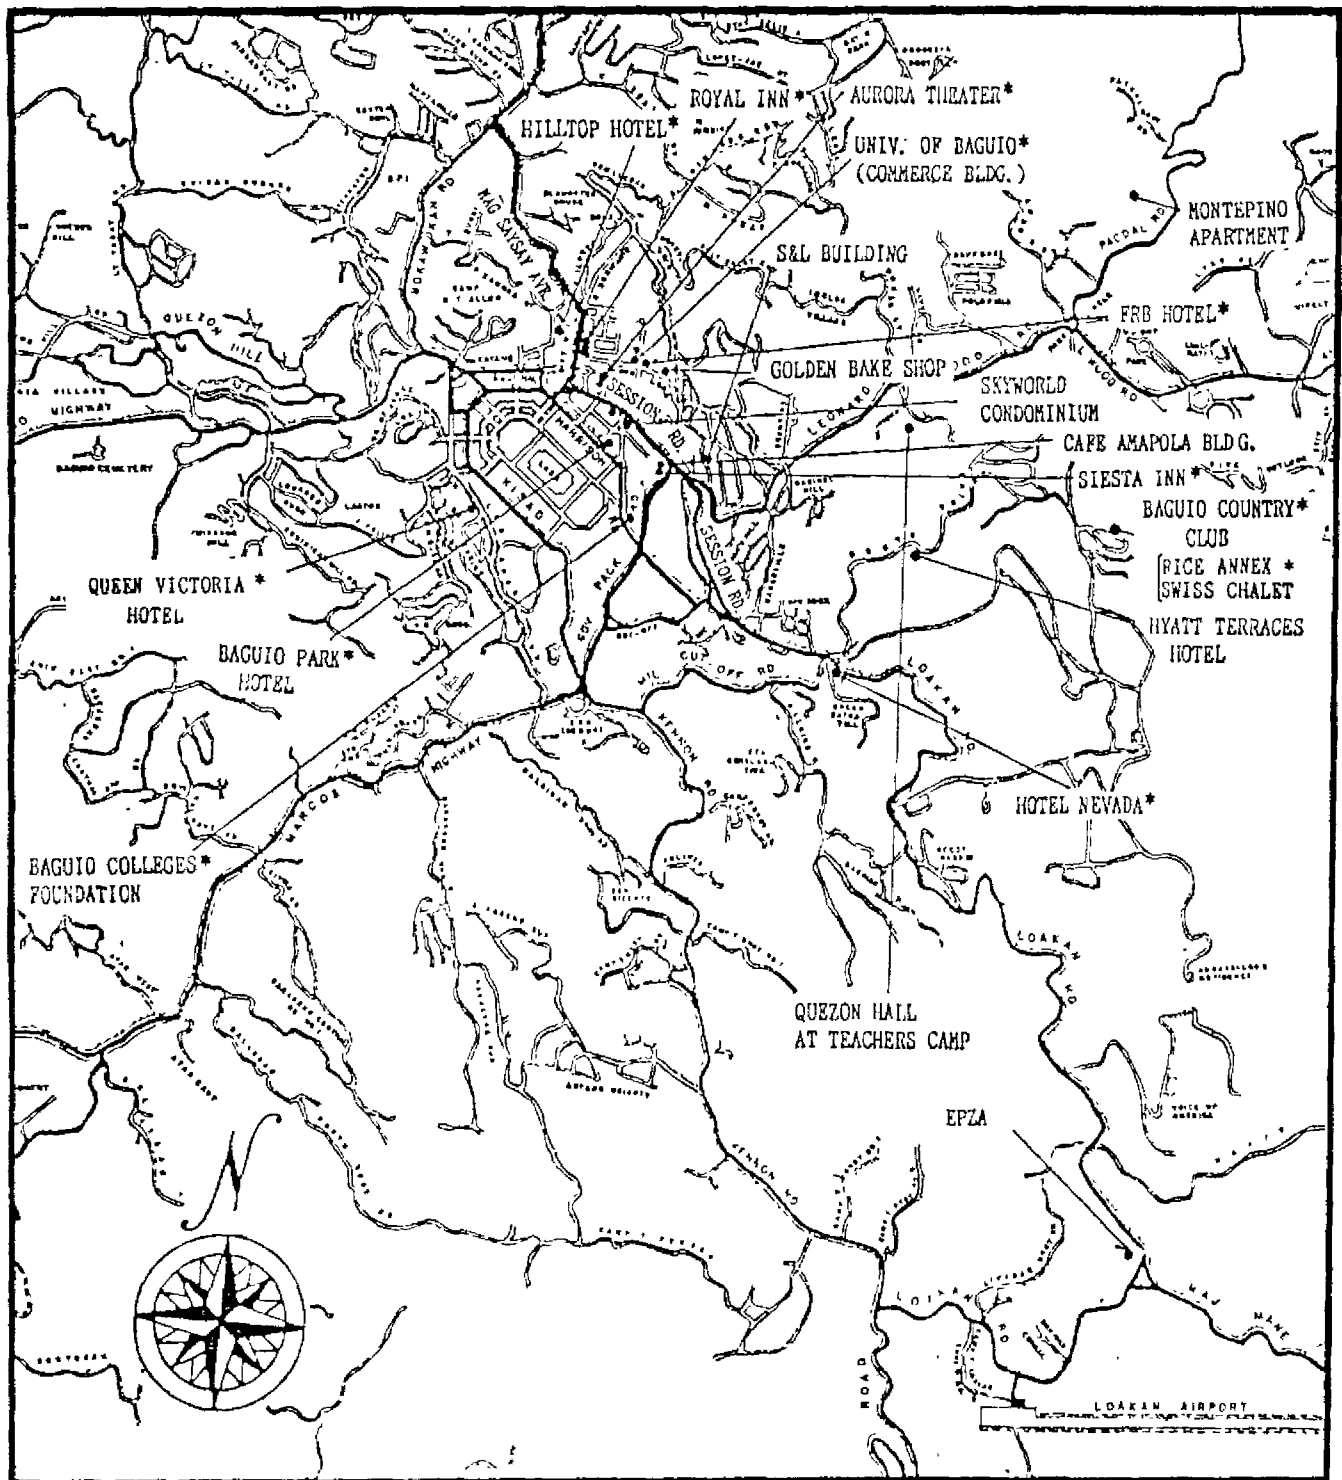
Summarizing the dominant effects of the Luzon Earthquake of 16 July 1990 in Baguio City it could be concluded that most of the highrise buildings of modern 5 - 11 storeys reinforced-concrete structures collapsed in most unfavourable modes of failure exhibiting misconceptual earthquake resistance design typical "one line of defense" of low ductility frame structural systems. Failure of most of these buildings was the main reason for 385 deaths and 1102 injuries representing the largest concentration 38.1% of human casualties out of total in this earthquake. In average, Baguio City experienced significant damage to the residential, schools, hospitals, public and in particular commercial and industrial buildings.

Fig. 3.1 Distribution of modern collapsed (\*) or heavily damaged buildings in Baguio City due to the earthquake (from 4, Architectural Institute of Japan; 10 October 1990).

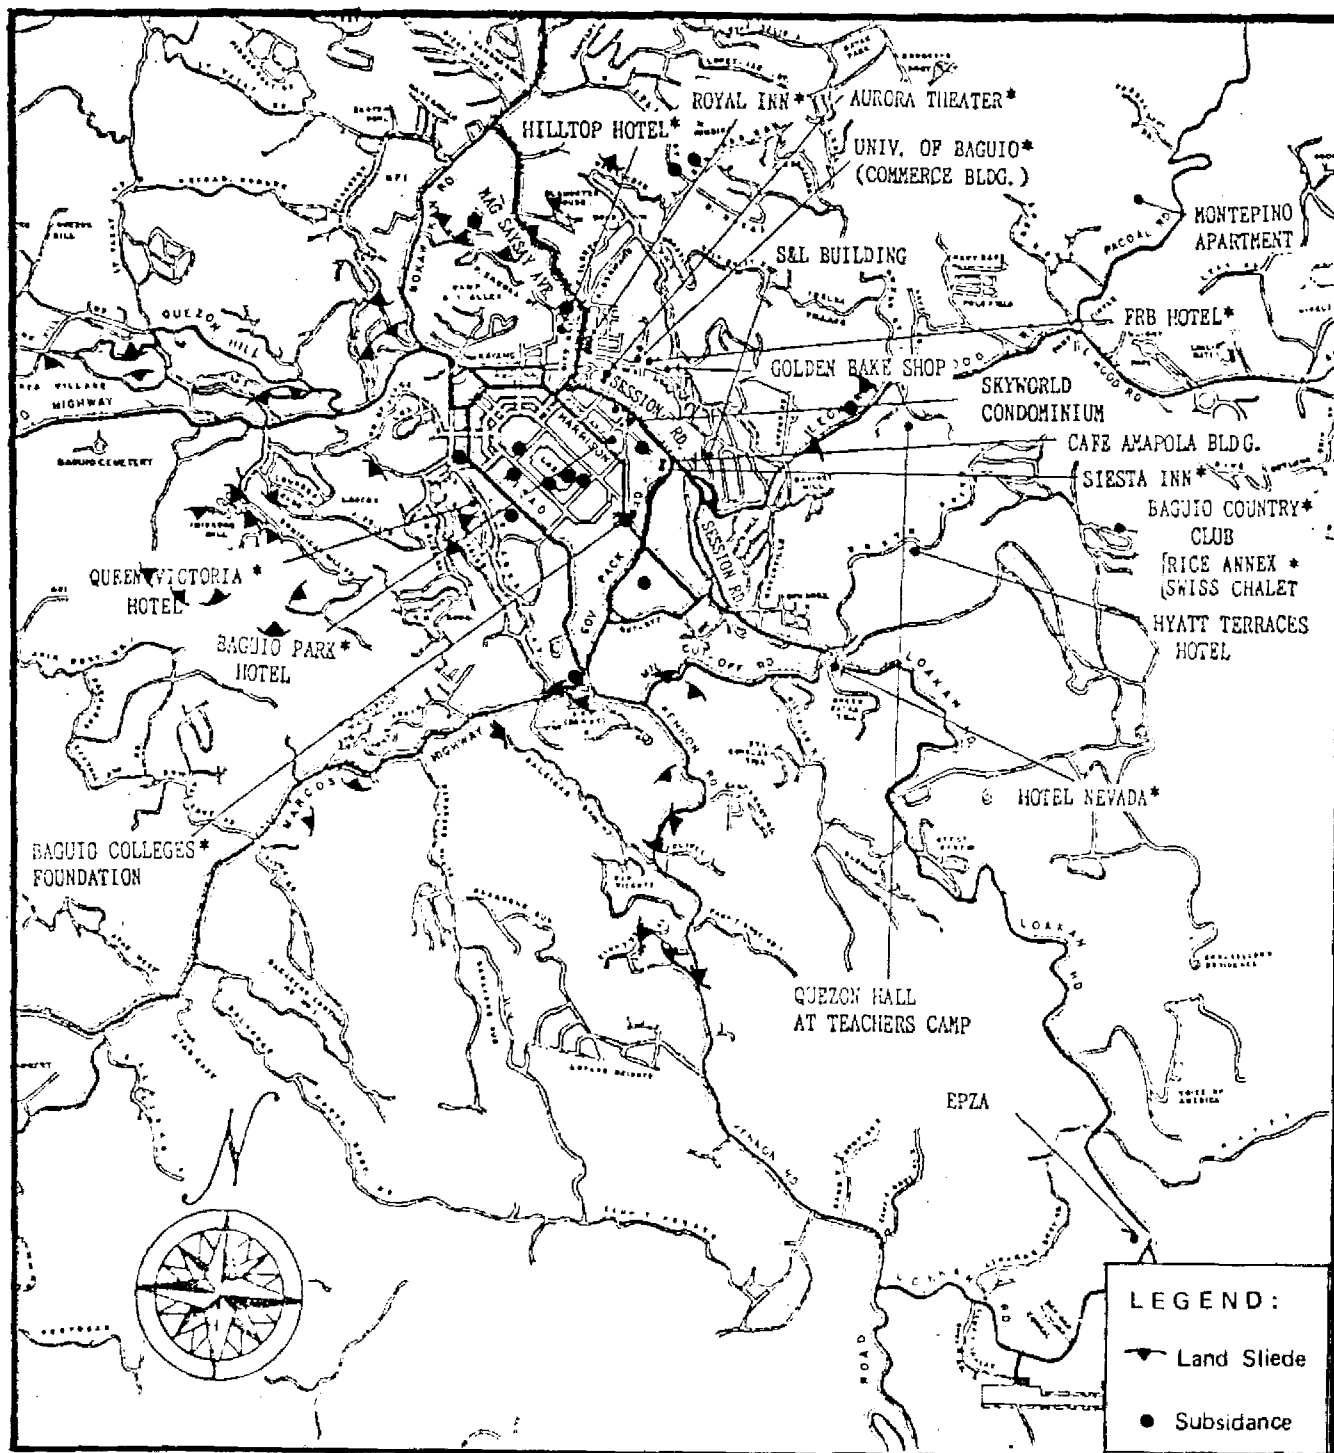
30 - 40%g (JSCE and Midorikawa, 1990), and partially to pronounced landslides and subsidence triggered by the earthquake (Fig. 3.2) as well as to extremely low earthquake resistance of modern reinforced concrete 4 - 11 storeys structural systems, which is dominated by the following major reasons:

Fig. 3.2 Distribution of sites in Baguio City with observed pronounced land instabilities: landslides; subsidence (from 1, DENR - NGB Task Force, August 8, 1990).

It is recommended urgent elaboration of preliminary seismic land capability map which should be a synthesis map of the expected vibrational effects, land instabilities (land slides, rockfalls, subsidence, etc.) and earthquake damage potential of the existing elements at risk (buildings by structural types, lifelines, transportation, power and communication systems) for a return period of 200 years. This seismic land capability map should be based on engineering geology, hydrogeology and geotechnical maps with particular identification of slope ranges and their expected instabilities for the determined levels of the earthquake ground motions by performing of detail seismic zoning of the entire urban area and vulnerability analysis of the existing elements at risk, as well as strong motion instrumentation.

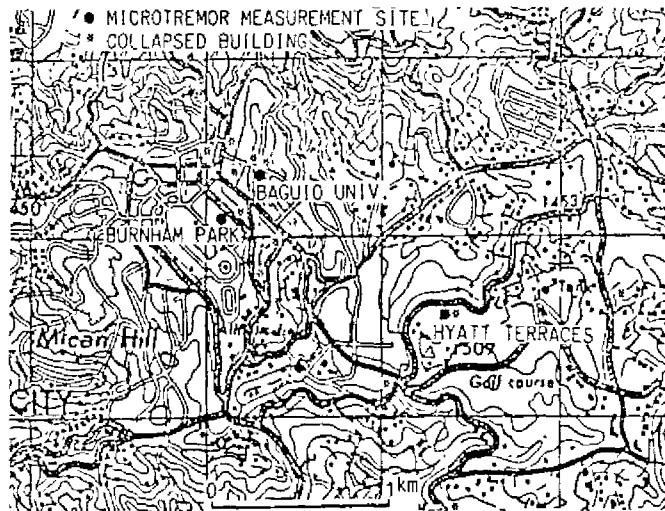
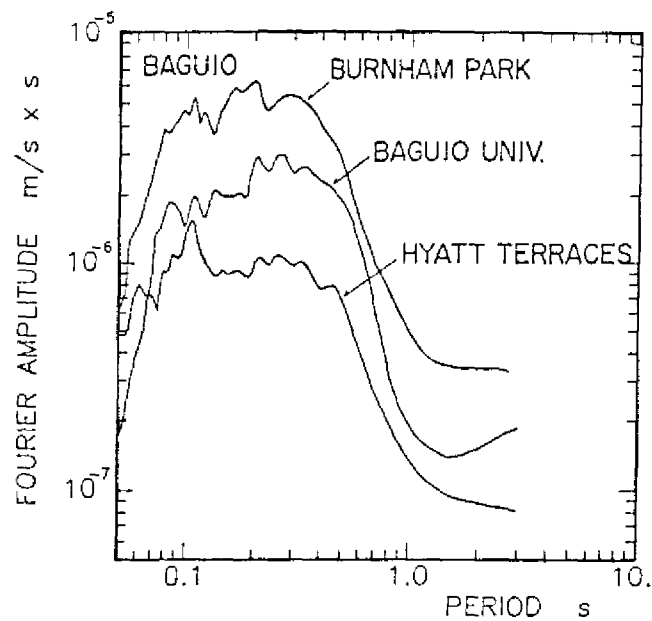
Fig. 3.3 Comparison of Fourier Spectra of microtremors measured at the sites of Burnham Park, Baguio University and Hyatt Terraces, Hotel in Baguio City (from Midorikawa, S., 1990).

guio, microtremors were measured at the sites as shown by solid circles in Fig. 3.3, together with the Fourier amplitude spectra for horizontal components at the same three sites in Baguio. The spectral shapes are similar to each other: the spectral amplitude are almost constant in period of 0.1 to 0.4 seconds, and become much smaller in period longer than 0.5 seconds. No predominant peaks are found in the spectra. The amplitude level is, however, different at each site. The difference may be not due to site effects, but due to different level of artificial disturbances which excite microtremors; Burnham park where the amplitude of the microtremors is largest, is just on the center of the city with heavy traffic, and Hyatt Terraces is on calm upland about one kilometer far from the center.

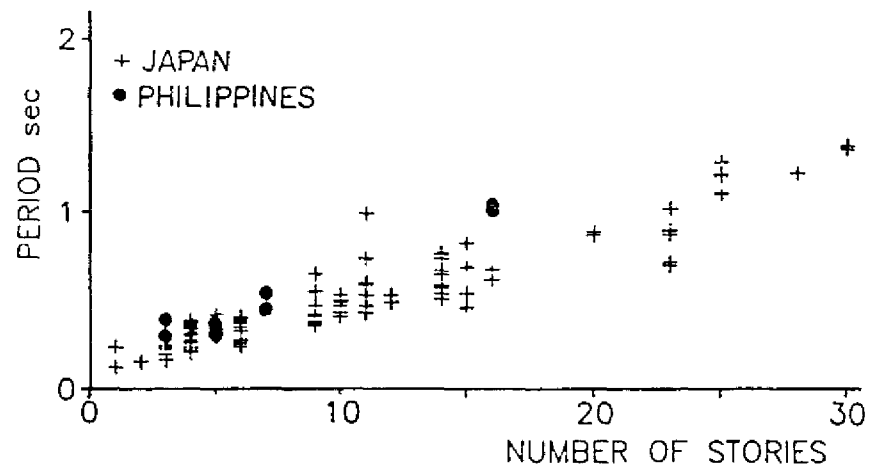
Fig. 3.4 Measured first mode period of vibration of the selected hotel buildings in Cabanatuan, Dagupan, Baguio, and Manila; and relationship of period of vibration with number of storeys of the measured buildings in Philippines and compared with similar height buildings in Japan (from Midorikawa, S., 1990).

ambient vibrations were measured at the top of the buildings, and the natural period of vibration and damping were determined by spectral analysis of the ambient vibration. No damage was observed for the buildings at Dagupan and Manila. Only minor cracks were found on infill walls in the buildings at Cabanatuan and Baguio. Fig. 3.4 shows the relation of period of translational vibration with number of stories. Data for reinforced concrete buildings in Japan are also plotted by cross. The relation for buildings in Philippines is almost the same as that for buildings in Japan; the period in second is approximately one fifteenth of number of stories. This means that the collapsed four to eleven storied buildings in Baguio would have the natural period of 0.3 to 0.8 seconds in small amplitude level. During strong shaking, however, buildings may show non-linear behaviour and the natural period may be much longer than that in small amplitude level. The data for Japanese buildings showed that the period becomes abruptly longer when the response acceleration at the top of the building exceeds  $20\%g$  (after Midorikawa, S, 1990). This could be valid in particular for most of the 4 - 11 storey buildings exhibiting failure in Baguio City which could be strongly related with earthquake ground motions with dominant period longer than 0.5 seconds as well as prevailing flexible structural systems of reinforced concrete frame buildings after contribution of the infill walls to the stiffness of the entire structure is gone due to initial cracking.

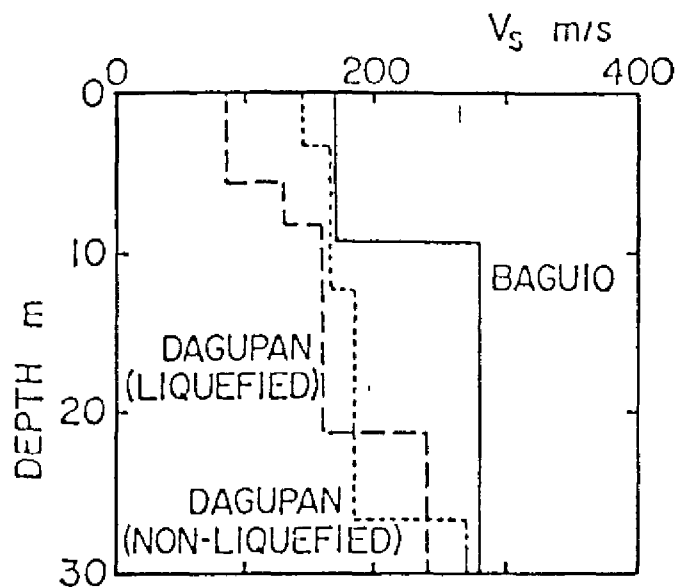
Fig. 3.5 Shear wave velocity profiles in Baguio and Dagupan as measured by AIJ (Japan) field mission (from Midorikawa, S., 1990).

**Shear wave velocities:** It is widely recognized that liquefiable soil layers have very low shear wave velocity. In Dagupan, seismic prospecting using Rayleigh wave have been performed. The results show that layers with low shear wave velocity of 60 to 90 m/s exist near surface at liquefied sites, but not at non-liquefied sites. The shear wave velocity profile at Hyatt Terrace Hotel in Baguio is shown in Fig. 3.5 together with typical shear wave profile in Dagupan. In Baguio, the thickness of soft layers with shear wave velocity lower than 200 m/s is less than 10 meters, while in Dagupan it is more than 20 meters. Based on analysis performed, the difference in the amplification factors in Baguio and Dagupan is small for the periods shorter than 0.3 seconds, but the amplification in Dagupan is twice larger than that in Baguio in the longer period range. Thus, the amplification of ground motions in Baguio is considered as small for longer-period motion. Since the seismic response of collapsed buildings in Baguio would be strongly related to ground motions with period longer than 0.5 seconds, it is difficult to interpret site effects on ground motions as the major cause of collapse of high-rise buildings in Baguio (after Midorikawa, S, 1990).
