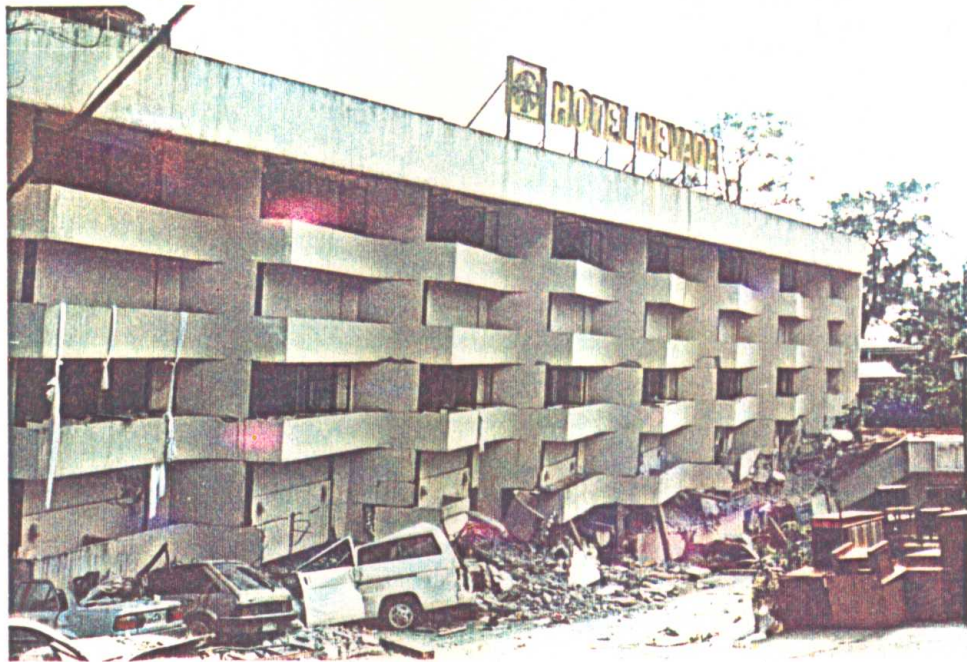
Photo 3.5 Failure of Hotel Nevada, 5-storey r.c. building ground floor collapsed. Typical irregular and brittle structural system with inclined walls exhibiting failure or heavy damage in other earthquake in the world (Montenegro, Yugoslavia earthquakes 1979, El Asnaw, Algeria earthquake, 1980).

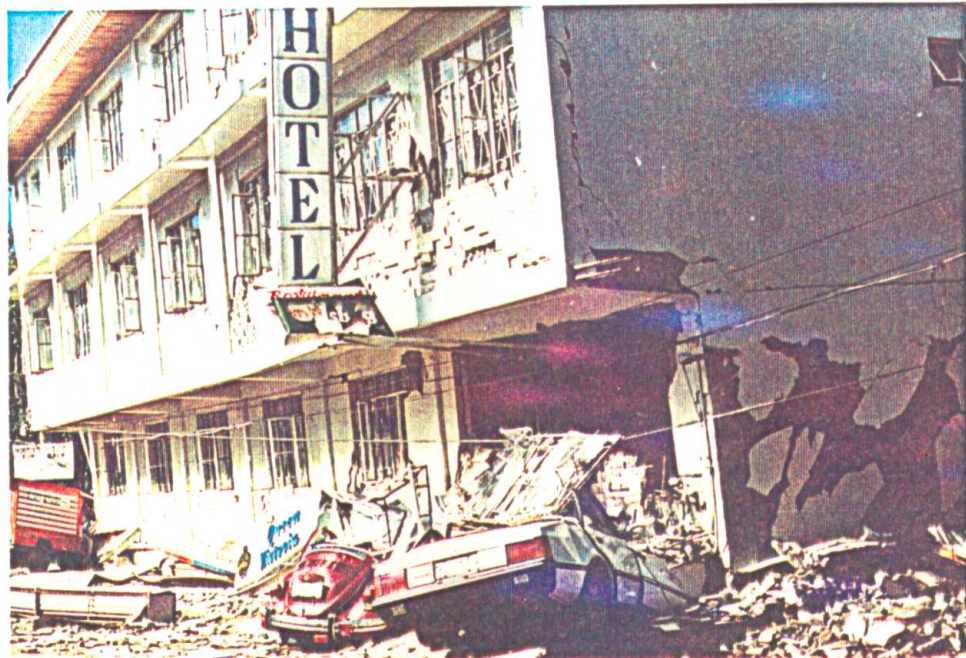
Photo 3.6 Hotel Queen Victoria 3-storey r.c. building with pronounced cantilivers. Typical high intensity vibrational effect producing intensive nonstructural and partial structural damage.

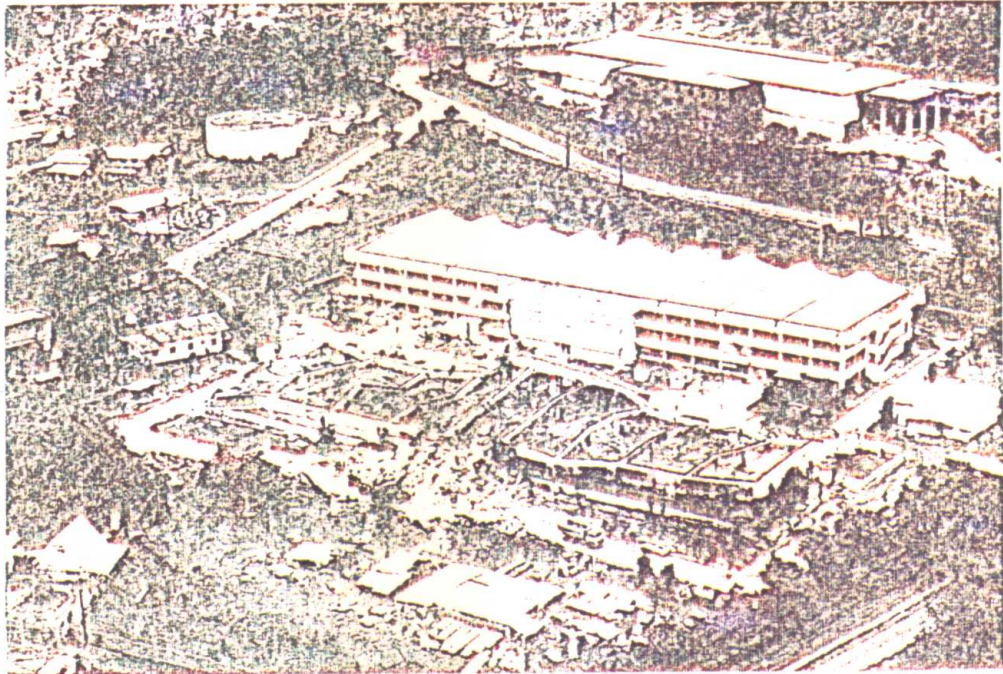
Photos 3.7 Aerial view on heavily damaged Export Processing Zone with collapsed and burned out. Brittle r.c. 4-storey manufacturing building and its twin severely damaged building.

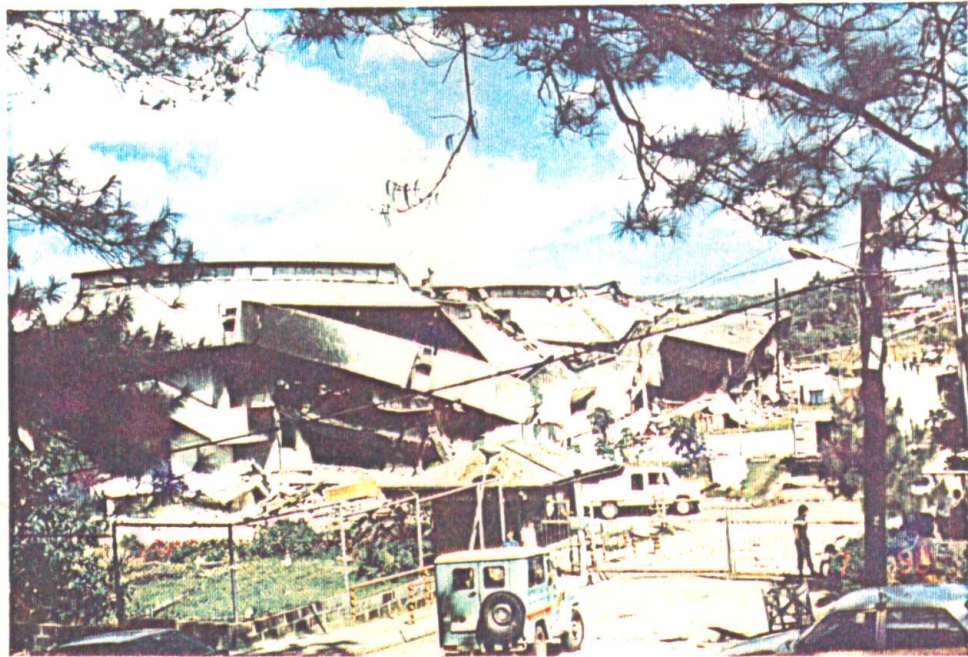
Photos 3.8 Collapsed manufacturing r.c. 4-storey building in the Export Processing Zone. Typical brittle failure and inadequate proportioning of load carrying and floor structural system (deepo lintle beams).
