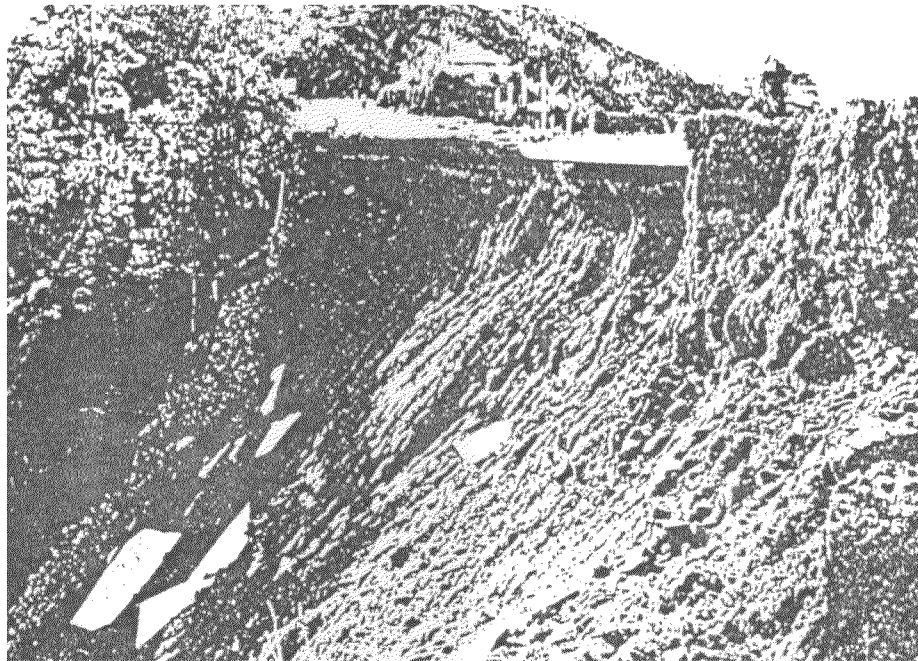
Photos 3.22 Large scale landslide cutting the Baguio-Bontoc Road (after 3).

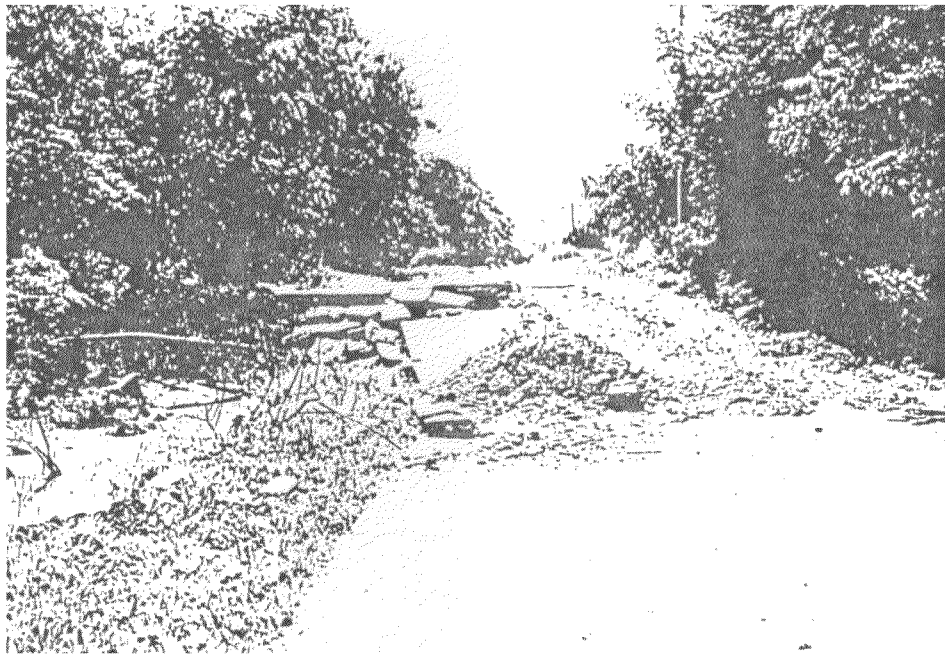
Photos 3.23 Intensive settlement of the road, about 1.0 meter, on the Jct. CVR - Carranglan Road (after 3).

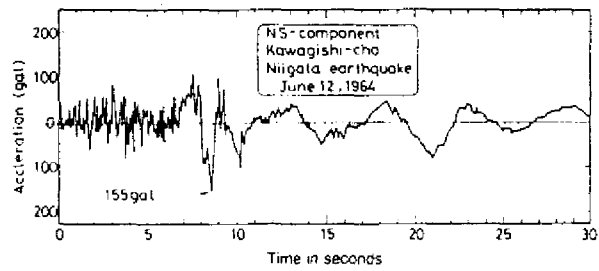
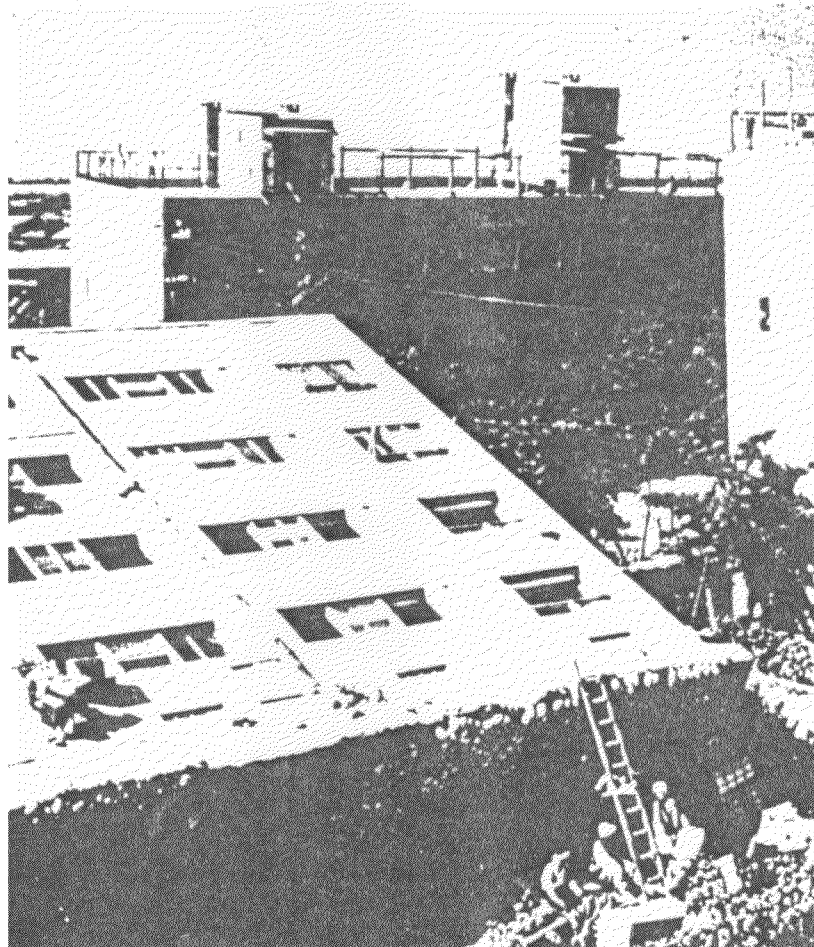
Photos 3.24 A strong acceleration time history ground motion of the 1964 Niigata, Japan Earthquake, recorded in one of the Kawagishi-cho apartment buildings, which are shown settled and tilted. The strong motion accelerograph record begins as a typical, high frequency, firm ground motion, but at about 7 seconds changes to a lower frequency, sloshing motion as the ground below the building partially or completely liquifies. (After Ronald F. Scott, 1990)
