Chapter 4

DAMAGE AND IMPACT OF EARTHQUAKE

4.1 Physical Damage and Human Impact

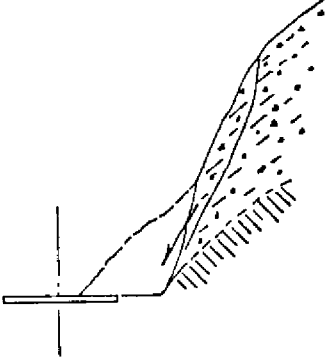
<p>Observed in mountainous areas.</p> <p>Surface slope failure, or shallow-slope failure, often observed in the mountain regions with no vegetation. Excessive denudation of slope surface and ensuing erosion and weathering are potential cause of failure.</p>
<p>5. Deep slope failure:</p>

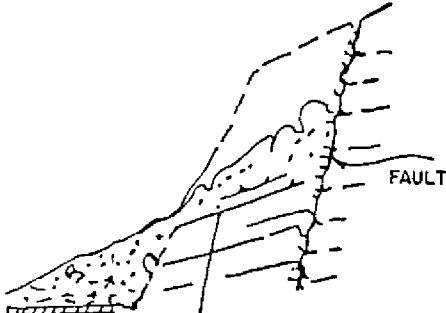
<p>Deep slope failure observed along the structural weakness of slope such as faults bedding planes and border planes between firm bedrock and overlaying detritus of weathered rock or soil.</p>
<p>6. Rock falls:</p>

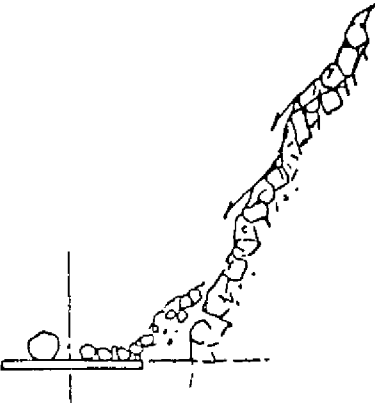
<p>Large number of sections in mountainous areas experienced this type of failure (Kennon Road, Marcos Highway, etc.). Large quantity of stone and rock masses from unstable mountain slopes fell down in the road sections.</p>
