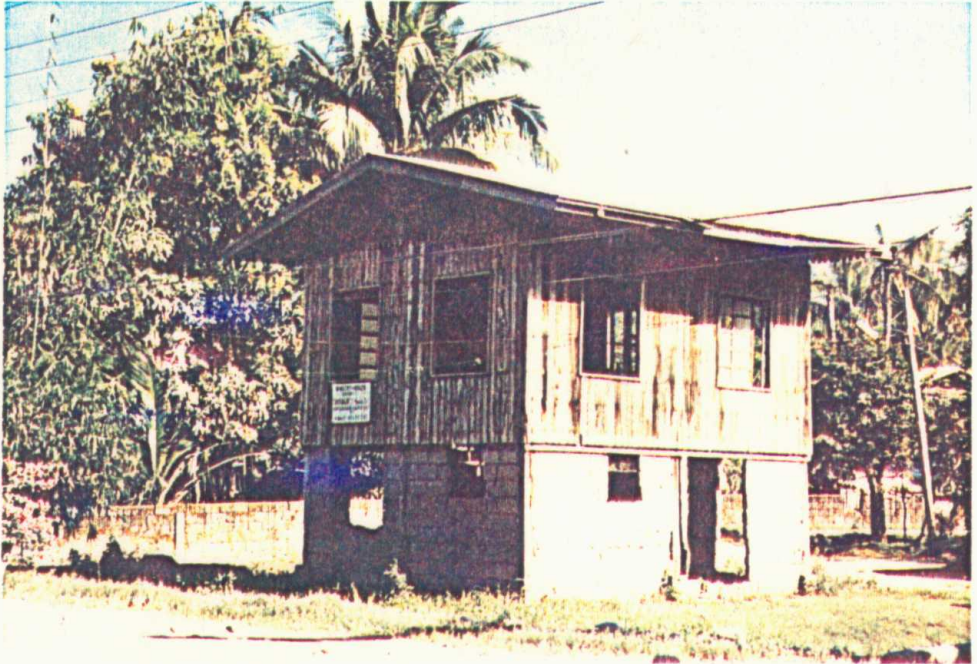
Photo 4.6 Typical village timber house with brittle and not integrated ground floor of block masonry. Damage and failure could be expected at large earthquake intensities.

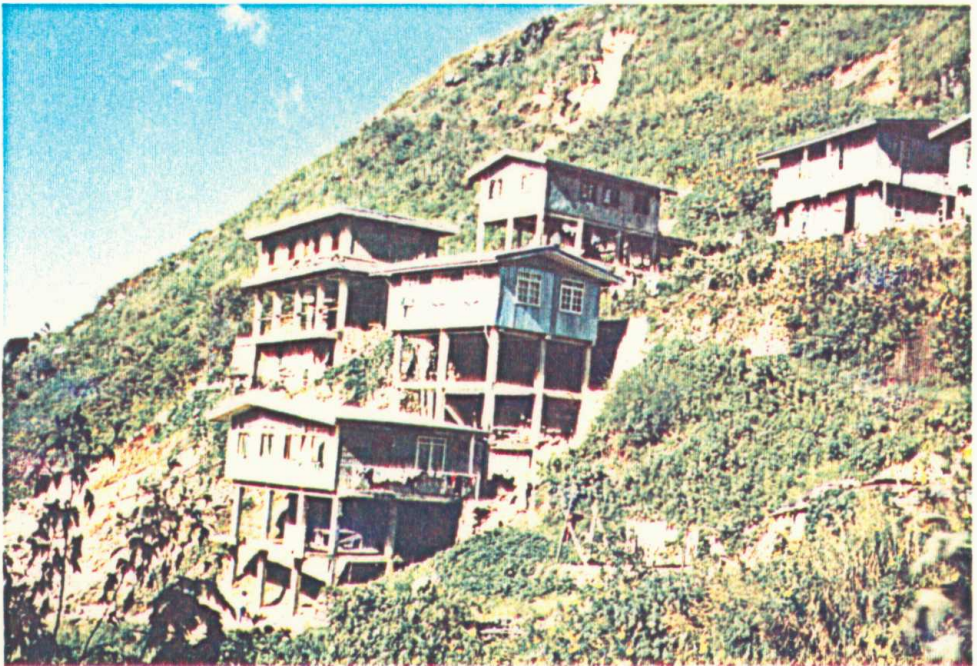
Photo 4.7 Houses built on the slopes in La Trinidad with high damage potential and progressive failure.

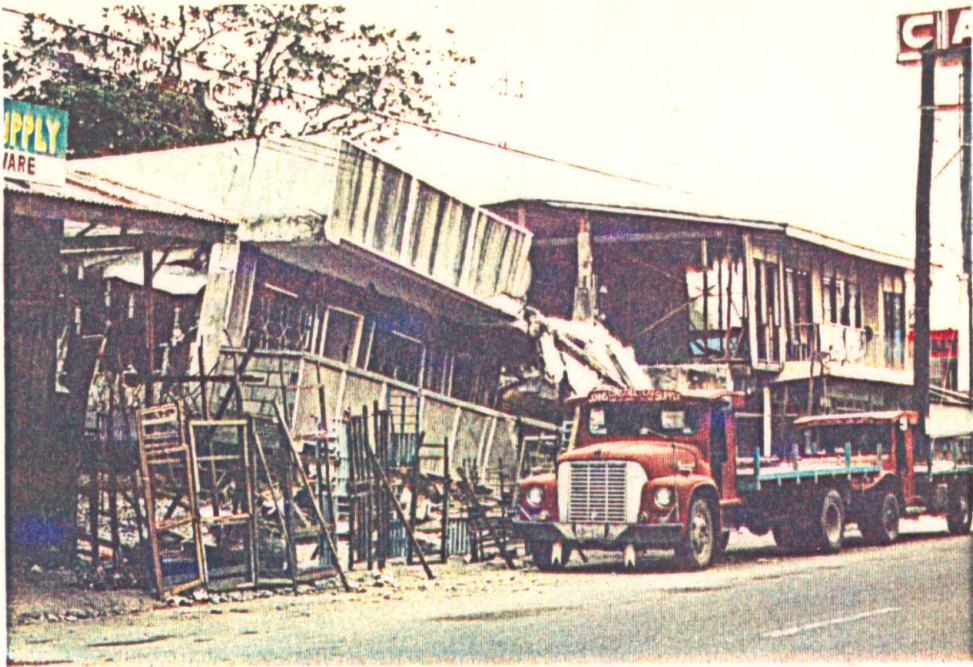
Photo 4.8 Reinforced concrete framed houses (non-engineered construction) performed poorly in comparison with timber framed houses - here (Agoo) an r.c. structure has collapsed between two lightly damaged timber framed structures.

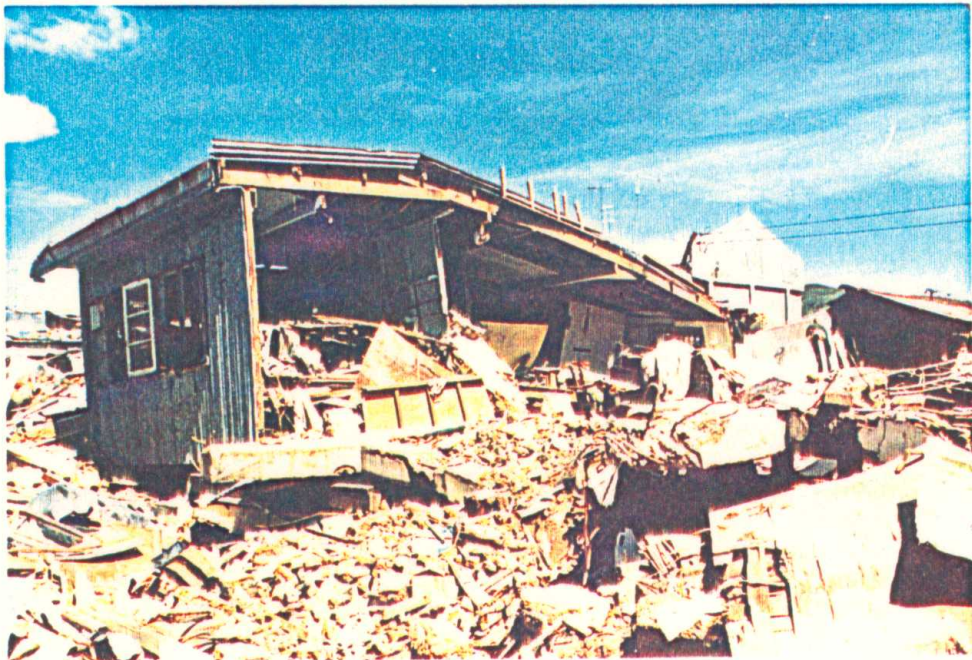
Photo 4.9 Few timber framed houses collapsed due to the vibrational effects of the earthquake, but some were damaged by the collapse of neighboring r.c. buildings as shown here. (Baguio)

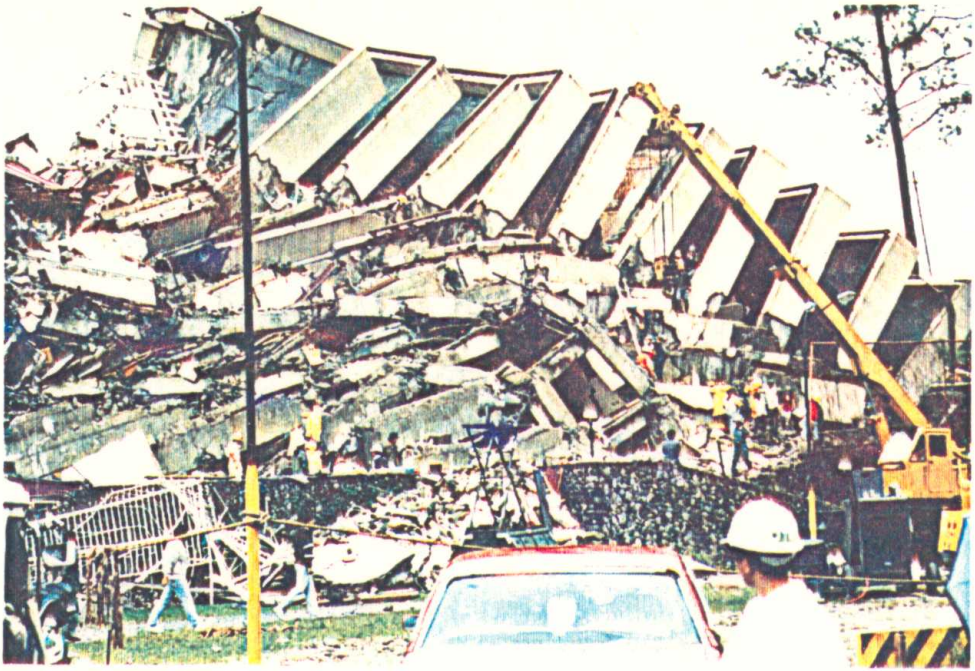
Photo 4.10 Largest 11 story building failure in Baguio City (Hyatt Terraces Hotel), mainly due to strong ground motions and inadequate conceptual earthquake resistance design of r.c. frame structural system.

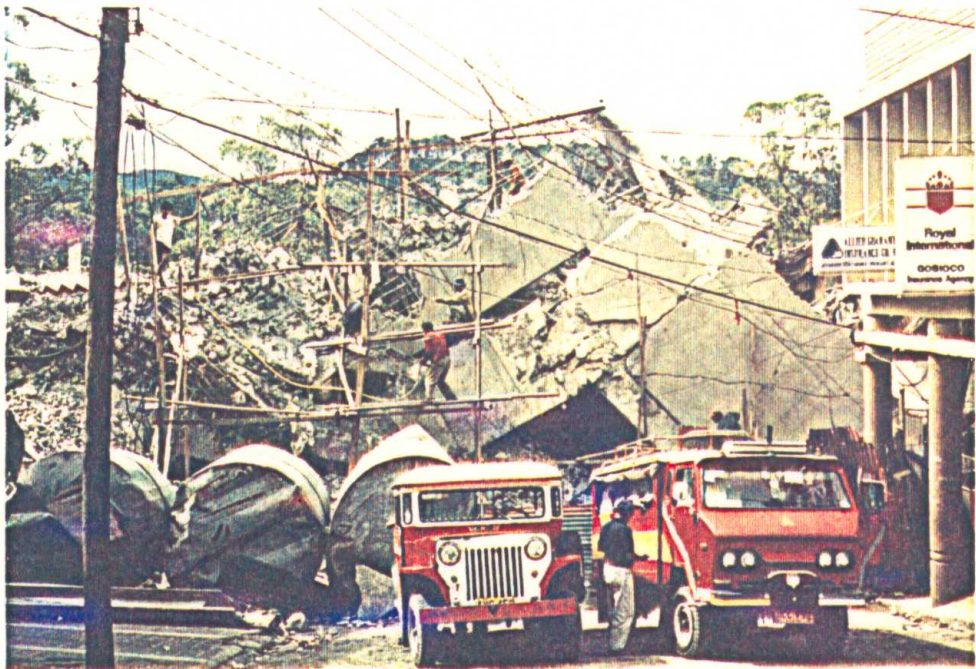
Photo 4.11 Failure of seven story Park Hotel in Baguio City constructed as r.c. frame structure with brittle and non-adequate proportioning of column and beam sections.
