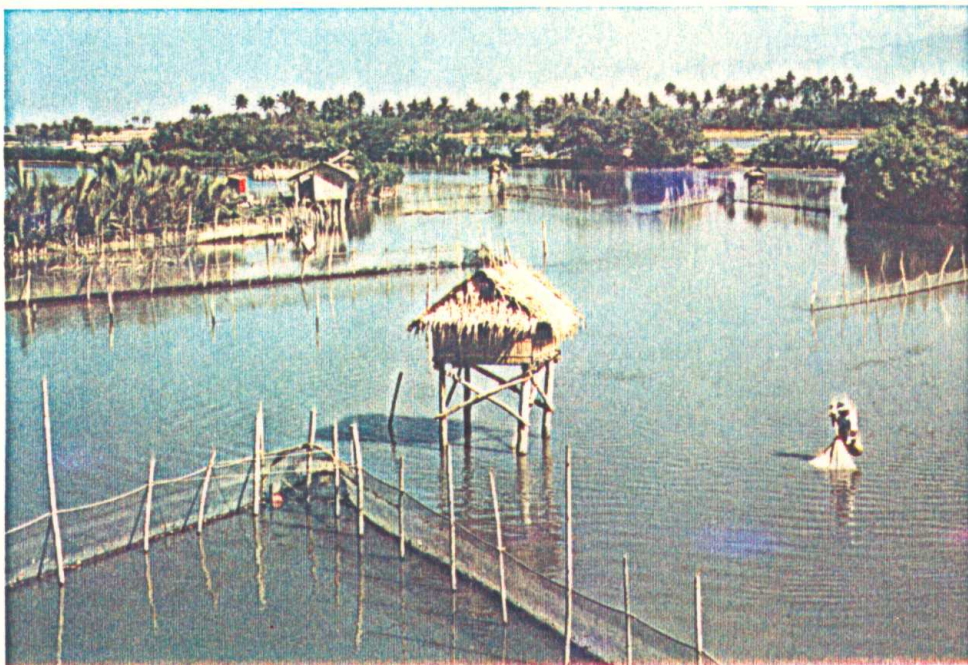
Photo 4.16 Fishfarms in the are of Dagupan City experienced large damage and economic losses, mostly due to liquefaction of soil settlement and lateral spreading and failure of dikes and canals.

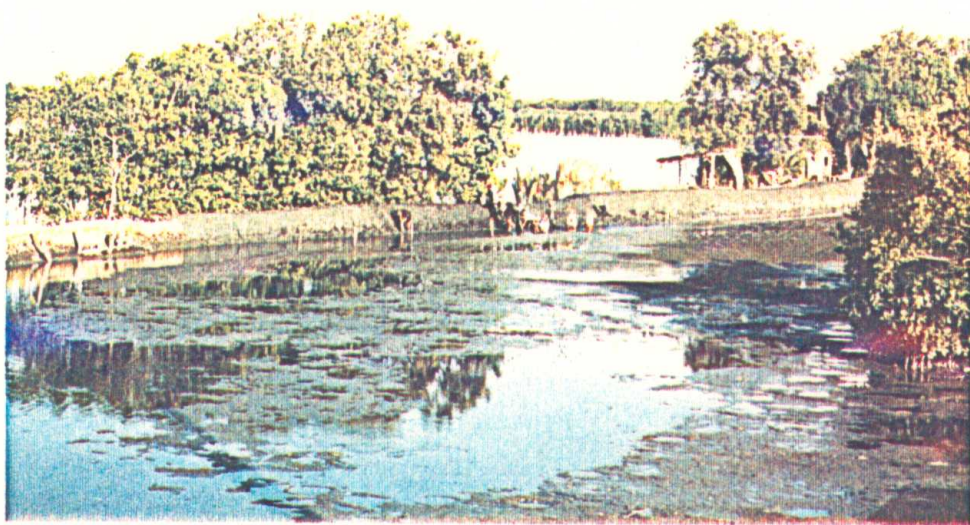
Photo 4.17 Repair work of collapsed and settled section of the dikes in the area of Dagupan City.

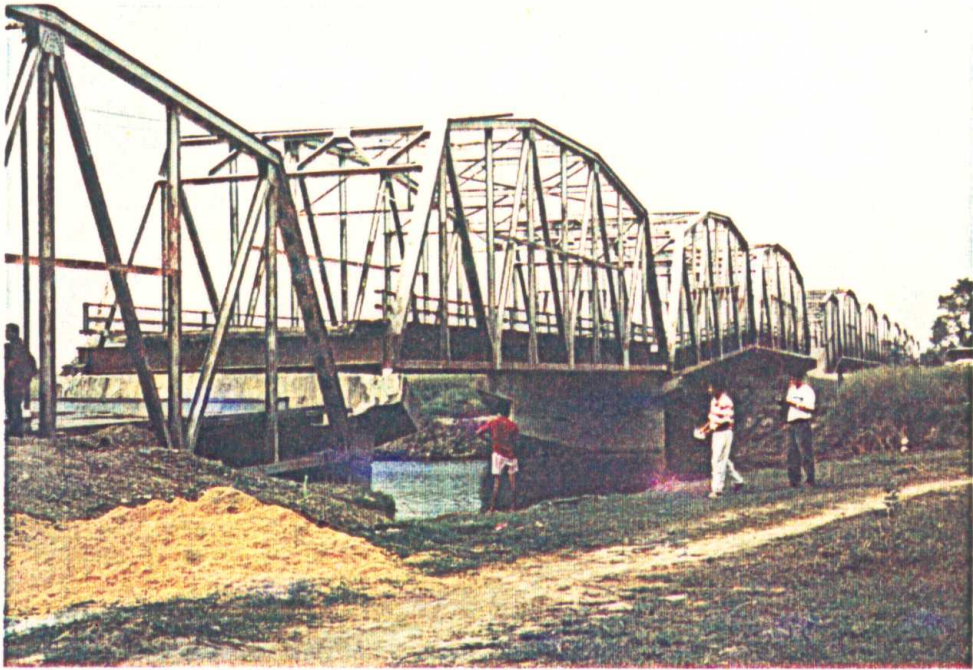
Photo 4.18 Failure of Carmen Bridge on the road Manila-Baguion, out of 12 spans, 6 collapsed or experienced large deformation due to liquefaction causing intensive settlements and tilting of piers. Sandboils due to liquefaction observed in the vicinity of the bridge.

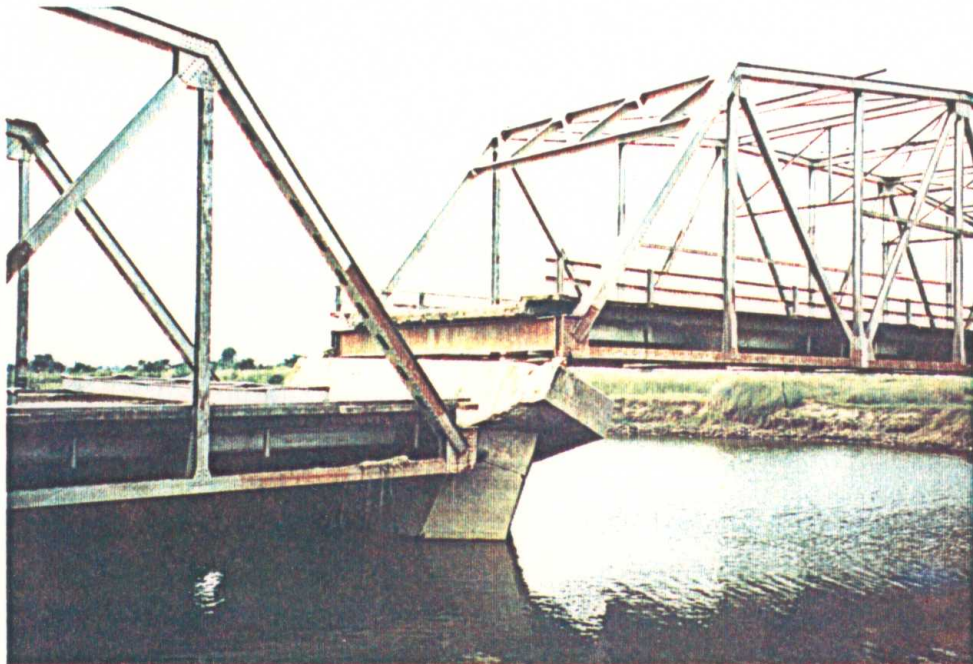
Photo 4.19 Failure mode of Carmen Bridge, intensive settlement and tilting of pier due to liquefaction.

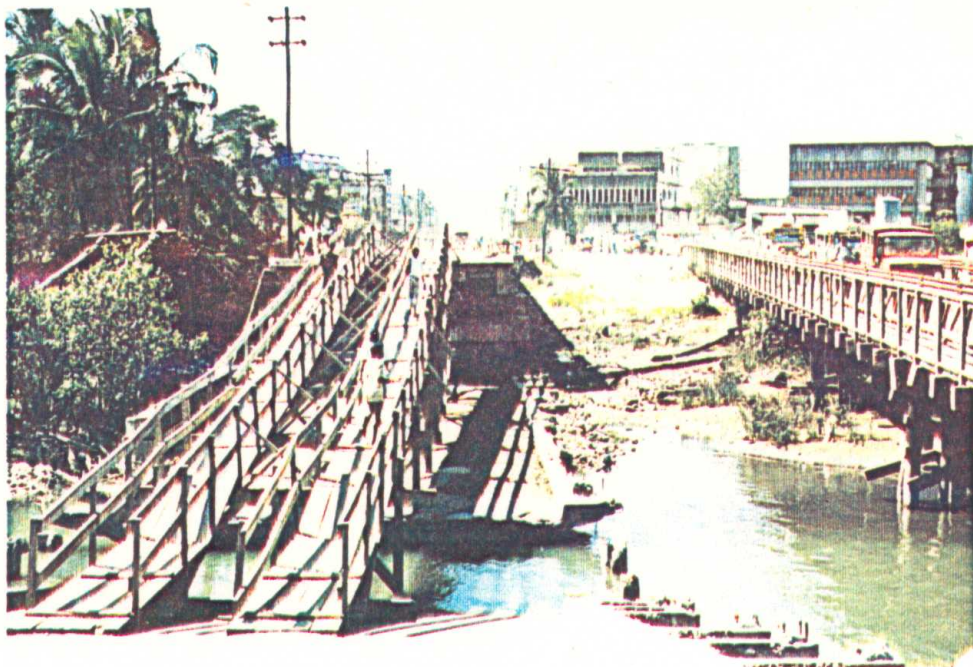
Photo 4.20 Failure of the bridge over Pantal River in the central business district of Dagupan City, due to liquefaction causing failure of piers and abutments. Left temporary walkway and failed bridge deck, right temporary Bailey Bridge.

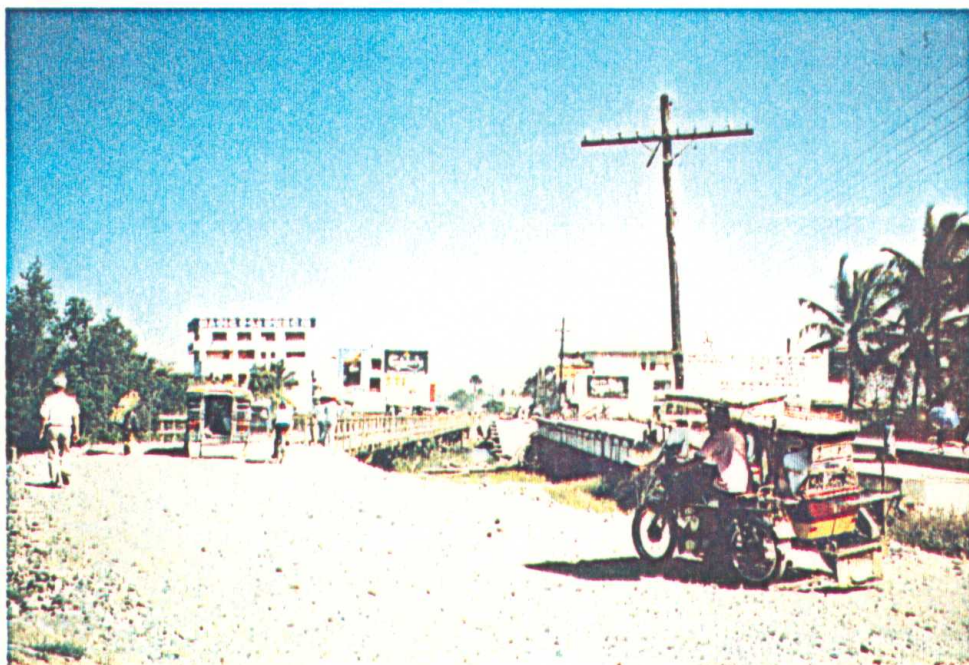
Photo 4.21 General view on Pantal river bridge in Dagupan City and tilted buildings on the river banks.
