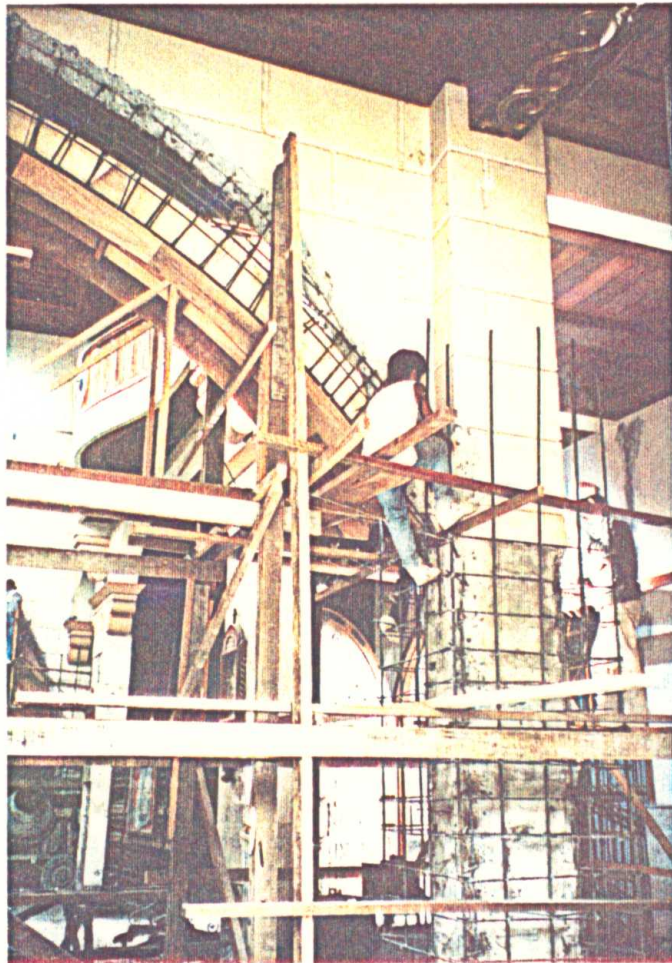
Photo 4.35 Basilica of Our Lady of Charity at Agoa, built as r.c. structure, damaged. Strengthening of the r.c. columns with jackets through foundations and new arches for increase of stiffness in the longitudinal direction.

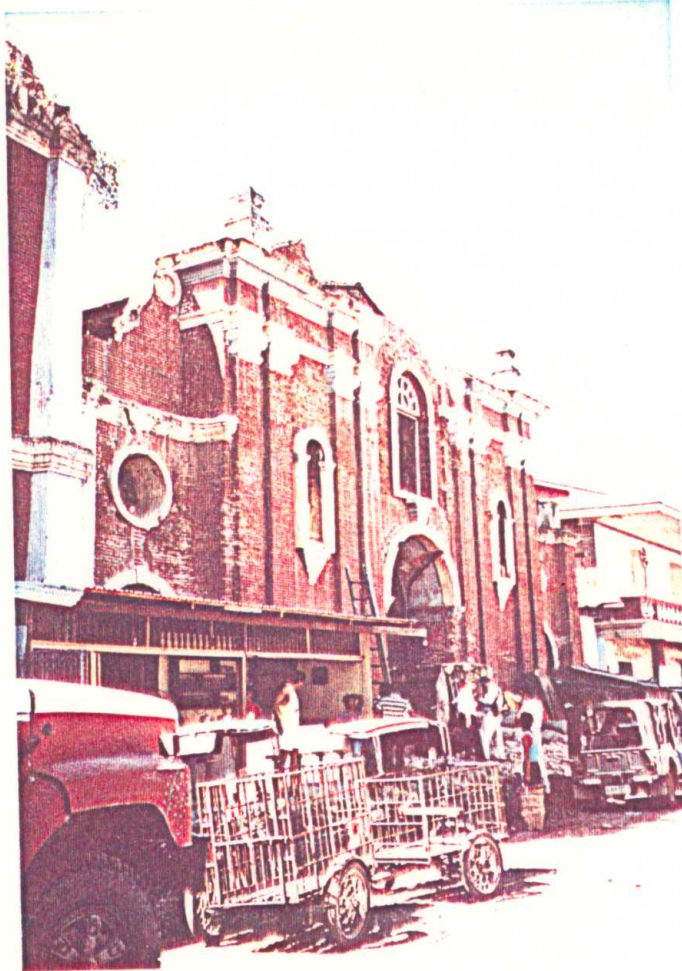
Photo 4.36 Damaged brick masonry - Church of Dagupan. The church was in poor structural conditions prior to the earthquake with extensive settlement cracks.

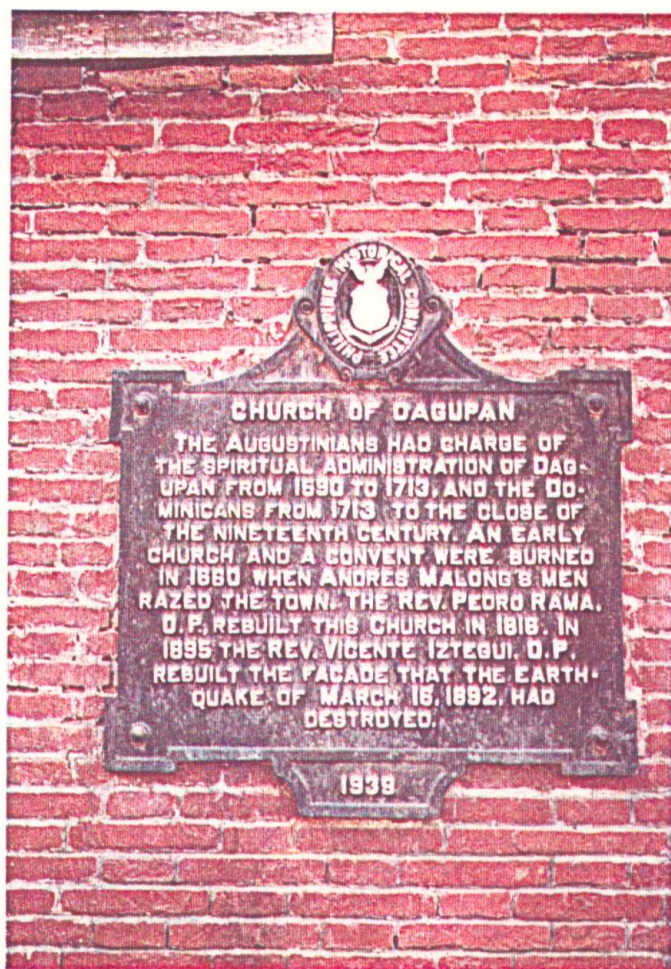
Photo 4.37 Front plate at the Church of Dagupan damaged and repaired after the earthquake of 1892.
