Geotechnical Observations at the Van Norman Complex after the 1994 Northridge Earthquake

C.A. Davis, Associate Engineer,
Department of Water and Power, Los Angeles, CA.

J.P. Bardet, Associate Professor,
University of Southern California, Los Angeles, CA.

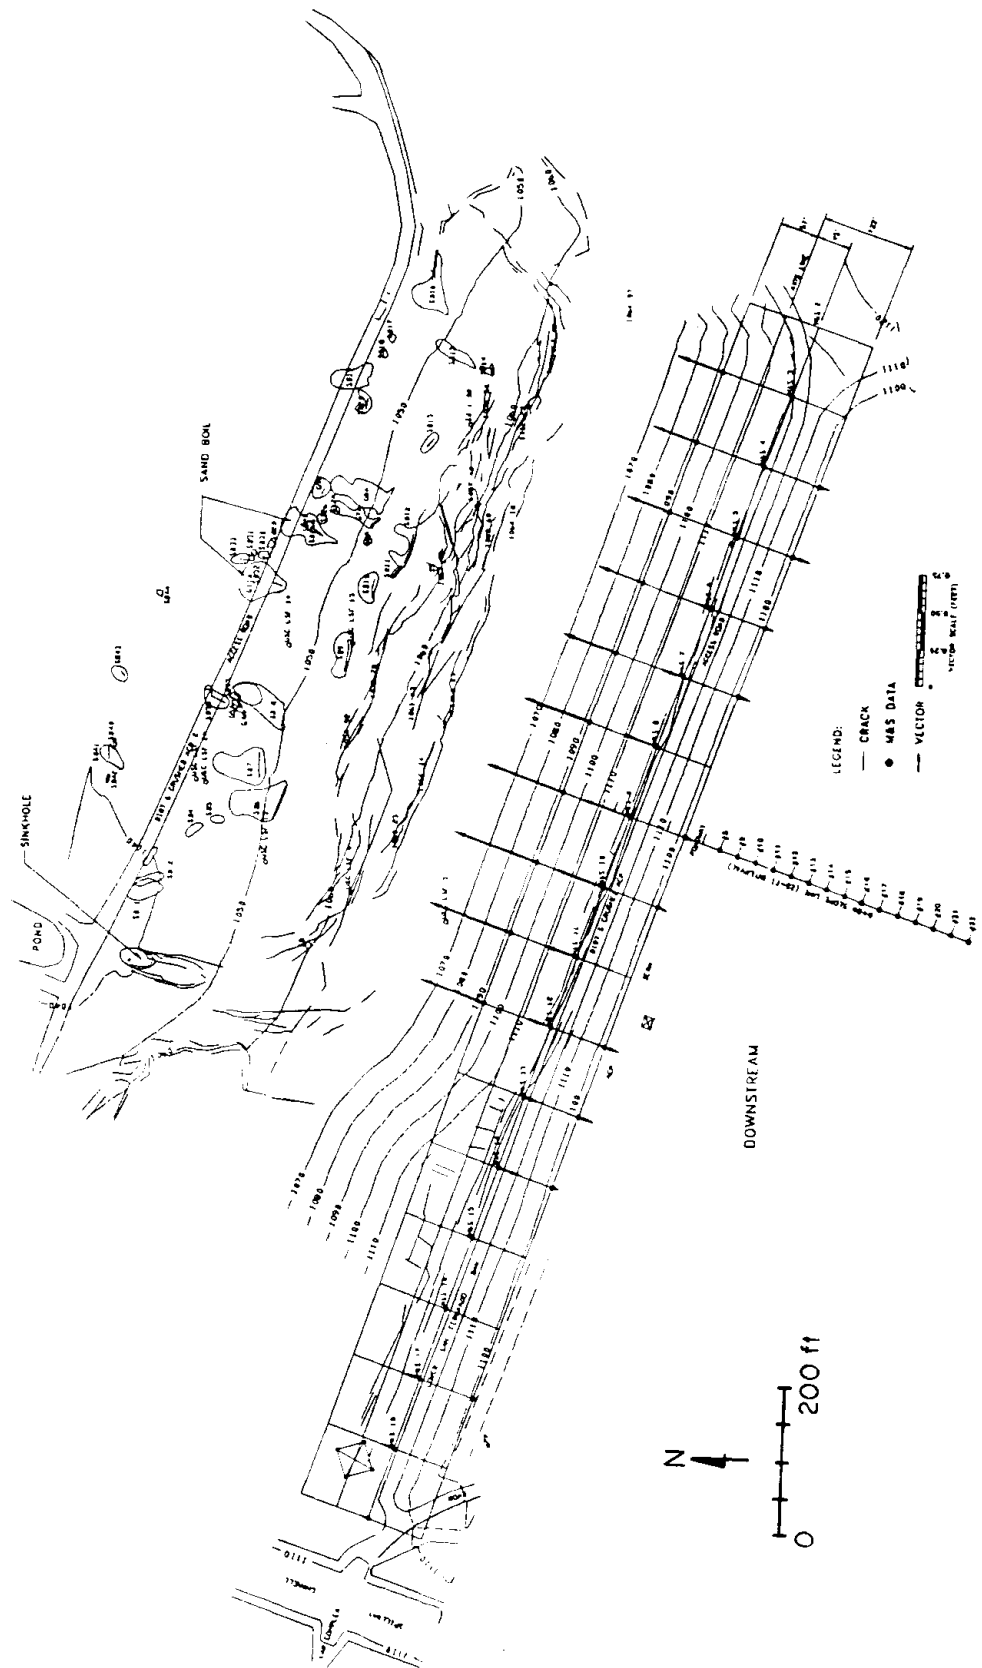
Fig.6 presents a detailed mapping of the cracks and sand boils observed after the earthquake. Fig.6 also shows the lateral displacements perpendicular to the dam axis. The maximum lateral movement on the upstream slope exceeded 1/2 foot in the upstream direction. Along the crest, the maximum movement was just under 1/2 foot, and was similar to that on the upstream slope. The maximum downstream movement was approximately 3 inches on the downstream slope. Maximum settlement of 8 inches occurred along the crest, while settlement along the upstream slope reached nearly 1/2 foot. The maximum settlement and lateral displacement were measured in the same areas. Settlement along the upstream slope, parallel to the axis, was relatively consistent averaging a little over 4 inches, and increased linearly with the dam height. All settlements and displacements were obtained from the surveys of March 4, 1994 and February 24, 1993.

Earthquake shaking produced extensive cracks along the crest and upstream berm. The cracks were observed to extend across the entire width of the dam. Most cracking occurred in the longitudinal direction. However, there were transverse cracks at the abutments. Some cracks on the berm were observed to have up to 9 inches of vertical displacement. Some small cracking was observed through the grass at the top of the upstream slope. No cracks were observed on the downstream slope which was covered with thick grass. Approximately fifty large sand boils emerged through cracks on the upstream slope of the berm as seen in Fig.6.

Figure 6. Location of cracks, sand boils, and displacement vectors in Lower San Fernando Dam.

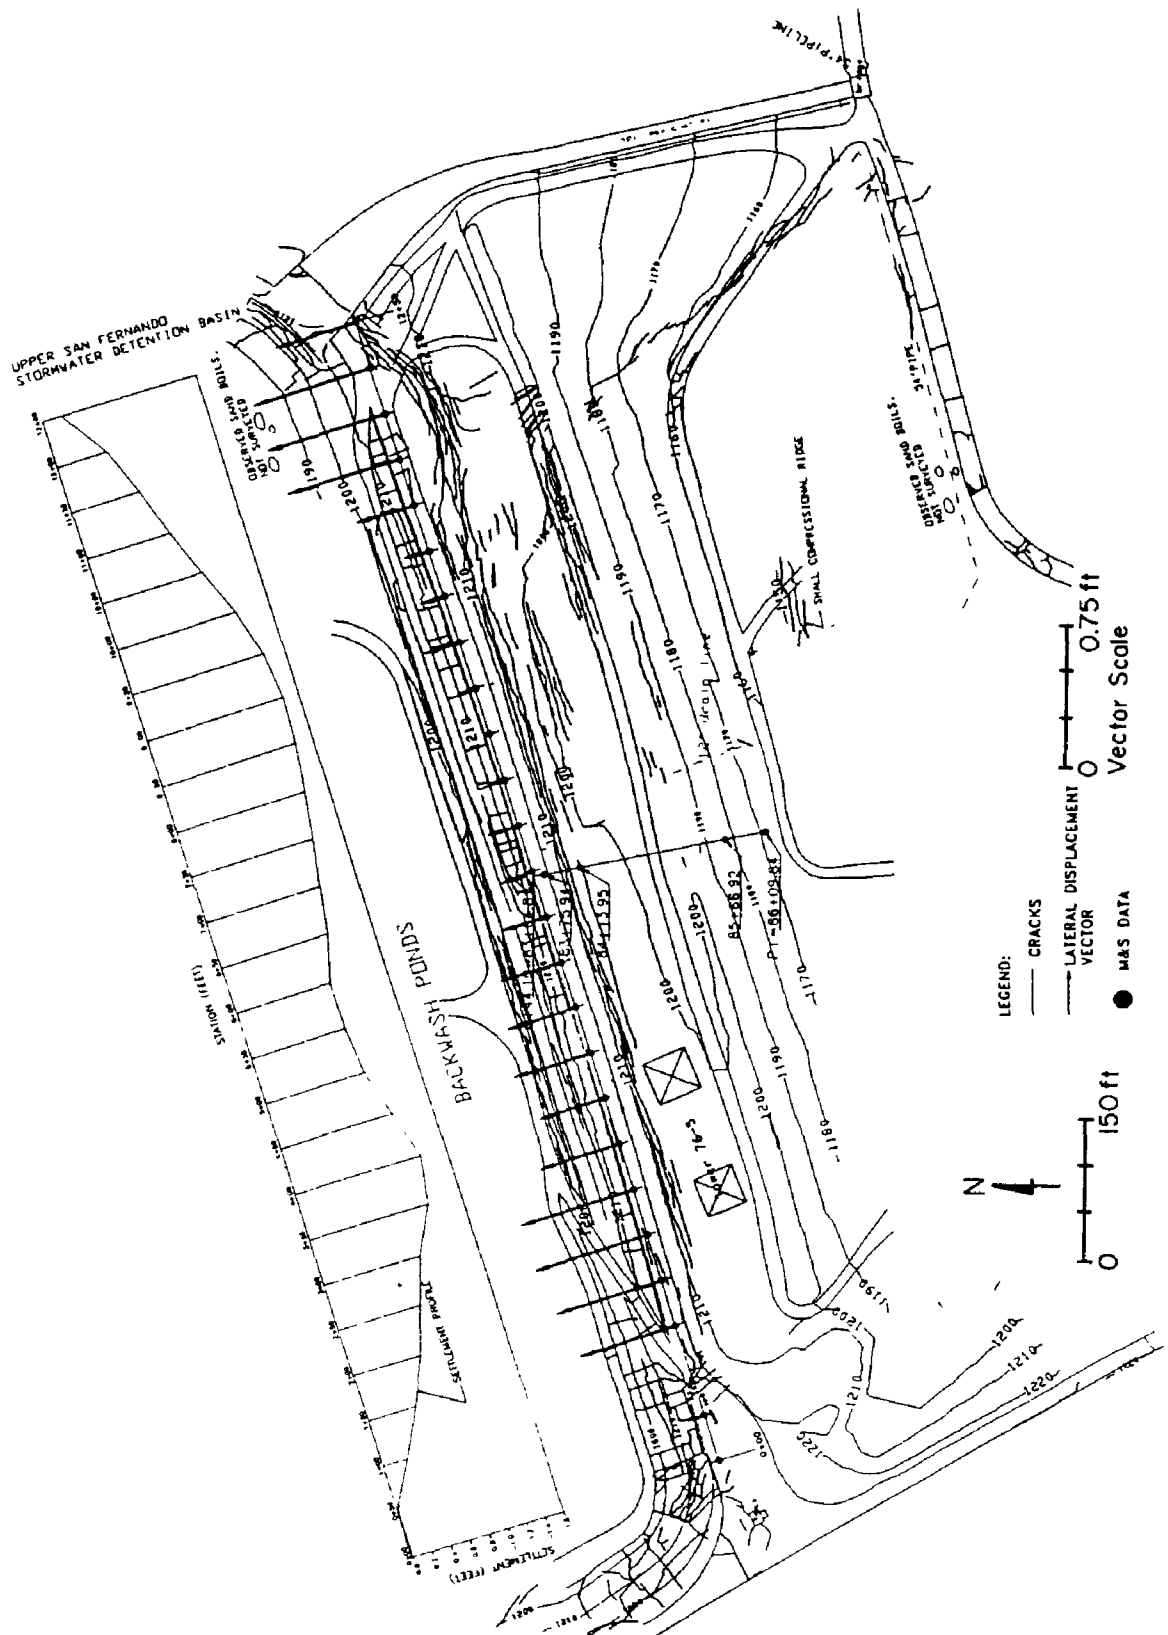
Water retained behind the Upper San Fernando Dam was limited to a few feet within the backwash ponds (see Fig.2). Similar to the Lower San Fernando Dam, the upper dam also underwent extensive cracking in 1994. Fig.7 presents a detailed mapping of cracks and sand boils observed after the earthquake.

Fig.7 shows the lateral movement at monument locations, and a settlement profile. The movement was obtained by comparing the survey of March 4, 1994 to that of July 29, 1993. Maximum settlement reached nearly 1.5 feet. The maximum settlement curiously corresponds with the minimum lateral movement. After intense shakings, the crest moved laterally a maximum of 7 inches in the upstream direction near the west and

An extensive network of cracks emerged on the surface of the upper dam, extending from the west abutment across the entire width of the dam and through the spillway on the east side. The majority of cracks were longitudinal to the axis, and became transverse near each abutment. Similar crack patterns were observed in the 1971 San Fernando Earthquake. However, in 1971, settlement reached 3 feet while movement was up to 5 feet in the downstream direction.

Figure 7. Location of cracks, sand boils, and displacement vectors in Upper San Fernando Dam.

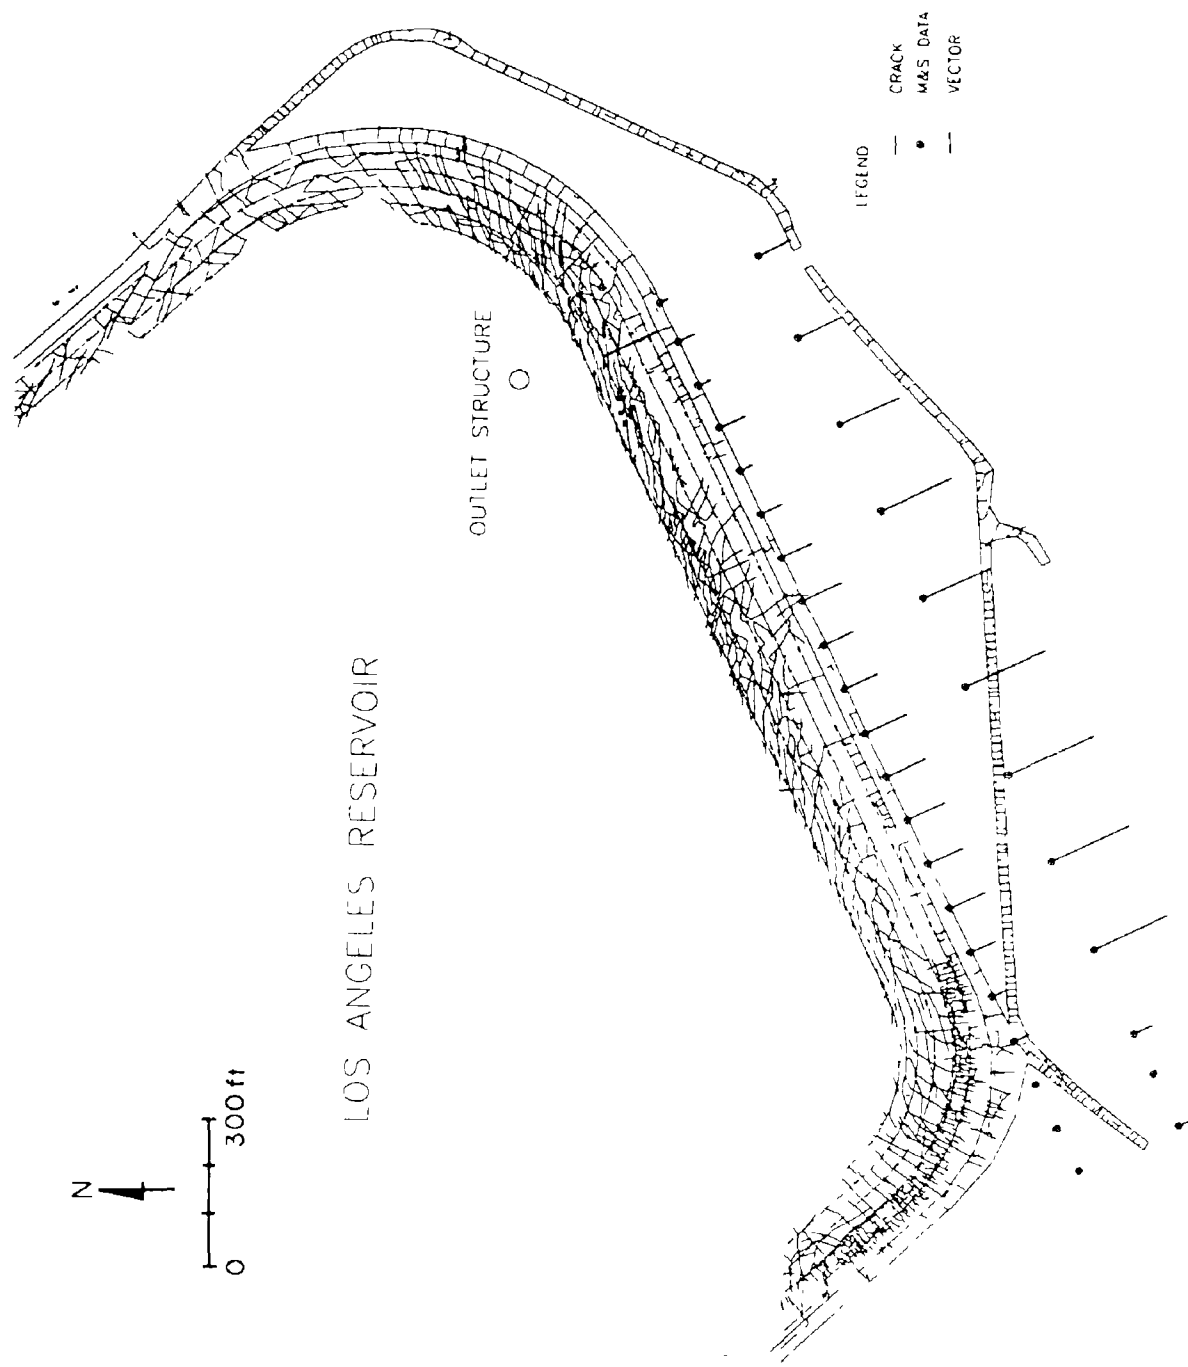
As shown in Fig.8, the upstream slope displayed a vast array of cracks, the largest cracks occurring at the east abutment. Settlement in this area reached 3.5 inches. These cracks were associated with a wavy and bulging surface. Many of the cracks on the east side were of compressional nature, unlike on the rest of the dam surface. Transverse oriented cracks occurred along the crest road. In many cases the cracks lined up with diagonal cracks extending to the crest on the upstream face. Trenches were excavated across the largest cracks on the crest and upstream slope, and revealed that the cracks died out rapidly with depth. Within the zone encompassed by cracks, three small slump areas were also observed on the upstream face just west of the outlet tower.

Figure 8. Location of cracks in Los Angeles Reservoir Dam.

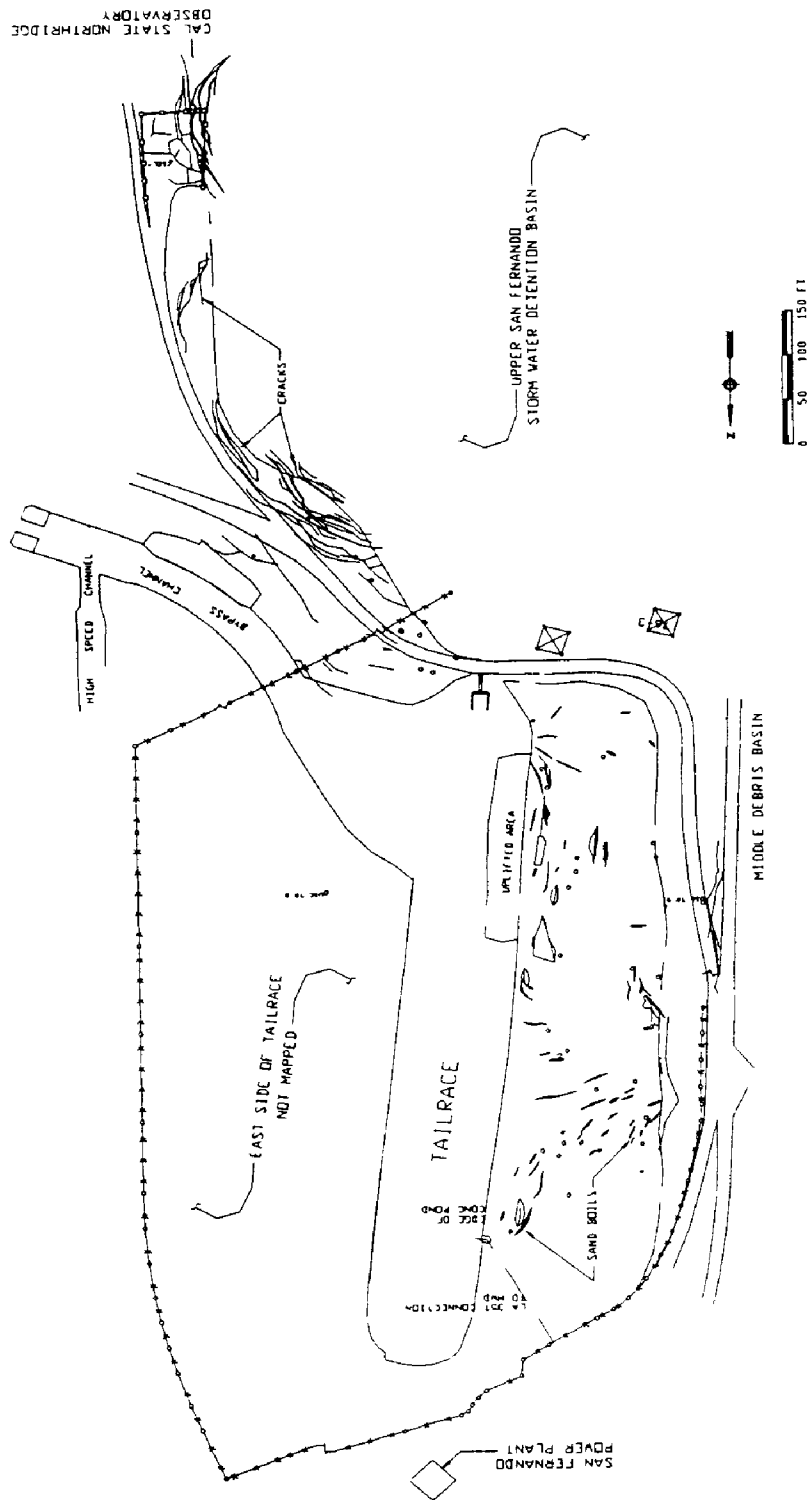
Fig.9 shows a detailed mapping of cracks and sand boils around the tailrace. Extensive cracking occurred on both banks of the channel as a result of the lateral spreading induced by liquefaction. Numerous sand boils erupted around the tailrace, mostly on the west bank, although a few were observed on the east bank. A slide over 200 feet wide occurred on the west bank near the south end of the channel. The concrete liner within the channel was pushed over and up five to six feet. The west bank around the slide area settled a few feet, and displayed numerous cracks, most of them having less than 2 inches in width.

Figure 9. Location of cracks and sand boils in the vicinity of Power Plant Tailrace.
