# **EARTHQUAKE PERFORMANCE OF GAS TRANSMISSION PIPELINES**

## **ABSTRACT**

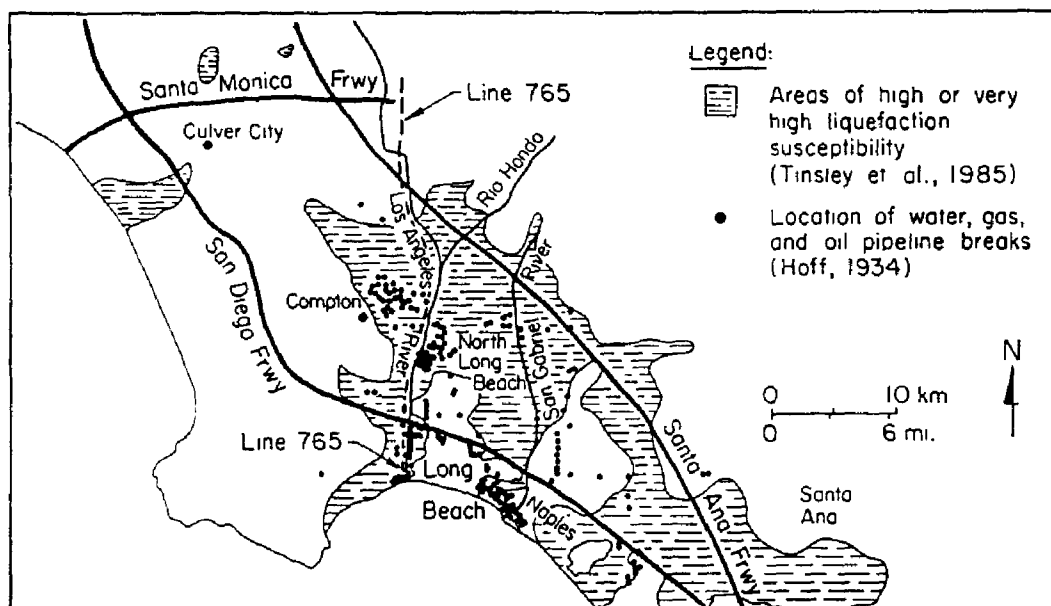
FIGURE 1. Pipeline Damage Caused by the 1933 Long Beach Earthquake [adapted from Hoff, 1934]

Figure 1 shows the locations of main line breaks of water, gas, and oil lines caused by the 1933 Long Beach earthquake as plotted by Hoff [1934] and superimposed on a map of liquefaction susceptibility prepared by Tinsley, et al. [1985]. Shaded areas are those Tinsley, et al. designate as having "very high" and "high" susceptibility to liquefaction on the basis of geologic age, type of sedimentary

Pipeline damage caused by the 1933 Long Beach earthquake has been described by Bryant [1934] and Hoff [1934]. There were more than 500 main line breaks of water, gas, and oil lines in the areas of maximum seismic intensity [Hoff, 1934]. Within the City of Long Beach gas distribution system, there were a total of 119 main breaks, 91 of which were in the high pressure feeder mains [Bryant, 1934]. Every failure discovered in the high pressure distribution system occurred at a welded joint, and more than 50 of the 91 breaks were in artificially-filled areas. Forty-six breaks were discovered in the large diameter mains [460 to 510 mm (18 to 20 in.)] that supplied the Harbor District of Long Beach, which was an area where artificial fills were predominant [Bryant, 1934]. Repair crews reported that the original welds lacked proper penetration and proper bond with the pipe body [Bryant, 1934].

Line 765, which is shown in the figure, was constructed in 1931. It was 650 mm (26 in.) in diameter, with 6.4 mm (0.25 in.) wall thickness. It was composed of Grade A and B steel, and had a maximum allowable operating pressure (MAOP) of 1.0 MPa (150 psi) just before it was removed from service in 1992. The pipeline was constructed with electric arc welds. The welding process differed from modern procedures for butt welded transmission pipe in that the weld was applied by unshielded electric arc techniques at opposing belled pipe ends, which were positioned on an underlying steel ring. Although the pipeline was located in the region of maximum seismic intensity, including locations of known liquefaction adjacent to the Los Angeles River, there are no records of pipeline damage or repair to this line dating from the time of the 1933 earthquake.

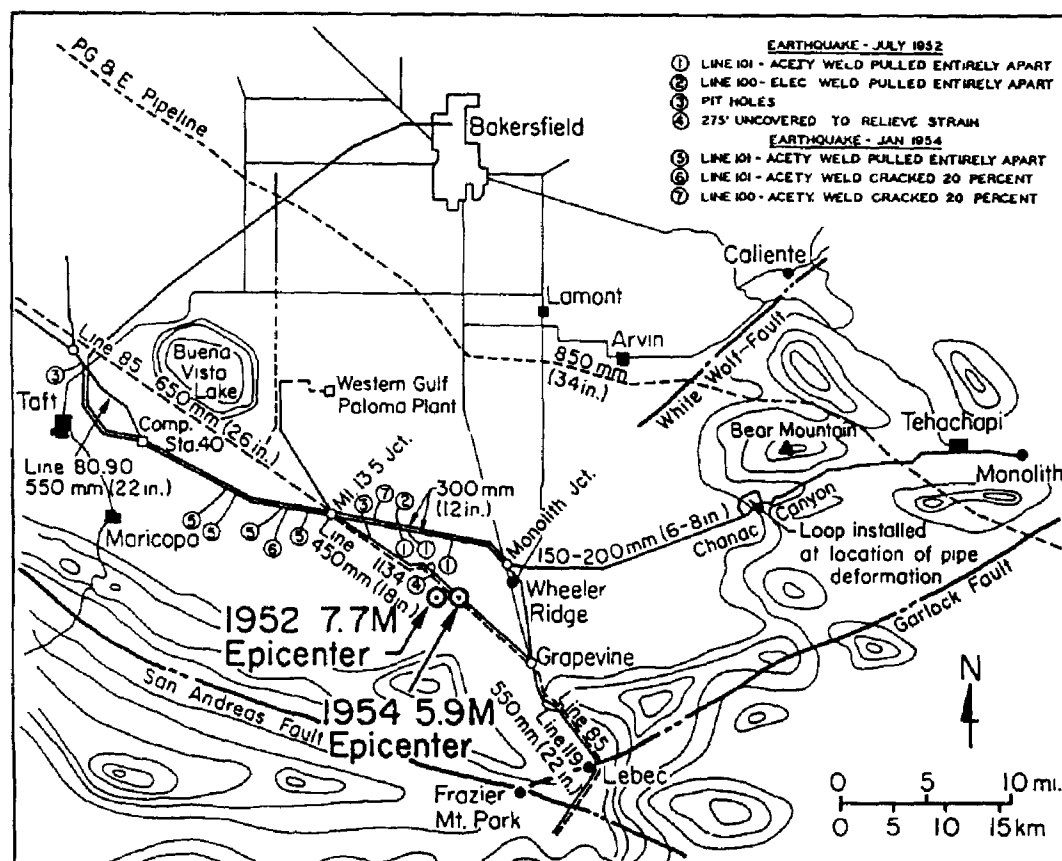
FIGURE 2. Gas Pipeline Damage Caused by the 1952 and 1954 Kern County Earthquakes [adapted from Newby, 1954]

"It developed that the 12-inch acetylene welded line installed in 1921 had broken welds at the three locations marked 1 on Figure No. 1 (Figure 2). The ends of the pipe were from 1/2 to 2 inches apart at the different breaks. The 12-inch line that had been reconditioned in 1932, and electric-welded using chill rings, failed at location marked 2. This weld evidently failed from compression and then from tension.

Pit hole leaks popped out on a 22-inch line near Taft and on an 18-inch line at Wheeler Ridge, locations 3 (Figure 2) These leaks were from external corrosion Location 4 shows where 275 feet of 18-inch line was uncovered to relieve strain from the 1952 quake

As shown on Figure 2, this quake parted the acetylene-welded line at four welds at locations marked 5, and cracked an acetylene weld 20% at location marked 6, and on the electric-welded line, a lone acetylene weld cracked 20% at location 7 "

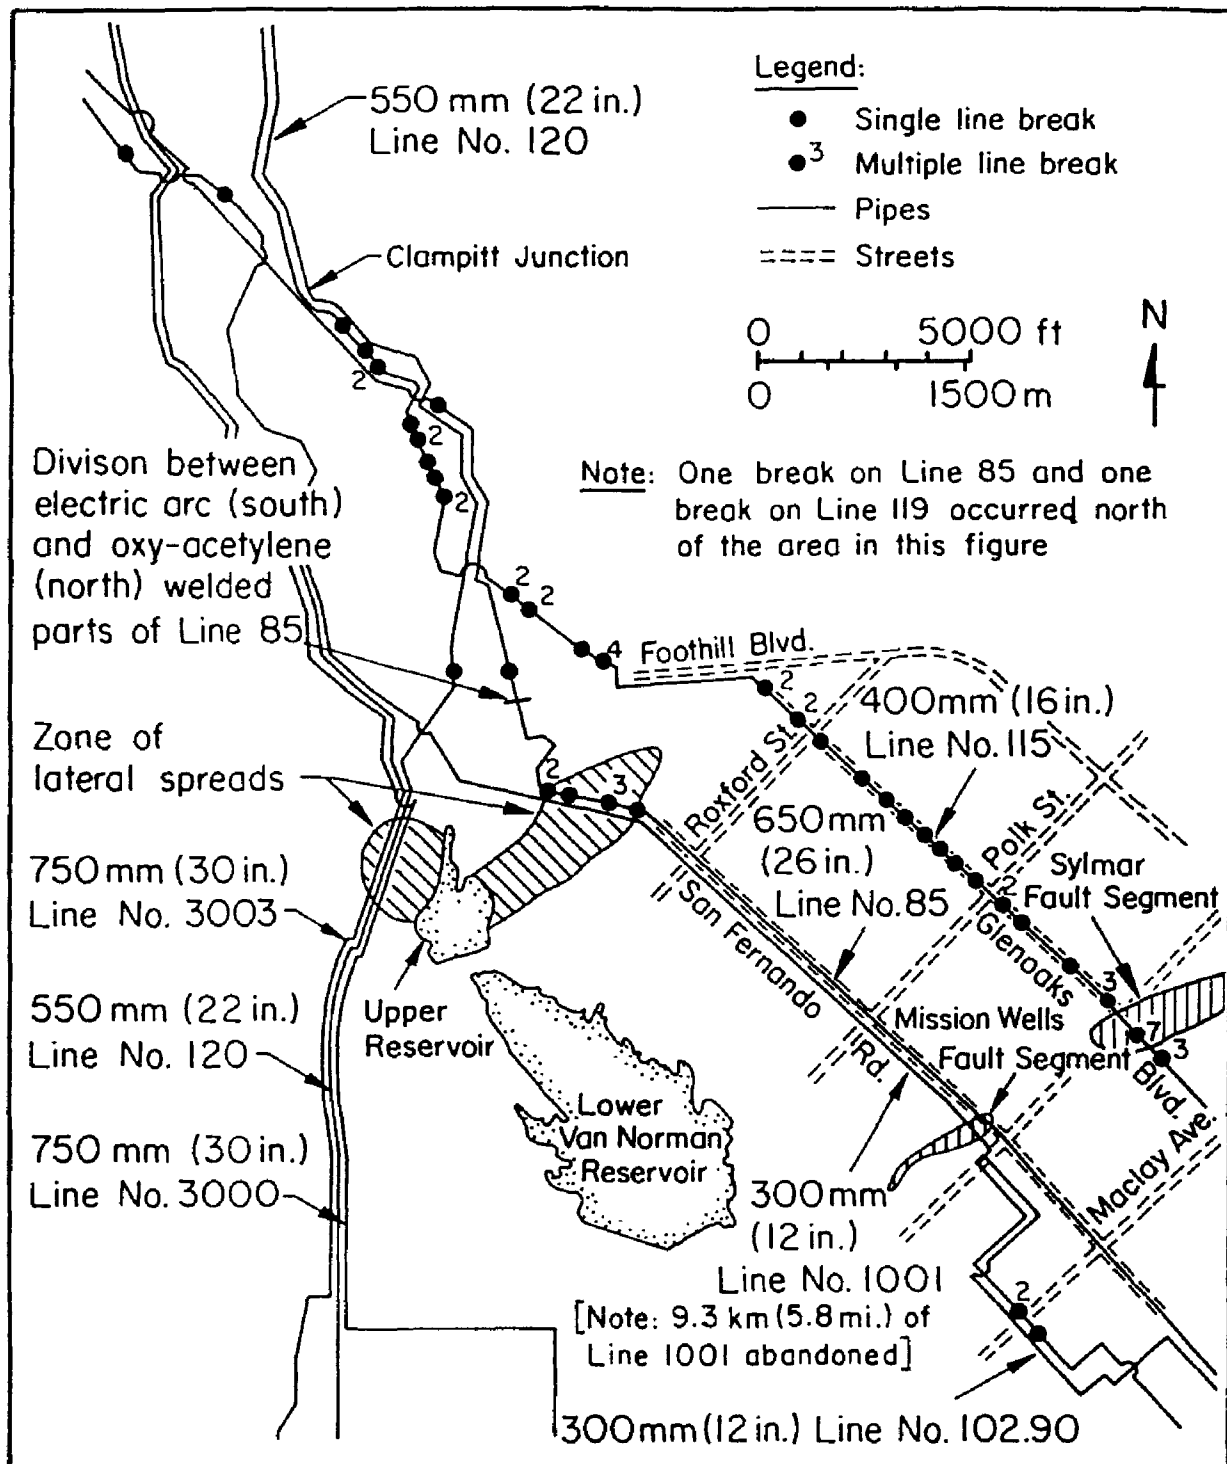
**FIGURE 3.** Locations of Gas Pipeline Damage, Lateral Spreads, and Fault Segments Associated with the 1971 San Fernando Earthquake [adapted from Southern California Gas Company, 1973]

Gas transmission and supply line damage as a result of the San Fernando earthquake has been described by the Southern California Gas Company [1973] and O'Rourke, et al [1992] Figure 3 shows a map adapted from the Southern California Gas Company [1973] on which are plotted the gas transmission and supply lines most significantly affected by the earthquake, locations of damage between San Fernando and just north of Clappitt Junction, and the approximate zones of permanent ground deformation associated with liquefaction adjacent to the Upper Van Norman Reservoir, as well as surface faulting along the Sylmar and Mission Wells segments of the San Fernando fault

Substantial damage was sustained by Lines 1001 and 115 Line 1001 was a 300-mm-(12-in )-diameter steel pipeline, constructed in 1925 with oxy-acetylene welds and operated at MAOP of 2.4 MPa (345 psi) Because of numerous breaks, predominantly at welds, approximately 9.3 km (5.8 mi ) of the line were abandoned Line 115 was a 400-mm- (16-in )-diameter steel pipeline of unknown grade, constructed in 1926 with oxy-acetylene welds In the approximate 9.7-km- (6-mi )-length of pipeline between Clappitt Junction and San Fernando, there were 52 breaks Shell buckling of the pipeline occurred in the vicinity of its crossing of the Sylmar segment of the San Fernando fault [Southern California Gas Company, 1973]

Line 85 was a 650-mm- (26-in )-diameter pipeline, with Grade A steel pipe wall 6.4 mm (0.25 in ) thick, operated at MAOP of 1.7 MPa (250 psi) In Figure 3, the location marking the division between the electric arc and oxy-acetylene welded segments of Line 85 is shown North of the division, the line was constructed originally with oxy-acetylene welds In 1932, roughly 30% of the oxy-acetylene welds in this section were reconditioned with electric arc welded reinforcements South of the division,

The electric arc welded portion of Line 85 was damaged at seven locations within the zone of lateral spread along the east side of the Upper Van Norman Reservoir. The partially reconditioned oxy-acetylene welded portion of the line was damaged at three locations north of the division, of which only two are shown in the figure.

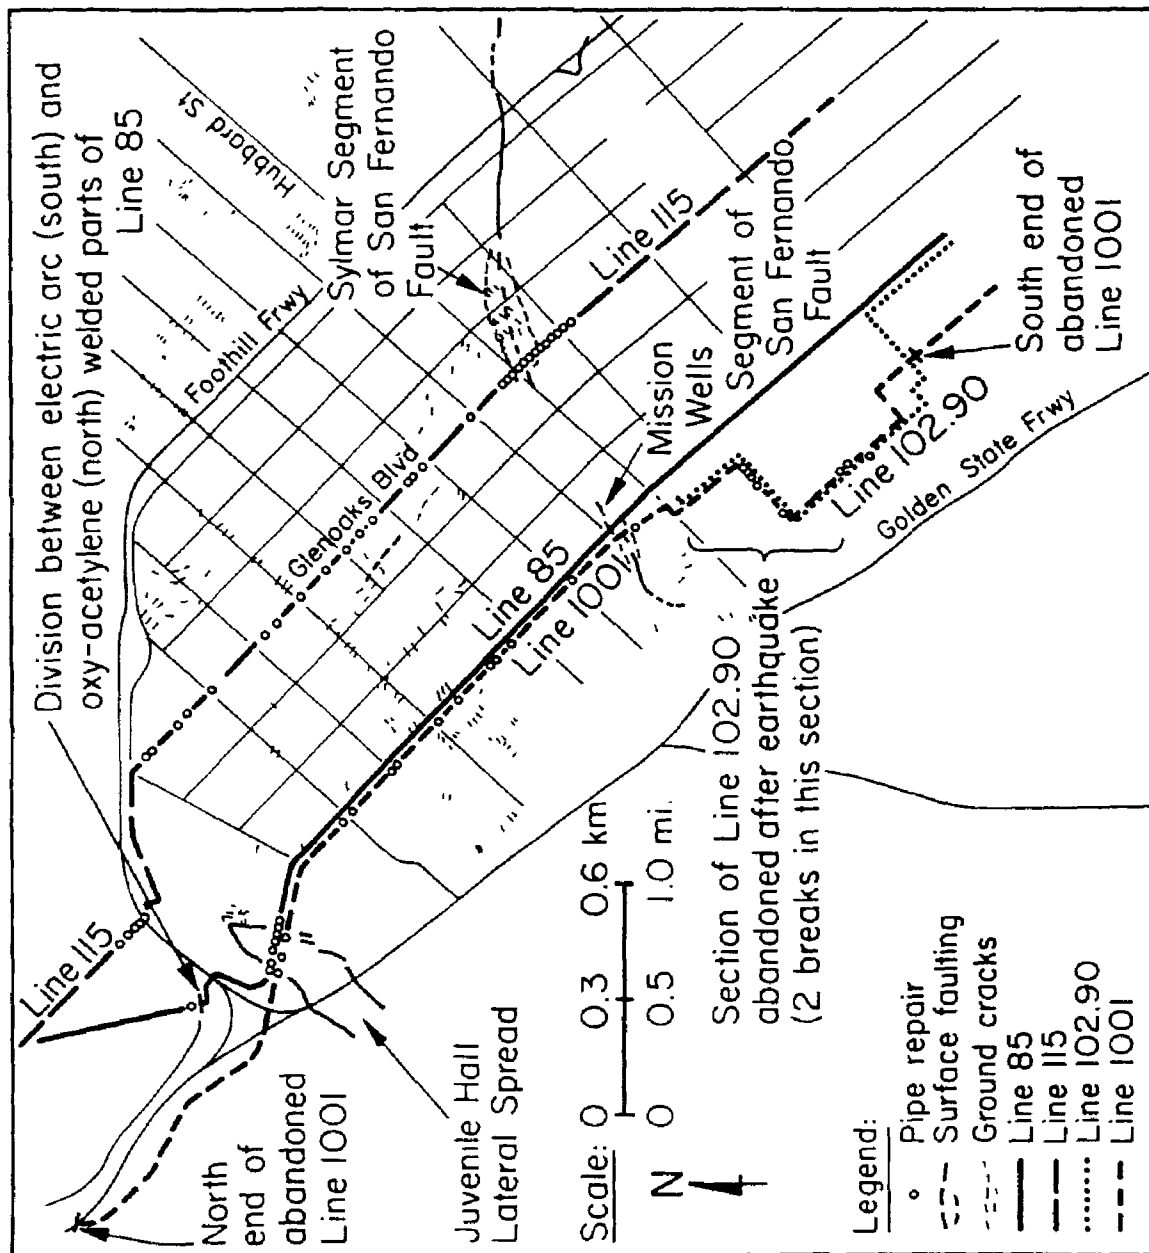
**FIGURE 4.** Locations of Damage to Lines 115, 1001, 85, and 102.90 in the San Fernando Area as a Result of the 1971 Earthquake

Figure 4 shows the locations of damage to Lines 115, 1001, 85, and 102 90 in the San Fernando area at an expanded scale. Damage locations were determined from repair records summarized by Southern California Gas personnel [Johnson, 1982]. The preponderant form of damage was rupture or leakage at oxy-acetylene welds. Also shown on the map are locations of ground failures and surface soil cracks as mapped by the U.S. Geological Survey and the California Division of Mines and Geology [U.S. Geological Survey Staff, 1971, Steinbrugge, et al., 1971].

Near the Sylmar segment of the San Fernando fault, there were approximately three compression and ten tensile ruptures of Line 115. One break occurred in Line 1001 at its crossing of the Mission Wells segment of the San Fernando fault, and three breaks were reported in this line in the vicinity of the Juvenile Hall lateral spread on San Fernando Road. With the exception of Line 85 damage at the lateral spread, all other breaks in Figure 4 do not appear to be associated with permanent ground movement.

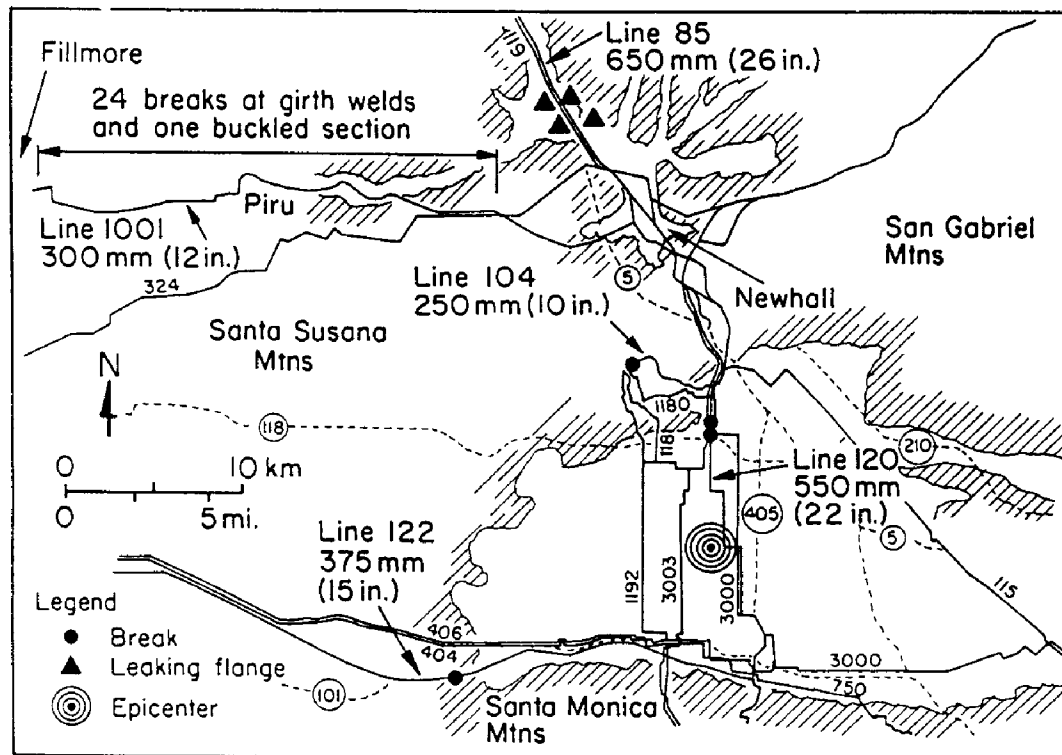
FIGURE 5. Map of Gas Transmission Pipelines in the Area of Strong Ground Shaking

There were 35 non-corrosion related repairs in the transmission system, of which 27 were at cracked or ruptured oxy-acetylene girth welds in pre-1932 pipelines. Figure 5 shows a plan view of selected transmission pipelines in the area of most severe ground shaking. Locations of damage in the form of pipeline breaks and leaking flanges are shown in the figure.

As shown in Figure 5, there were 24 breaks at oxy-acetylene girth welds and one location of buckled pipe in Line 1001, which conveys gas between Newhall and Fillmore, many of which were in Potrero Canyon. Line 1001 was constructed in 1925, and was operated at the time of the earthquake at 1.7 MPa (245 psi) internal pressure. The pipeline is 300 mm (12 in.) in diameter, with 5.6-mm- (0.22-in.)-thick wall of unknown grade steel.

Of the 25 repairs in Line 1001, 18 were in Potrero Canyon. Six breaks in oxy-acetylene welds were located in areas adjacent to the Santa Clara River east of Piru and west of Potrero Canyon. One oxy-acetylene weld ruptured at the eastern city limits of Fillmore, leaving a crater approximately 2.7 m (9 ft) deep and 4.5 m (15 ft) by 6 m (20 ft) in area. Gas escaping at the location of this break under Highway 126 was ignited by a downed power line.

Flange leaks occurred at the four locations shown in Figure 5 at sections of aboveground piping. There was also a break in an oxy-acetylene weld in Line 85 at a location approximately 39 km (24 mi.) northwest of Newhall, which is not shown in the figure. Damage was mainly in the form of flange separation and leaking gaskets. One of the flanges was fractured. At the damaged locations, Line 85 is a 650-mm- (26-in.)-diameter pipeline with a pipe wall 6.4 mm (0.25 in.) thick, of Grade A steel, operated at MAOP of 2.2 MPa (317 psi). The ruptured oxy-acetylene weld and four leaking flanges occurred in a partially reconditioned portion of Line 85. The weld failure was at an original oxy-acetylene weld.

A fractured oxy-acetylene girth weld was repaired in Line 122 at the location shown in Figure 5. Although this pipeline is not operated as a transmission line, it nevertheless is described in this paper because of its relatively high operating pressure of 1 MPa (150 psi). The pipeline was

As shown in Figure 5, there was a break in Line 104 inside the Aliso Canyon Gas Storage Field. The pipeline is 250 mm (10 in.) in diameter and has an MAOP of 1.6 MPa (228 psi), but it is operated at 1.4 MPa (200 psi). It was constructed with electric arc girth welds in 1941. The pipe has a 5.2-mm- (0.203-in )-thick wall of unknown grade steel.

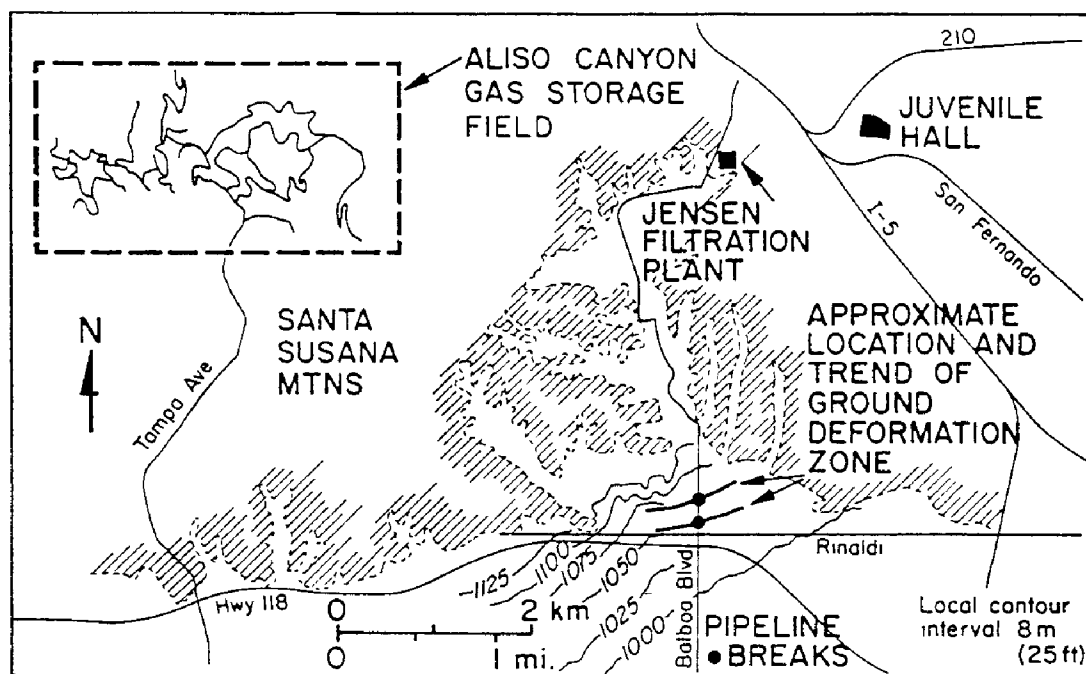
FIGURE 6. Map of the Area North of the Northridge Earthquake Epicenter

Figure 6 is a map of the area just north of the earthquake epicenter, showing the Aliso Canyon Gas Storage Field and the locations of two gas transmission line breaks on Balboa Blvd. The Aliso Canyon facility, which covers some 14.7 km<sup>2</sup> (3,600 acres) and 56 km (35 mi) of access road, is used to store gas in an underground reservoir that once was used for oil production. Gas is injected during low demand summer months and withdrawn during high demand winter months. Earthquake effects in the facility included deformation of aboveground pipe supports, displacements of runs of injection and withdrawal lines, and structural damage to a fin fan unit used to cool compressed gas before its injection in storage wells. The supply of gas from Aliso Canyon was interrupted for five days.

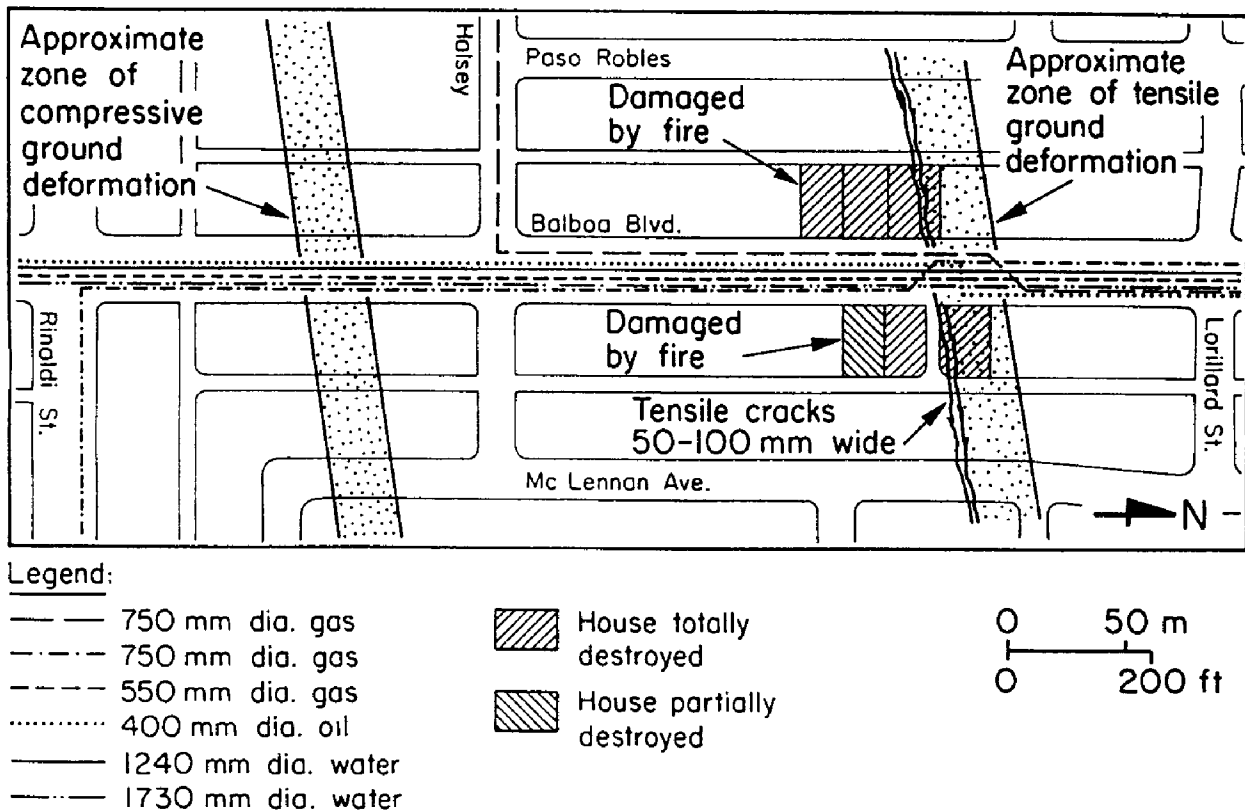
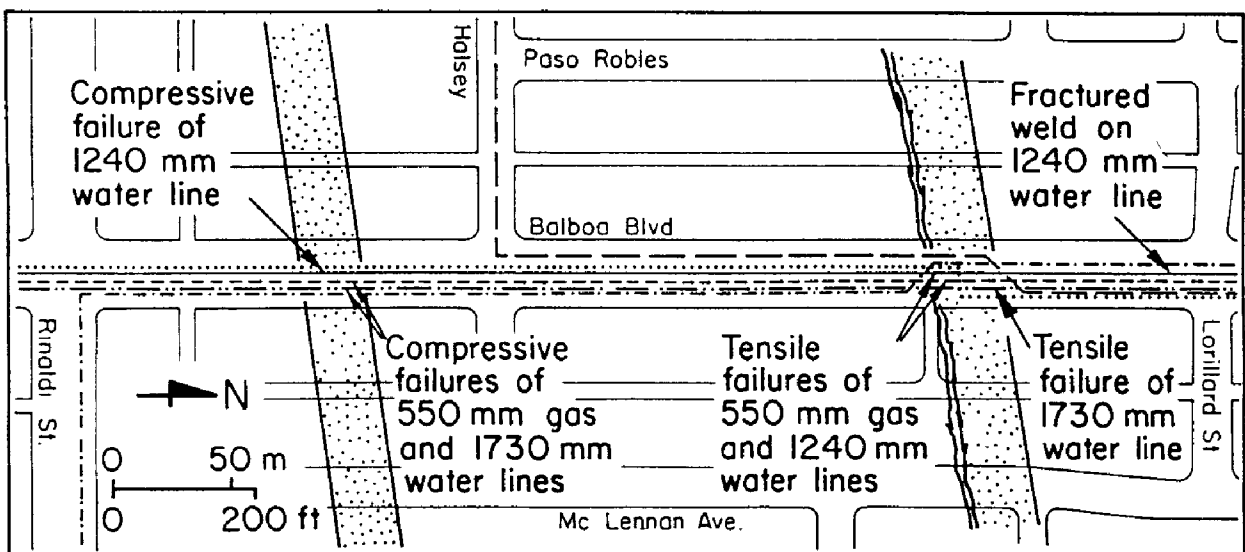
Figures 7 and 8 show maps of the pipelines in Balboa Blvd. near the zones of permanent ground deformation. In addition to numerous distribution mains, there were six transmission and water trunk lines at this site. There were two 750-mm- (30-in )-diameter gas transmission lines constructed of X-52 steel in the 1950s which were not damaged. There was a 400-mm- (16-in )-diameter petroleum pipeline, operated by the Mobil Oil Corporation, which was not damaged. The pipeline was composed of X-52 steel and installed in 1991. Two water trunk lines, the 1,240-mm- (49-in )-diameter Granada and the 1,730-mm- (68-in )-diameter Rinaldi Trunk Lines, failed in tension and compression in the tensile and compressive zones of ground deformation, respectively.

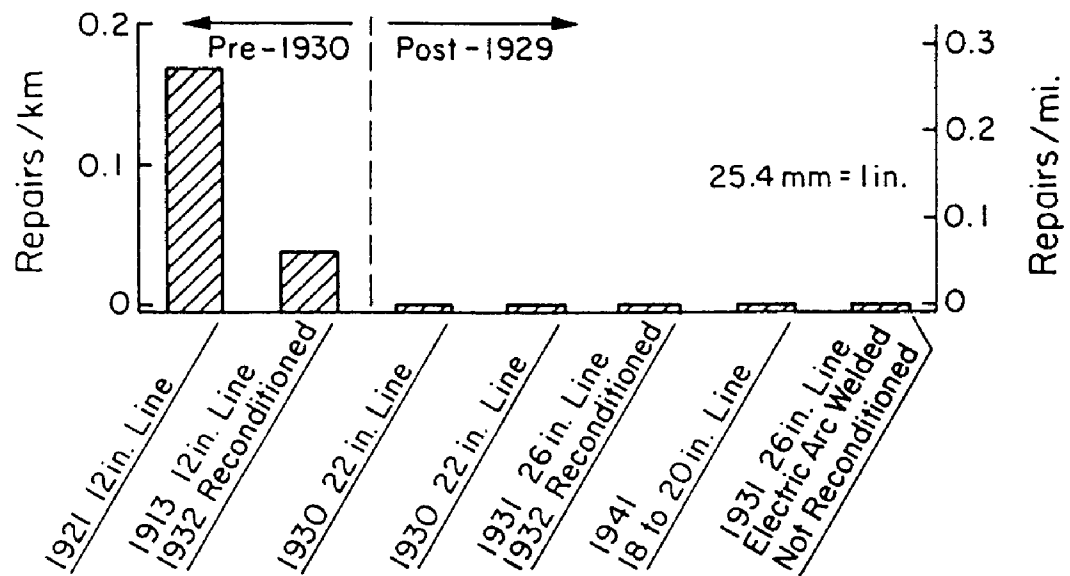
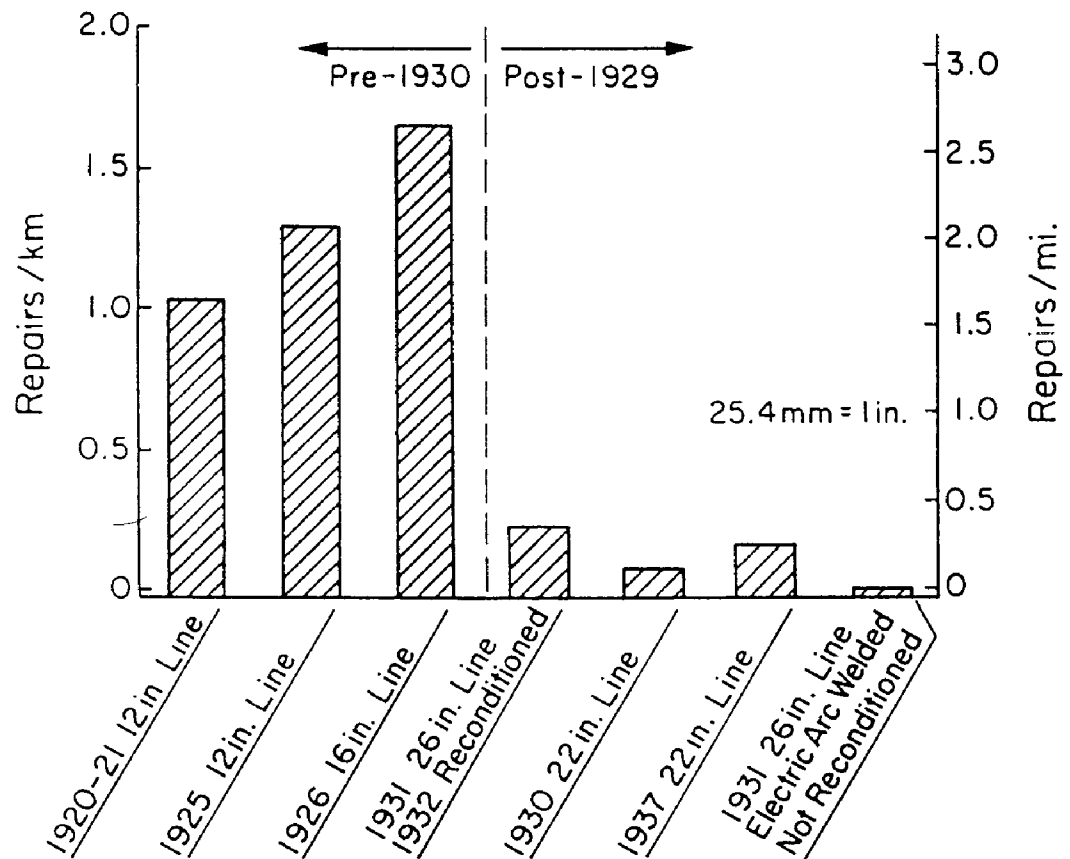
FIGURE 9. Damage Rates for Gas Transmission and Supply Lines in Areas with No Reported Permanent Ground Deformation

The information in the table can be used to point out some interesting trends, as illustrated in Figure 9. In this figure, the repair rates for the 1952 and 1954 Kern County and 1971 San Fernando earthquakes are plotted according to age of installation. Both earthquakes show similar trends, in that the damage rate for pipelines constructed before 1930 are approximately an order of magnitude higher than those constructed during or after 1930.

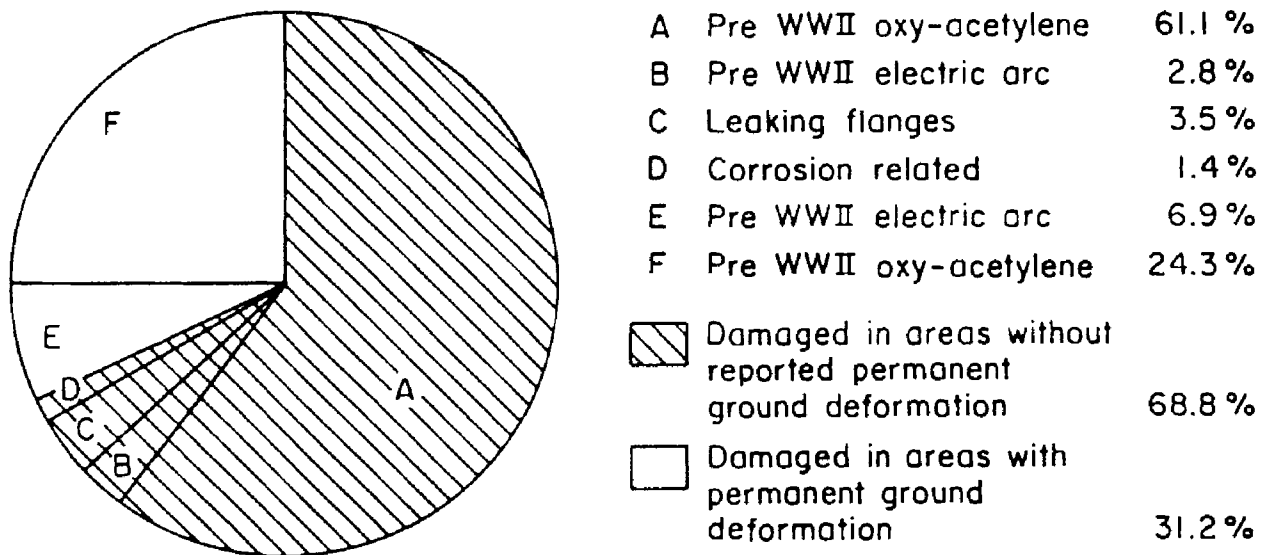
**FIGURE 10.** Pie Chart Showing Relative Proportions of Earthquake-Related Repairs Associated with Various Categories of Damage

Table IV and Figure 10 summarize all gas transmission and supply line repairs. The formats of the table and figure are similar to those presented by O'Rourke and Palmer (1994a,b) with several notable exceptions. The repair statistics are grouped under categories in which damage occurred in areas either with or without reported permanent ground deformation. Previous treatment of the statistics grouped repairs according to damage by either traveling ground waves or permanent ground deformation. Grouping the data according to the absence or presence of permanent ground deformation is more consistent with the evidence. The absence of reported ground displacements does not eliminate the possibility of movement which escaped observation. However, a careful check of damage locations, which had been inspected and/or mapped for ground movements, does show that many locations of damage to oxy-acetylene welded lines are in areas which lack significant permanent differential ground movement and thus were likely affected by traveling ground waves.
