EARTHQUAKE DAMAGE INSPECTION AND EVALUATION

The Namioka Town Hospital, a reinforced concrete five stories building, suffered earthquake damage by the 1983 Nihonkai chubu Earthquake. The application results of the GUIDELINES FOR POST-EARTHQUAKE DAMAGE INSPECTION AND EVALUATION and the GUIDELINES FOR RESTORATION TECHNIQUES FOR DAMAGED BUILDINGS are presented as an example.

3. OUTLINES OF BUILDING AND DAMAGE

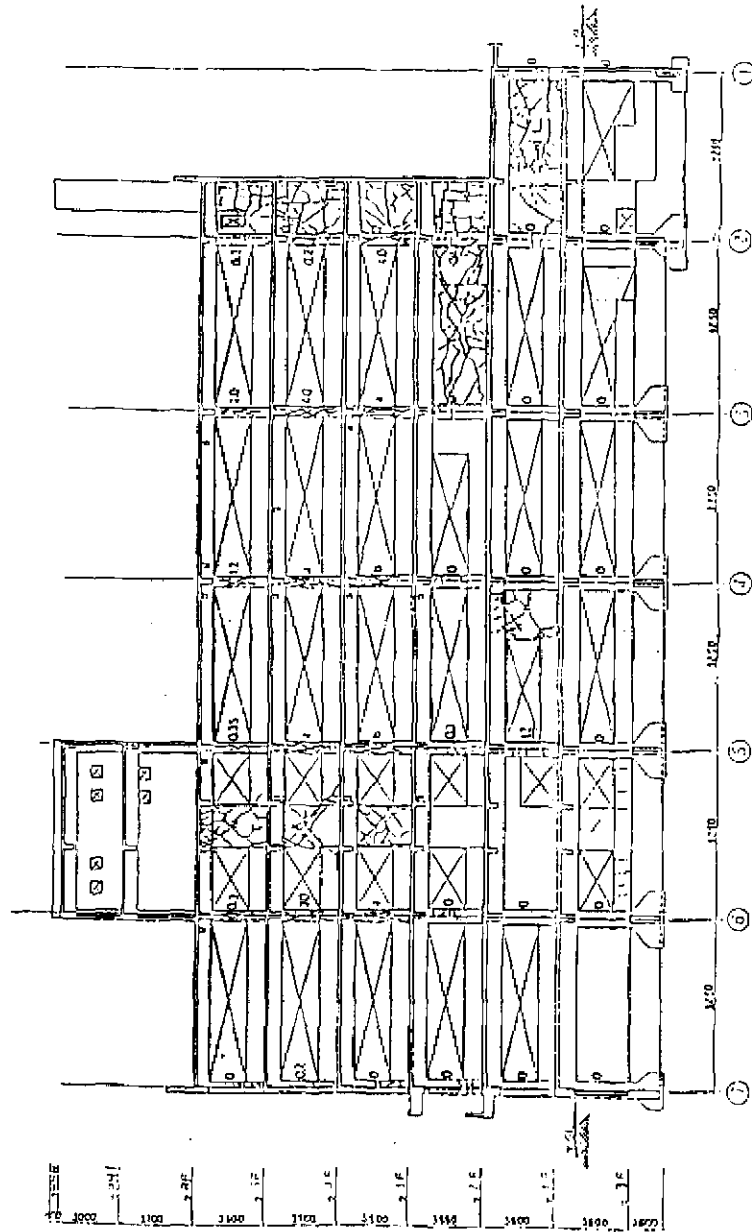
FIG. 3.4 : CRACK PATTERN OF EXTERIOR J-FRAME IN X-DIRECTION

The crack pattern of J-frame in X-direction is shown in Fig.3.4. Almost all the columns between the third line and the sixth line upper than third floor had clear shear cracks. In particular, the shear cracks on the columns at third floor were rather big with bond splitting failure cracks or concrete spalling. Fig.3.5 shows the typical shear failure with bond splitting failure cracks. The reinforced concrete walls upper than third floor, which were not designed as structural shear wall, suffered severe damage as shown in Fig.3.4 and Fig.3.6. The non-structural spandrel walls which were on the floor beams did not suffered any damage. However, floor beams had several narrow flexural cracks, which were observed after ceilings were removed.

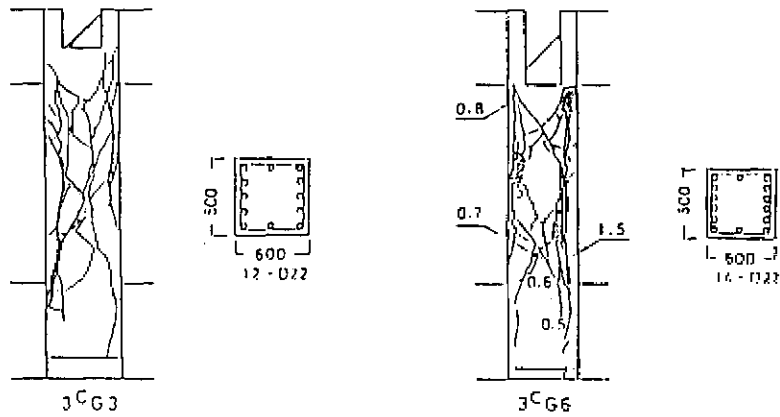
FIG. 3.5 : CRACK PATTERN OF COLUMNS WITH SEVERE DAMAGE

(a) EXAMPLE OF SHEAR FAILURE
COLUMN (CG3 on 3rd floor)

(b) EXAMPLE OF BOND SPLITTING
FAILURE (CG6 on 3rd floor)

The DAMAGE RANK concerning damage of the structures was judged as "RANK-C" without a computation by Eq. (3.2) given in the "GUIDELINES FOR DAMAGE INSPECTION AND EVALUATION", because the severe damage corresponding to "RANK-IV" (concrete spalled) or "RANK-V" (core concrete crushed) were observed on the several columns at the third floor.

- (a) Some technique should be applied to mitigate the degradation of capacity to sustain a vertical load for some columns damaged severely at the third floor.
- (b) Strengthening, such as adding steel bracing system, should be applied to recover the lateral capacity in X-direction at the third or fourth floor.
- (c) The inclined parapets or chimney should be demolished.

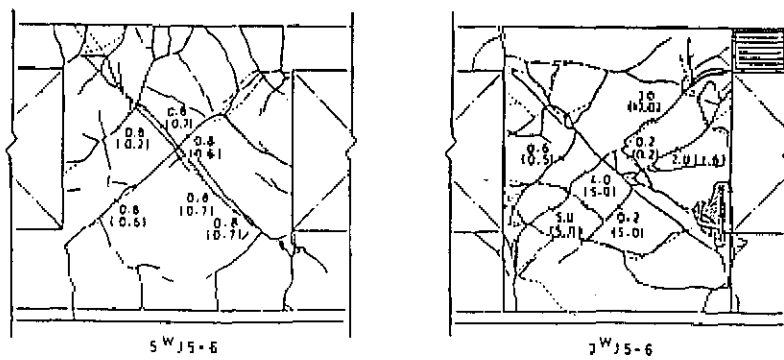
FIG. 3.6 : CRACK PATTERN OF WALLS IN X-DIRECTION

Many narrow shear cracks were observed on each shear wall between the second and seventh line in Y-direction upper than second floor. Also some columns with non-structural spandrel walls on the second floor had the narrow shear cracks. The big shear cracks were observed on the roof beam that supported the wall of penthouse.

(a) Wall WJ5-6 on 5th floor

(b) Wall WJ5-6 on 3rd floor

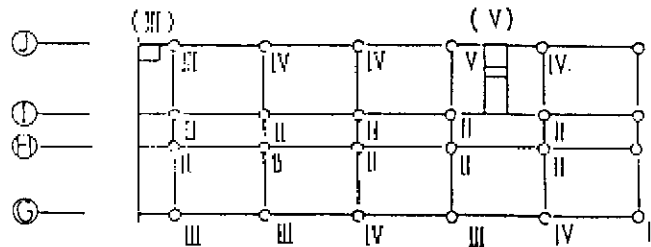
FIG. 6.1 : DAMAGE RANK OF COLUMNS AT THE THIRD FLOOR

The damage inspection for structural members was done at the third floor, where was the severest damage in the north building. The Damage Rank of Members, which were classified according to Table-3.1 given in the Section 3 of GUIDELINES FOR DAMAGE INSPECTION AND EVALUATION, is presented in Fig.6.1.

The Damage Ratio D for X-direction at the third floor was evaluated by Eq. (3.2) which was given in the Section 3.3 of GUIDELINES FOR DAMAGE INSPECTION AND EVALUATION, using the Damage Rank of Columns given in Fig.6.1.

$$\begin{aligned} \text{Damage Rank I} &: D_1 = 10B_1/A = 10 \times 2/24 = 0.8 \\ \text{Damage Rank II} &: D_2 = 25B_2/A = 25 \times 11/24 = 11.9 \\ \text{Damage Rank III} &: D_3 = 60B_3/A = 60 \times 5/24 = 12.5 \\ \text{Damage Rank IV} &: D_4 = 100B_4/A = 100 \times 4/24 = 16.7 \\ \text{Damage Rank V} &: D_5 = 1000B_5/7/A = 1000 \times 2/7/24 = 11.9 \end{aligned}$$

The DAMAGE DEGREE of a building was judged as "SEVERE" according to the Section 3.3 of GUIDELINES FOR DAMAGE INSPECTION AND EVALUATION, because the sum of Damage Ratio $\sum D_i$ was more than 50 as

"STRENGTHENING" was also required for this building to use consistently, according to Table 3.2 of the GUIDELINES FOR DAMAGE, TION AND EVALUATION

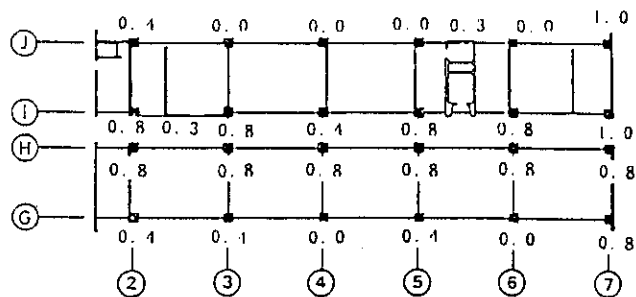
Fig. 7.2 : CAPACITY REDUCTION FACTOR η BY EARTHQUAKE DAMAGE

Fig.7.2 shows the capacity reduction factors of columns at the third floor after the earthquake. The capacity reduction factors are given in the table of GUIDELINES FOR RESTORATION TECHNIQUES OF SUFFERED BUILDINGS.

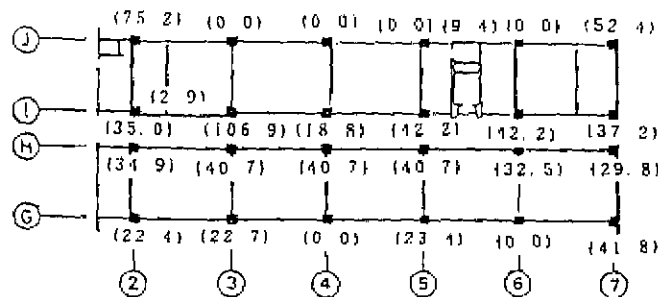
Fig. 7.3 REMAINING LATERAL STRENGTH OF COLUMNS OR WALLS

- Sum of lateral strength after damage, $\sum V_u = 644.9$ ton
- Building weight upper than 3rd floor, $\sum W = 2,970$ ton

* Index C, $C = \sum V_j / \sum W = 644.9 / 2,970 = 0.217$
 * Index Γ assumed, $\Gamma = 1.0$
 * Index E_0 after damage, $E_n = \frac{(n+1)/(n+2) \sqrt{(C \times \Gamma)^2}}{(5+1)/(5+2) \sqrt{(0.217 \times 1.0)^2}}$
 $= 0.75 \times 0.217 = 0.163$
