FIG.11 Well constructed stone masonries w/o mortar, and traditional chimney in the epicentral area of the Volvi 06.20.78 EQ. Many of them experienced no damage at all

FIG.12 Adobes in the epicentral area of the Volvi 06.20.78 EQ

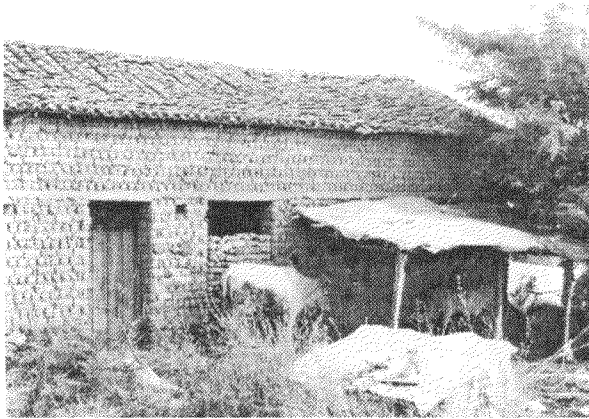
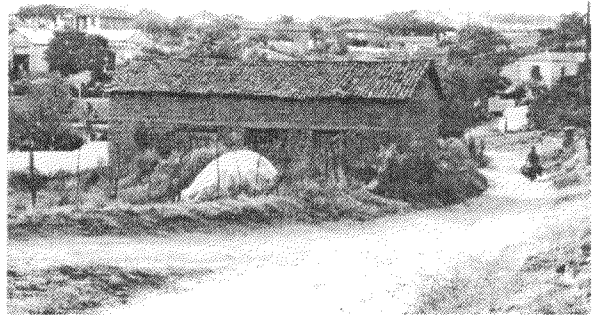
Well constructed adobes experienced no damage at all

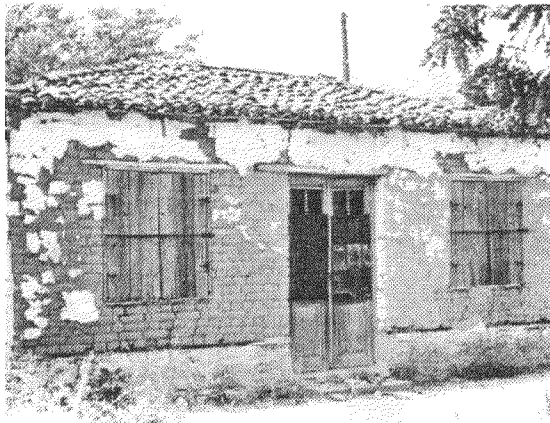
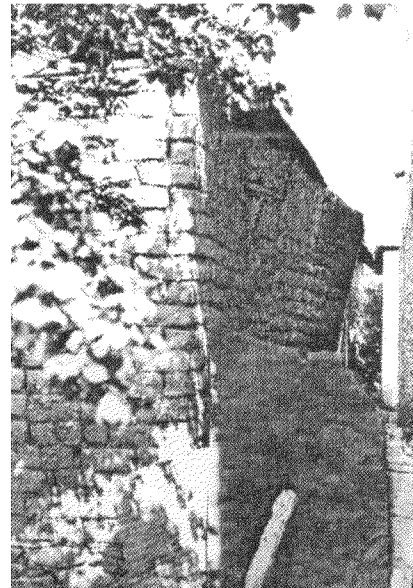
Poorly constructed adobes experienced moderate damage
