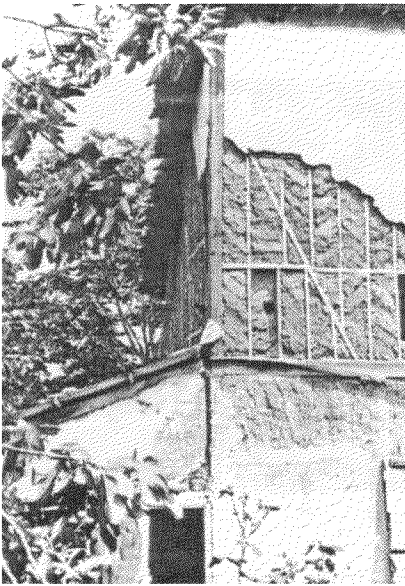
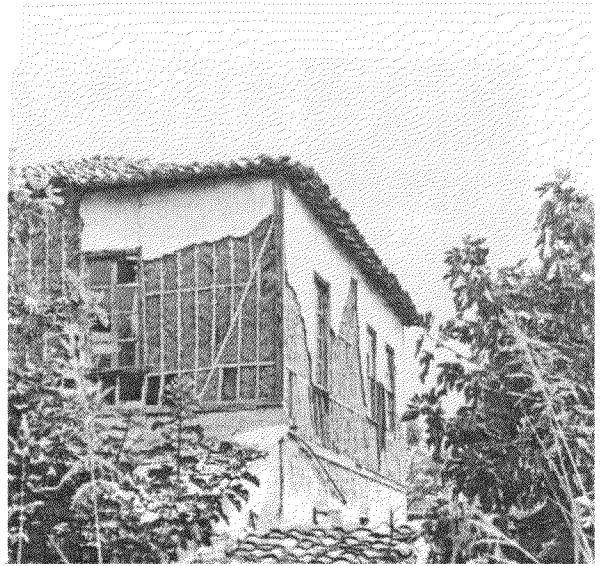
FIG.13 Adobe infilled timber framed dwelling in epicentral area of the Volvi 06.20.78 EQ. Many of them experienced only moderate damage

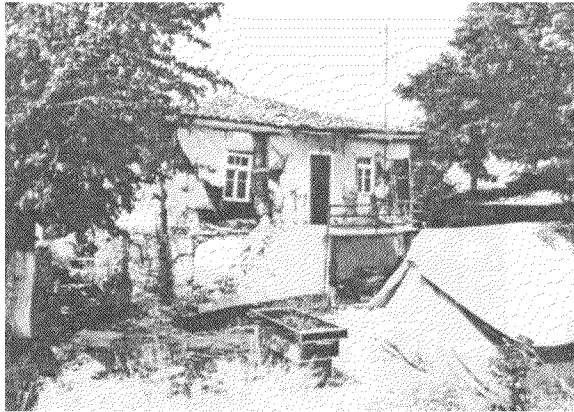
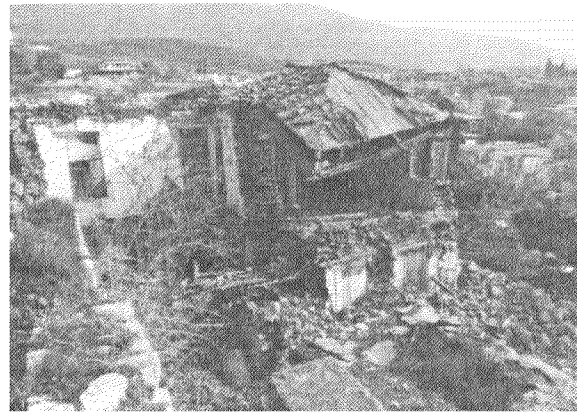
FIG.14 Traditional Construction Systems (Tsatma, Stone Masonry) of poor construction and/or maintenance experienced severe damage during recent EQs

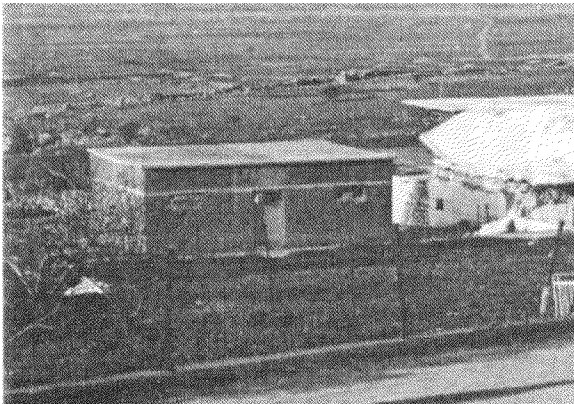
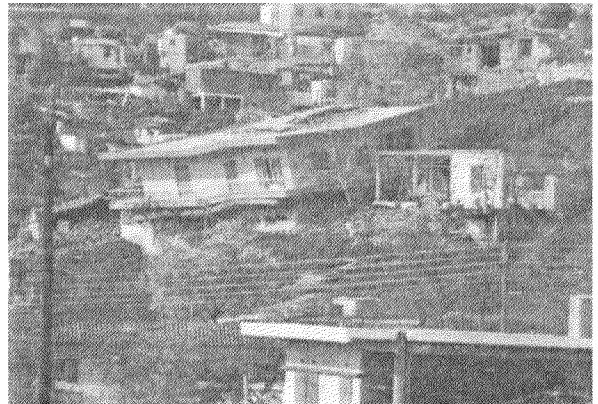
FIG.15 Modest brick masonry structure with light R.C. roof experienced no damage, while surrounding structures with mixed construction systems collapsed during the Alkyonides 03.4.81 EQ
