# THE WORK IN PROGRESS CONCERNING ASSISMIC EARTHEN HOUSING IN CHINA

Ye, Yaoxian<sup>1</sup>      Niu, Zezhen<sup>2</sup>

1 Engineer & Vice Director, Office of  
Earthquake Resistance, State Capital  
Construction Commission, Beijing, China

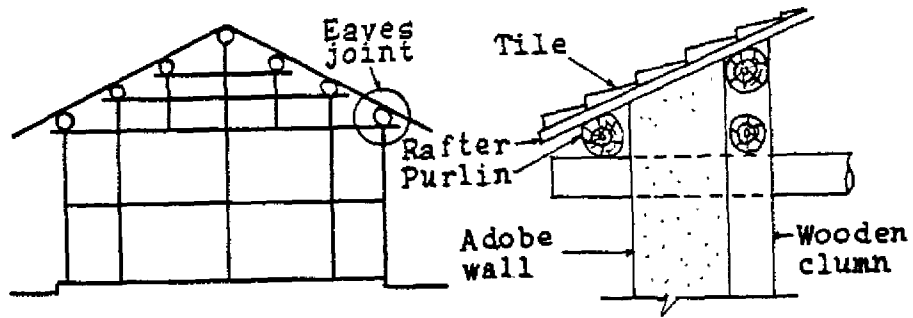
FIG.2 Utilizing two purlins to press the top of  
the adobe wall from both sides

2. The office building of Osan county town was built as of Chinese type of three bay, two stories wooden frame building with adobe cladding walls. The two purlins were arranged on both sides of the front exterior wall at the eaves level for holding the top of the wall. The two ring beams were placed in the middle part of the walls. The surfaces of walls were plastered with mixture of mud and straw (FIG.3 ). As the result of wooden columns which were placed on stone footings of 40cm high fell down in the earthquake, the building inclined. Although the wall tilted, it still stood.

— Utilizing purlins at the eaves level to hold the top of the adobe wall.

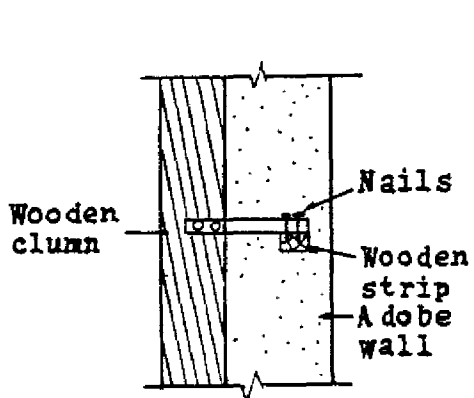
FIG.4 Wooden rod in the  
wall and its conec-  
tion

4. The house owned by productive brigade NO.1 of Osan county town was constructed as of Chinese type of three bay, two stories timber frame building. The gable wall of the building was 48cm thick, 5.2m high, and plastered with mixture of mud and straw and finished

with white lime. A wooden rod of 13 x 10cm cross section was placed in the middle part of the gable wall and was tied with wooden column (FIG.4).

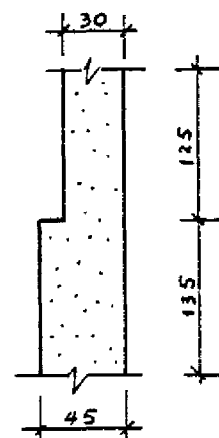
FIG.5 Earthen wall with  
varies cross sec-  
tion

7. It has been found that the meeting hall of productive brigade NO.1 of Osan county town was intact. This building was built as of two stories Chinese type timber frame, which had survived in the strong earthquake occurred 57 years ago. The adobe cladding walls plastered with mixture of mud and straw were used for the first story, and being thin at its top but thicker at its lower part. (FIG.5). The walls of the second story were made of board.

— Designing the wall with varied cross section, upper thin and lower thick.

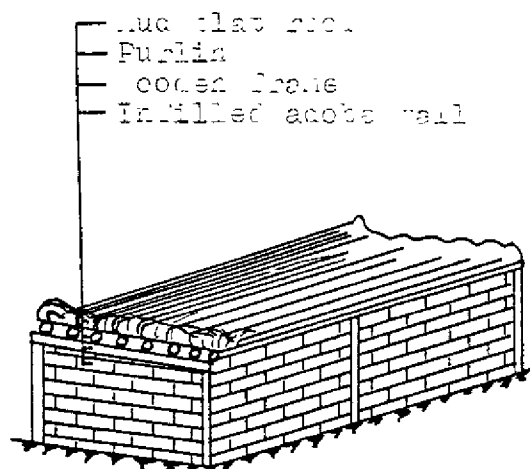
FIG.6 Single storey frame building with earthen flat roof and with infilled adobe walls

8. The house of a commune member of productive brigade NO.1 of Osan county town was a single story frame building with earthen flat roof and with infilled adobe walls (FIG.6). After the earthquake, this house including adobe walls was found still in good condition.

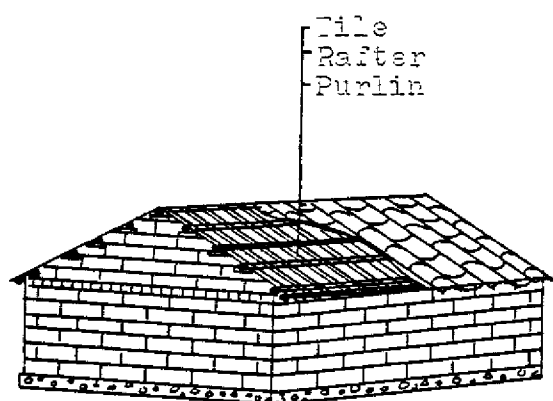
FIG.7 Single storey building with load-bearing earthen walls

For the single story earthen housing, the walls generally are the rammed earthen walls or the walls laid with adobes. The thickness of the walls is 30cm to 50cm, and the height of eaves is about 3m. The purlins are directly supported on the earthen wall. The roof may be covered by mud, tiles or straw. This kind of building is schematically illustrated in FIG. 7.

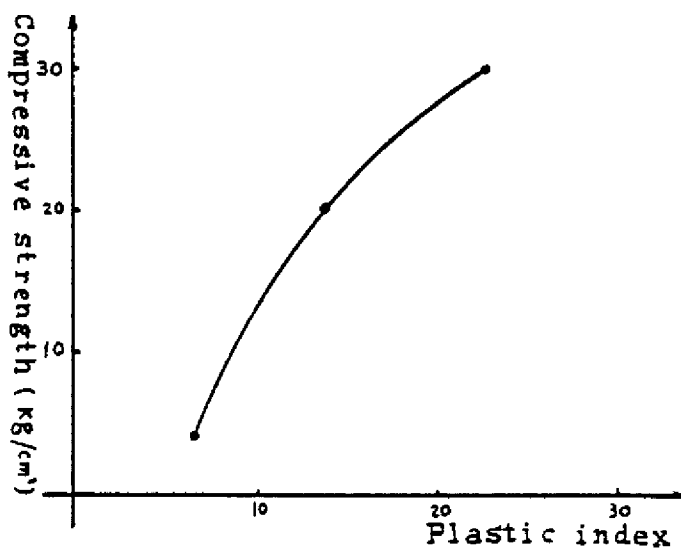
FIG.8 Compressive strength vs. plastic index

1. The compressive strength of lime-earth increases with the plastic index (Fig. 3).
2. The compressive strength of lime-earth increases with lime-earth ratio within a certain extent. The optimum lime-earth ratio is approximately 10 to 15 percent for the weight and is inversely proportional to the plastic index.
3. The compressive strength of lime-earth increases with its age. The compressive strength of the lime-earth less than one day old, is the same as that of pure earth. It will be increased over 250% when the lime-earth is 28 days old. Some testing reports show that the compressive strength of lime-earth is increased from  $15\text{kg/cm}^2$  at the age of 10 days to  $55\text{kg/cm}^2$  at the age of 10 years.
4. The compressive strength of lime-earth increases with its

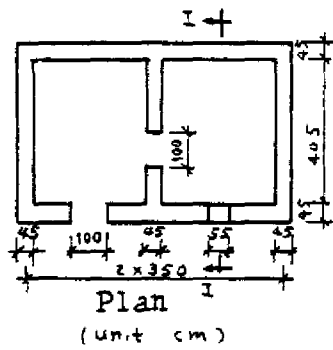
FIG. 9 Full scale  
test  
house

In autumn 1970, Institute of Engineering Mechanics (IEM) of Chinese Academy of Science conducted a field explosive earthquake simulating experiment of a full scale earthen house in Tonghai county, Yunnan province. FIG.9 shows the plan and the sectional drawing of the testing house.

The tested house had two rooms, the adobe walls were laid with local technique (the adobes were laid vertically) for one room, and with improved technique (the adobes were laid horizontally) for another. Vertical joints in the wall were filled with mud mortar. A layer of straw was placed in the walls every two courses.

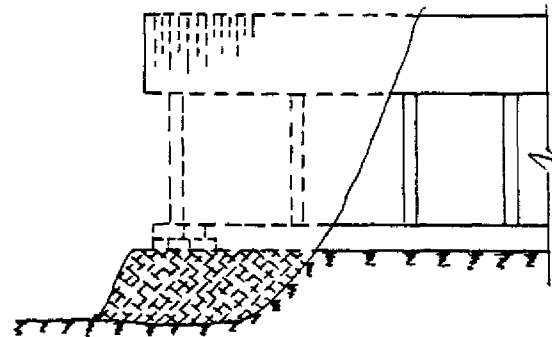
FIG. 10 Building built on  
partially cutting &  
filling subsoil,  
one part with  
dashed lines shows  
it may be collapsed  
in an earthquake

1. Where the subsoil is soft or the subsoil in the bearing layer associate with a soft and hard distribution, such as sections with abandoned and filled river bed and fracture belt of fault, hidden swamp, creek, gully and pit as well as partially cutting and filling subsoil, and where the distribution of the walls is severely unsymmetrical, the non-uniform settlement is easily taken

place, and can be led to cracks or collapse of the walls (FIG.10). Therefore, in order to prevent the nonuniform settlement, we have to pay more attention to the site selection and the arrangement of the walls.

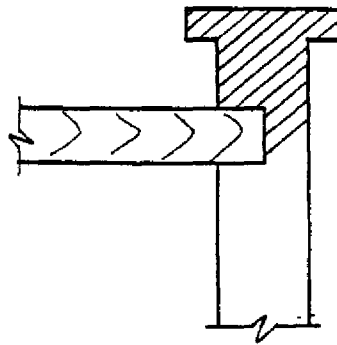
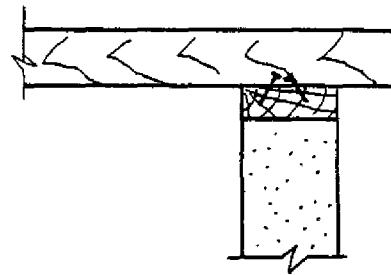
FIG. 11 Eaves

3. In earthquake, gables are very dangerous when they are made of adobe. For improving the aseismic capacity of a wall, the following measures can be used:

a. Without outstanding eaves,  
shaded part may be came  
down in an earthquake

- Elongating purlins supported by a gable towards outside in certain length, i.e. using outstanding eaves (FIG.11).
- Putting bearing beams underneath the purlins. The beams are tied with rod and anchored with bolts. (FIG.12).
- Setting wall ties in a gable wall (FIG.13).

b. Outstanding eaves by  
elongating a purlin  
outwards

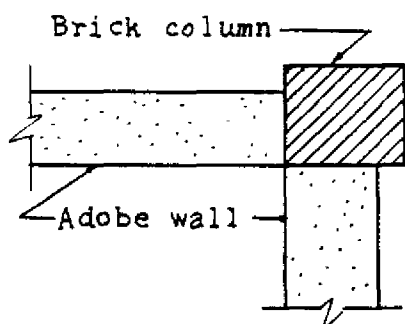
FIG. 14 Earthen wall with brick column

4. In earthen buildings with brick columns in corners and intersections of walls (FIG.14), during earthquake, the brick column can be separated with attached earthen wall, and led it to collapse. Therefore, this structural solution is not recommended.

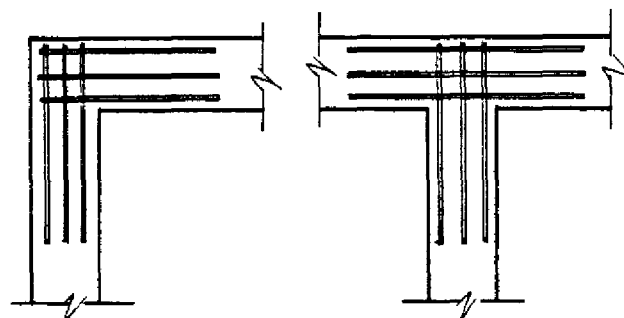
FIG. 15 Reinforcing materials in the intersections of walls

6. Owing to lack of the ties in intersections of earthen walls, during the earthquake, the vertical cracks were taken place in intersections, and in some cases, the walls were collapsed due to tilt of them. Therefore, at intersections of walls, bamboo ribs, straw, wooden battens and chaste twigs should be placed for

strengthening (FIG.15). The wooden ring beams should be installed in the walls for better integrity.

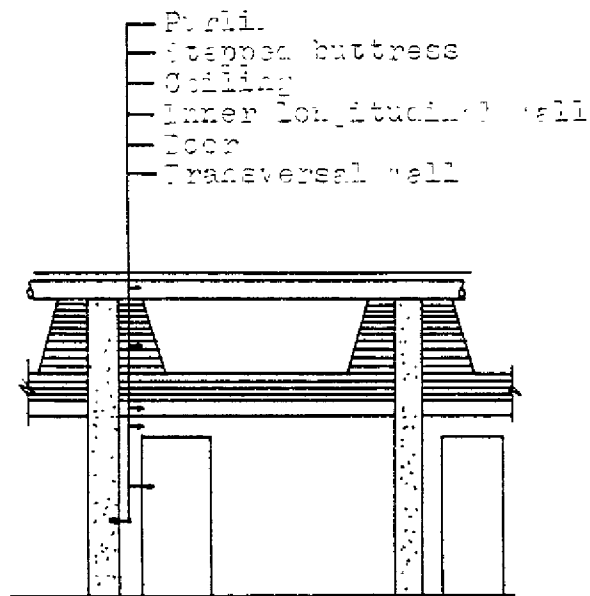
FIG.18 Stepped buttresses built on the top surface of inner longitudinal walls at both sides of the exterior and interior gable walls

12. For a house, in which the roof is the one with two sides and the purlins are directly supported by earthen gable walls, the upper triangular part of gables may collapsed during an earthquake. In such case, adding buttresses laid on longitudinal wall to triangular part of gables was recommended (FIG.18).

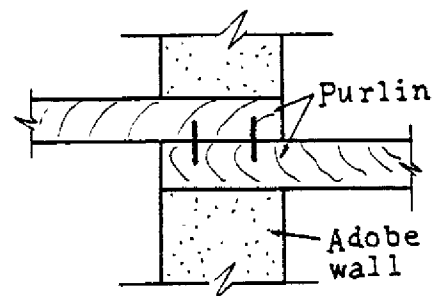
FIG.20 Connection of purlins on the wall

14. Vertical cracks may occur on the wall underneath the purlin due to stress concentration in the earthquake, if the purlin is placed directly on the top of the wall (FIG.20a). This damage can be avoided by inserting a bearing block under the purlin (FIG.20b).

15. If there is no mutual connection between purlins and no connection between the wall and purlins, some purlins could be drawn out from the wall, consequently, the wall would collapse and the roof would fall down. Therefore, the purlins should be connected among themselves and be connected with the wall (FIG.21).
