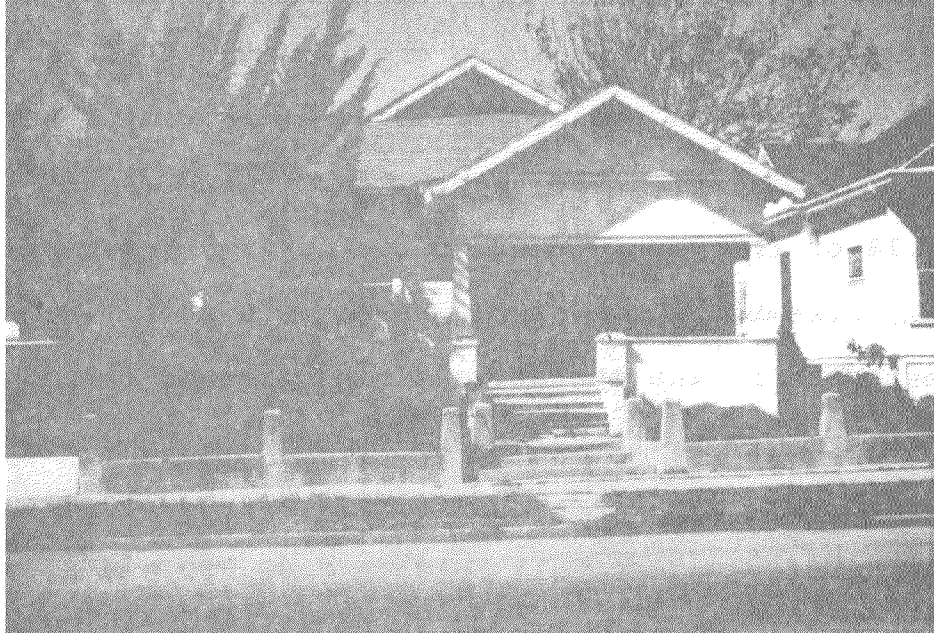
Small, well-maintained homes are representative of the housing in the special studies zones in Hollister (Photographs 40 and 41). Photograph 40, however, shows extensive structural damage to the walls and sidewalks.
