**The Post-George Repair and Strengthening of JN France Hospital
(with brief remarks about Cayon Clinic)**

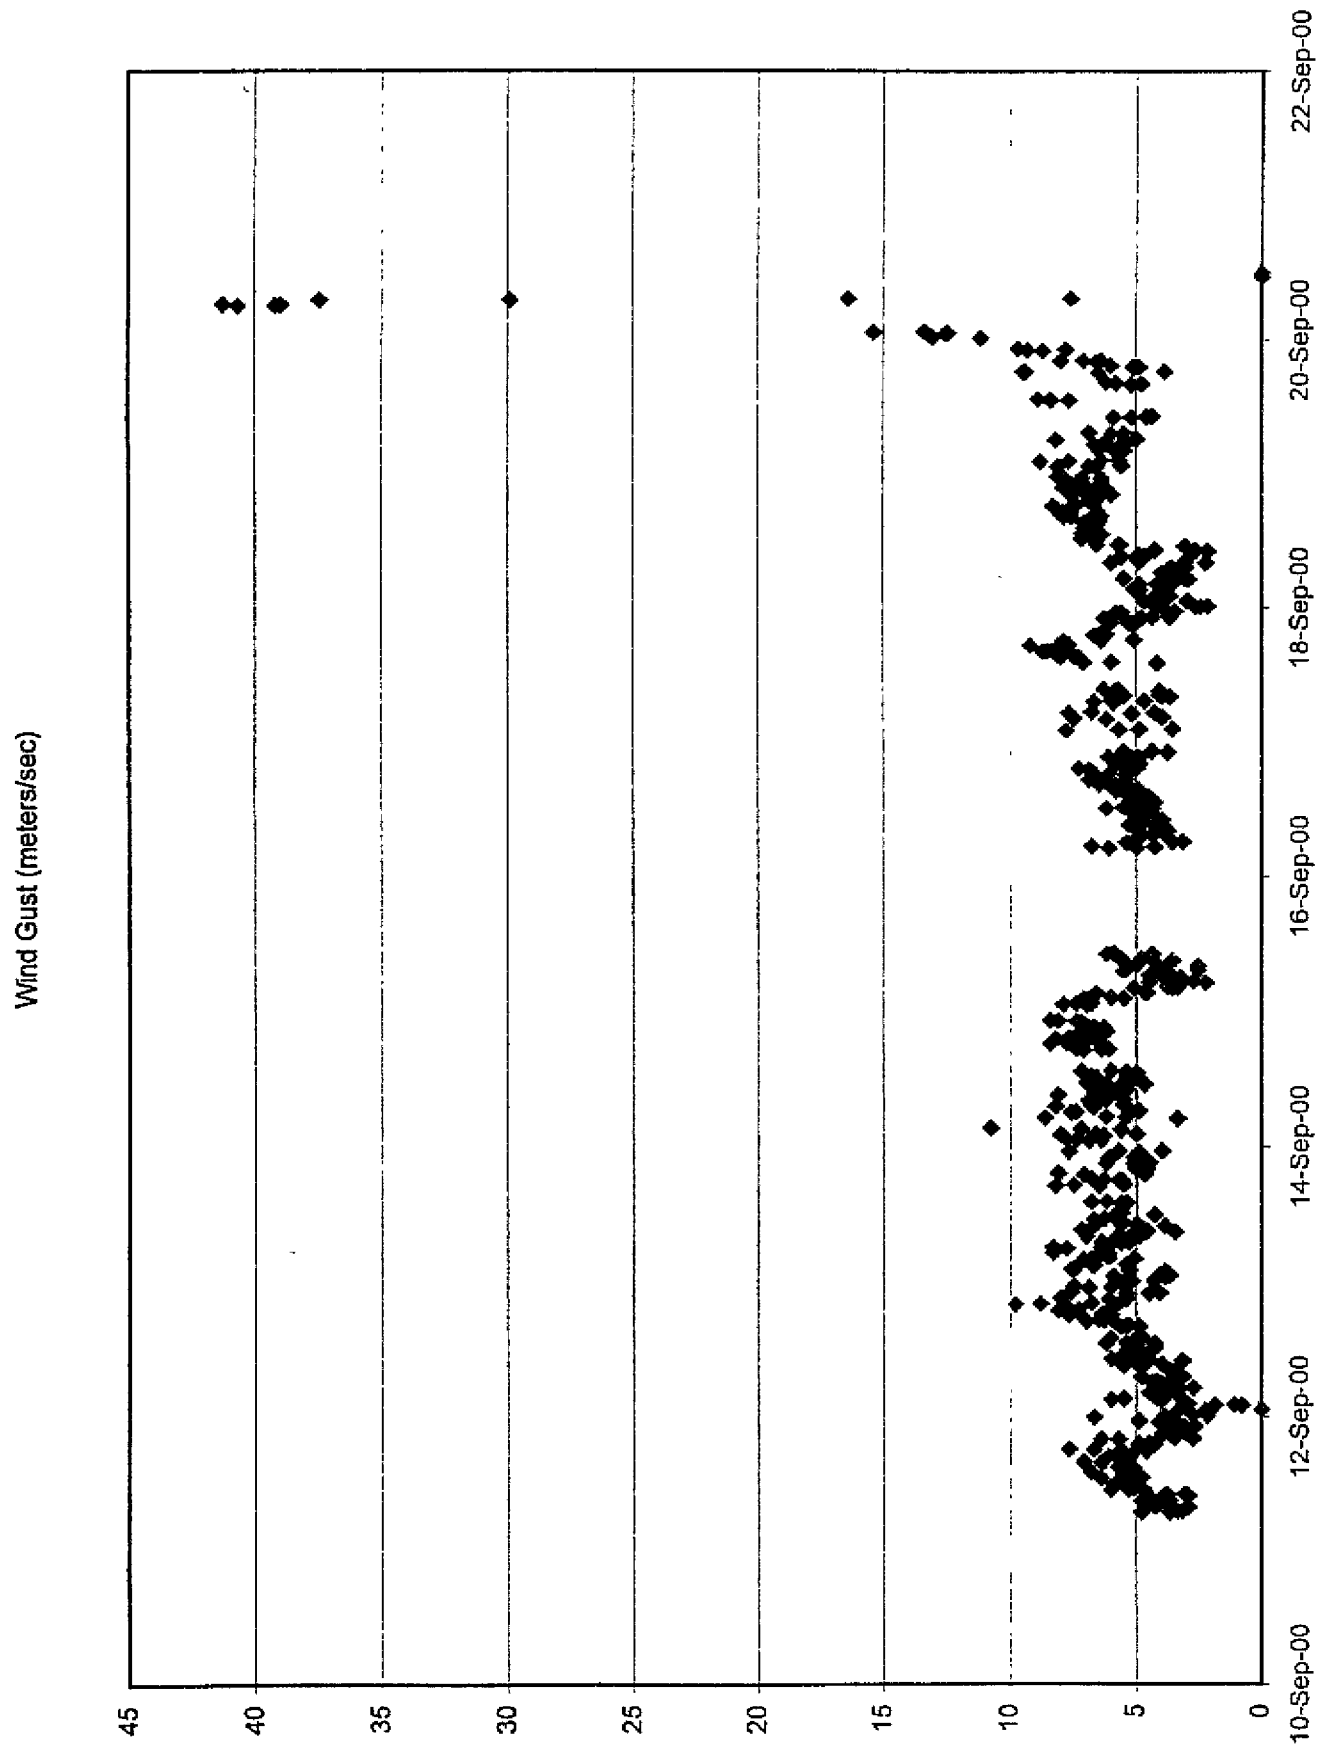
Figure 1
Anemometer readings - CPACC, Basseterre

The only anemometer recordings available for St Kitts were those from a CPACC¹ station in Basseterre. These are reproduced in Figure 1 in the Appendix. They indicate a maximum 15-second gust of 42 metres per second (equivalent to a 1-minute sustained speed of 84 miles per hour. The anemometer at VC Bird International Airport in neighbouring Antigua recorded a maximum (3-second) gust of 89 knots (see Figure 2), which is equivalent to a 1-minute-average speed of just over 84 miles per hour. There is some concern that reliable information on actual wind speeds in hurricanes is rarely available.
