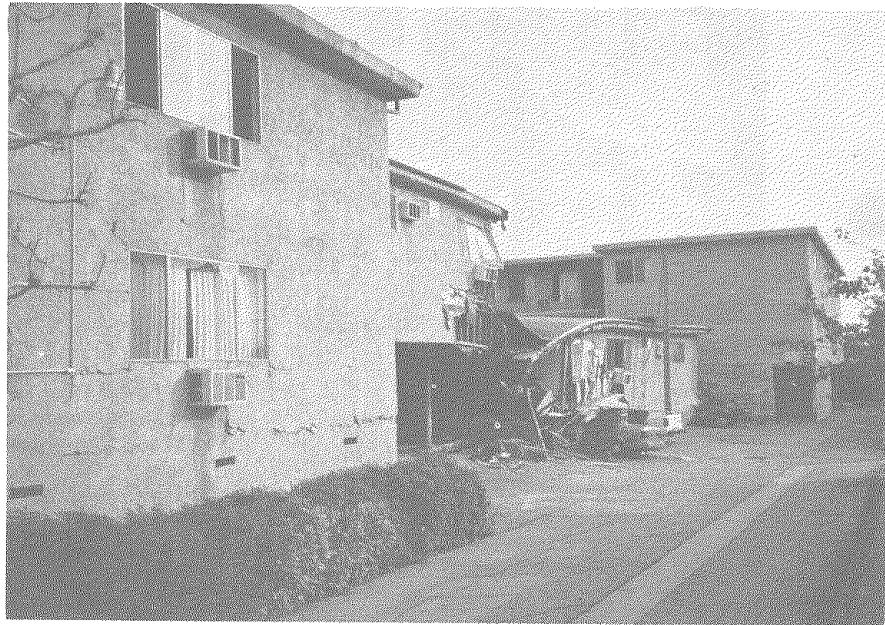
Fig. 39 First soft-story collapse of a timber structure.

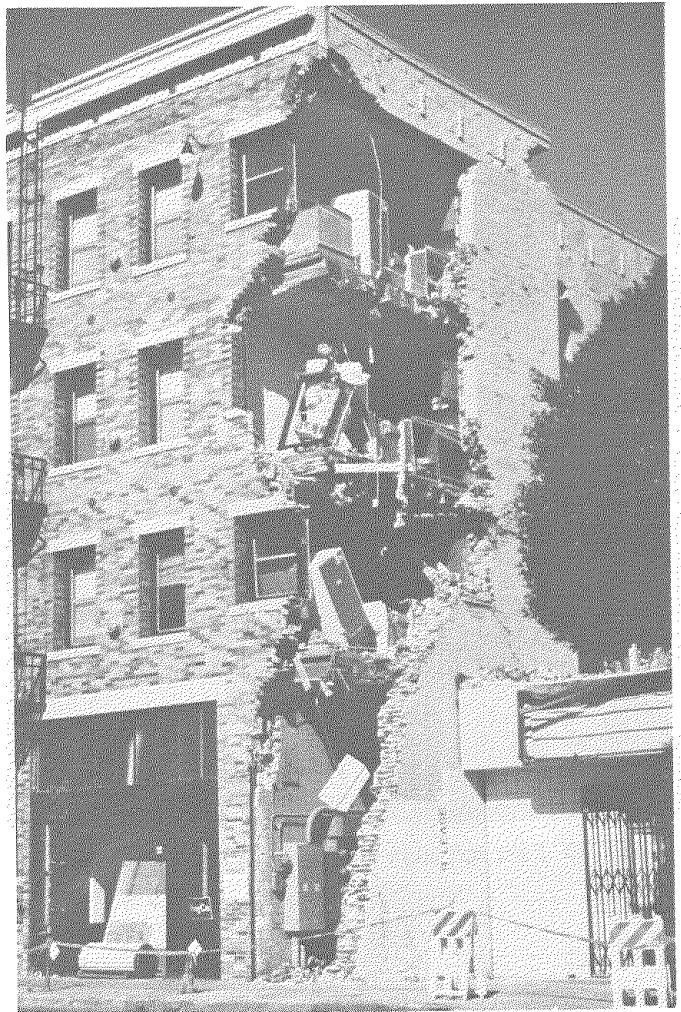
Fig. 40 Masonry crushing and out-of-plane failure.
