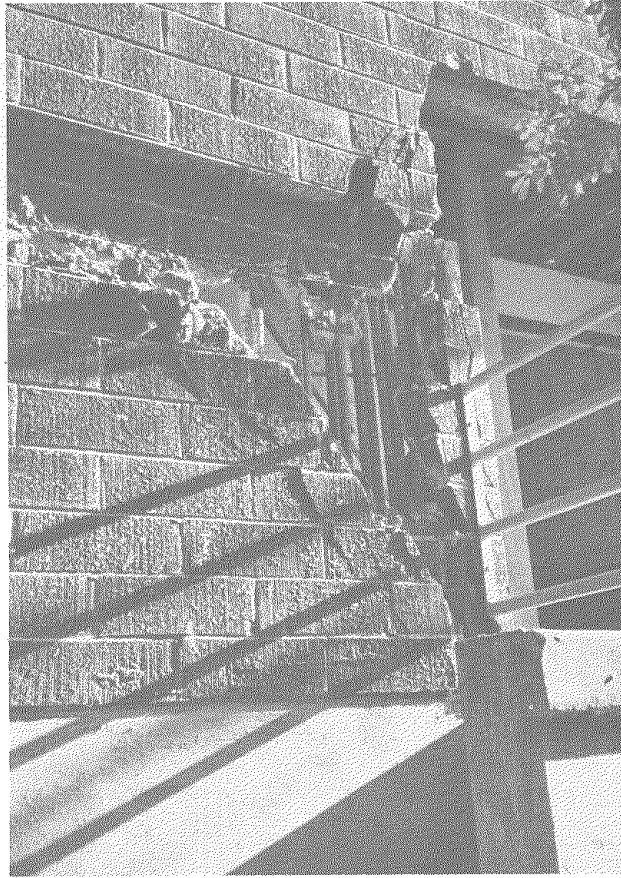
Fig. 41 Diagonal cracking and crushing of heavily reinforced masonry.

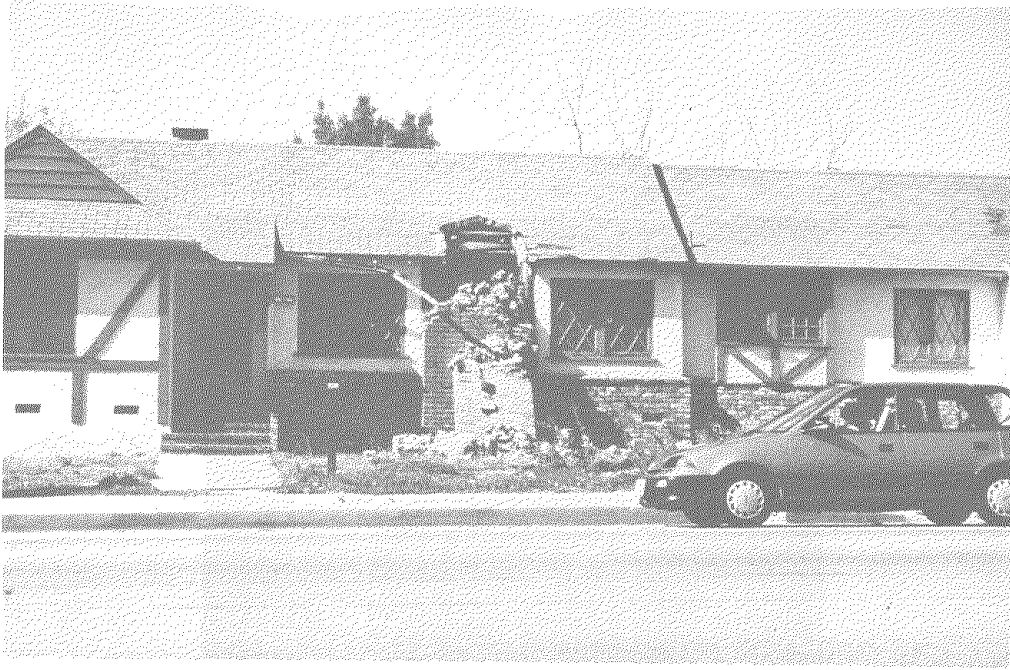
Fig. 42 Failure of a masonry chimney.

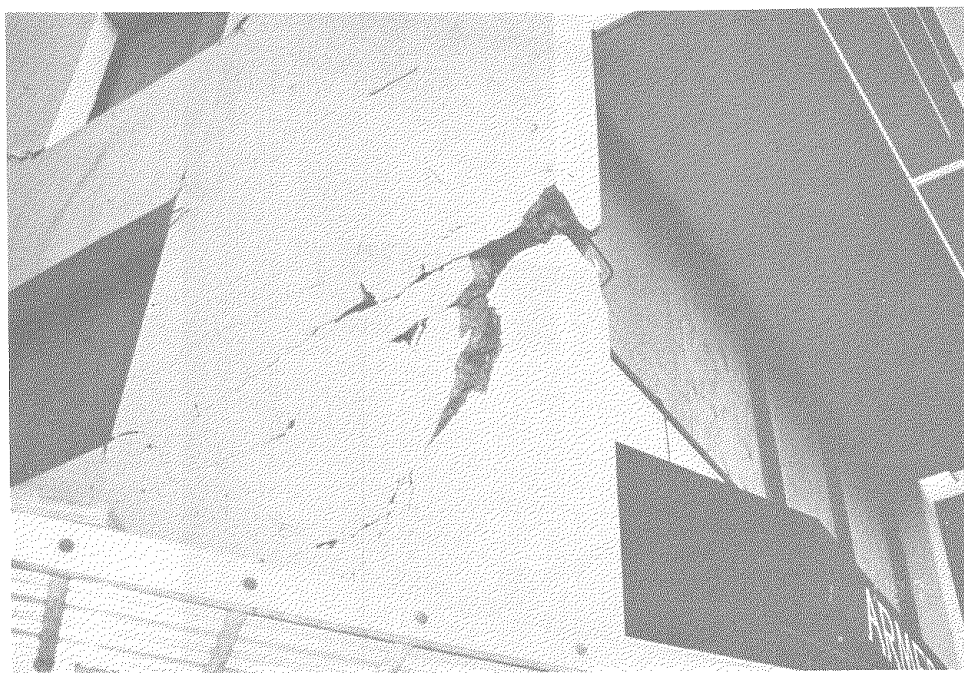
Fig. 44 Splice failure in RC boundary element.
