# Designing Retrofits

### High-Risk Schools

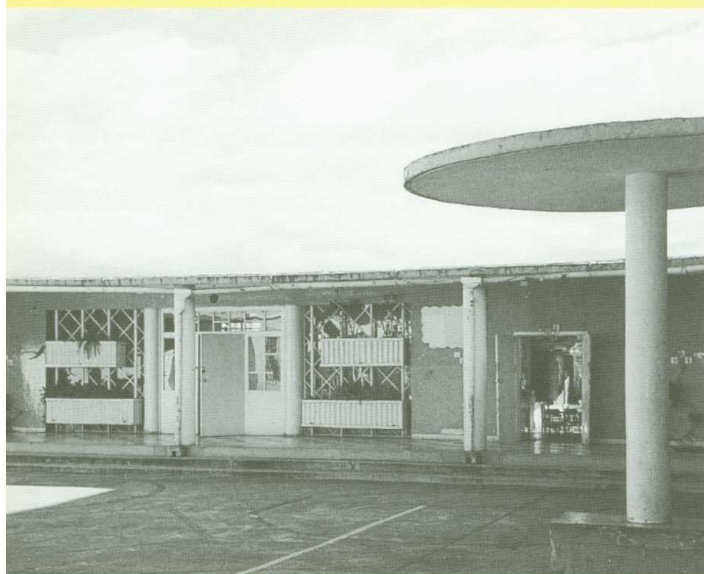
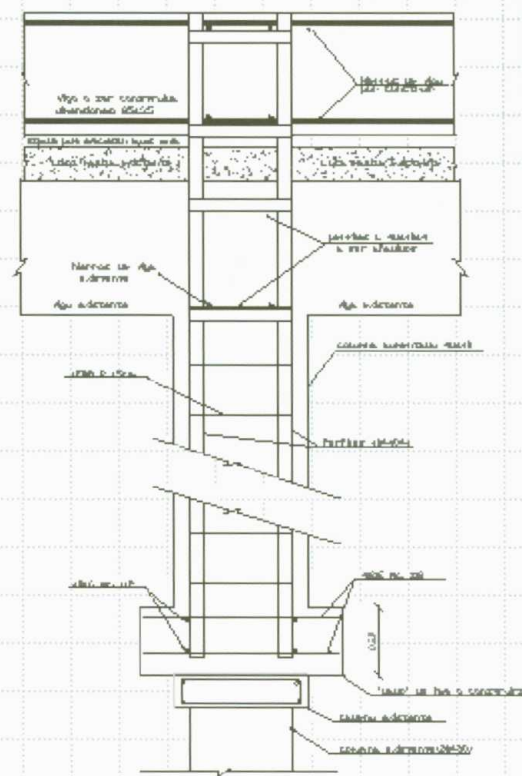
**Detail of Column and Roof Slab**

Weak concrete beams and columns put the structure's frame at risk of collapse during a major earthquake. Several columns are lacking sufficient reinforcing steel, and most beam-column joints are inadequate. The concrete roof slab is deflecting excessively in several places; cracks in the slab allow rainwater to leak into the building.

The building will be strengthened by adding reinforced concrete beams above the roof slab and steel columns, and by strengthening the existing reinforced concrete columns and beam-column joints. This would create lateral-load-resisting frames for the building, increasing its ductility during earthquakes, diminishing stress on its structural elements, and halting the deflection of the roof slab. The roof will be sealed with a watertight coating.
