**Retrofit Design Detail**

**Location:** Sucre Street, Barrio La Loma

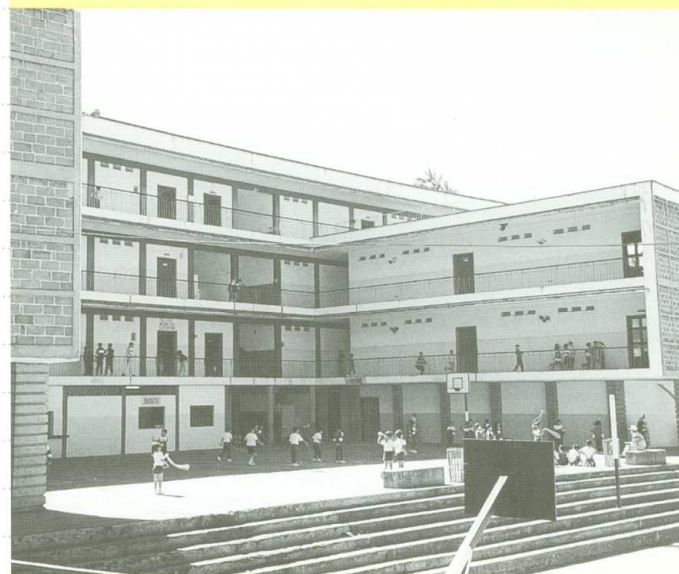
Experimental Sucre's beams and columns are not sufficiently strong to provide earthquake resistance to their structures. Door and window openings have created short columns. The first story of each transverse block lacks infill walls, creating a soft-story condition. The transverse buildings will likely pound against the main building during an earthquake.

Shear walls will be added to the buildings in both the longitudinal and transverse directions. Two options have been proposed for constructing the shear walls. The first consists of adding reinforced masonry walls to the first floor (transverse buildings only) and replacing the walls of upper floors with properly connected reinforced masonry ones. The second design consists of adding unreinforced masonry walls to the first floor (transverse buildings only), and surface strengthening them and upper-floor walls with steel mesh and concrete. Shear walls will increase the stiffness of the portal frames and thereby mitigate soft-story and pounding hazards. Separation joints will be added between walls and columns to mitigate short-column hazards.

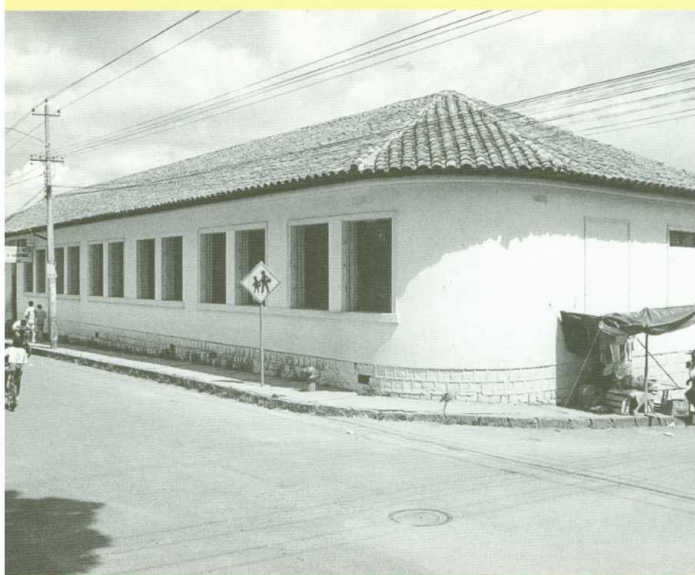
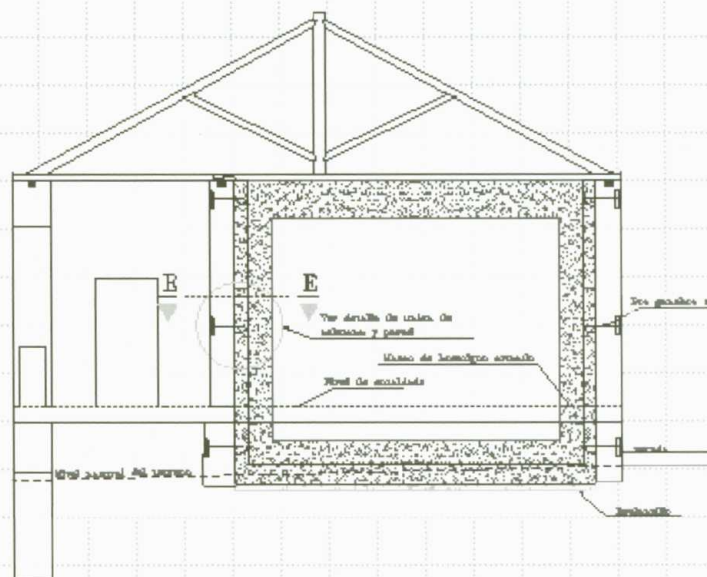
**Retrofit Design Detail**

The two major problems with this building are a weakness in its transverse direction and the hazardous roof. The longitudinal walls have long, unbraced spans between transverse walls. The extreme length of the spans makes them dangerously flexible in the out-of-plane direction.

The wood roof trusses are splitting in places. The truss joints and connections to the walls are not sufficient to transfer earthquake loads. The roof lacks bracing in the longitudinal direction. These deficiencies could cause the roof structure and overlying tiles to collapse into the classrooms below during an earthquake. The roof tiles, held in place by gravity alone, could slide off the roof in an earthquake and onto the playground and sidewalk below.

Two options were suggested to reinforce the structure along its transverse axis. The first consists of building in the transverse direction a 40-cm-thick, continuous unreinforced masonry wall, confined by a reinforced concrete beam and columns. This would divide a large, multiple-use classroom. The second, a less invasive design, is to construct two reinforced concrete frames in the transverse direction of the building.

The roof trusses will be repaired and their joints and connections strengthened, and cross-bracing will be added in the plane of the roof. The roof tiles will be anchored to prevent them from moving in an earthquake.

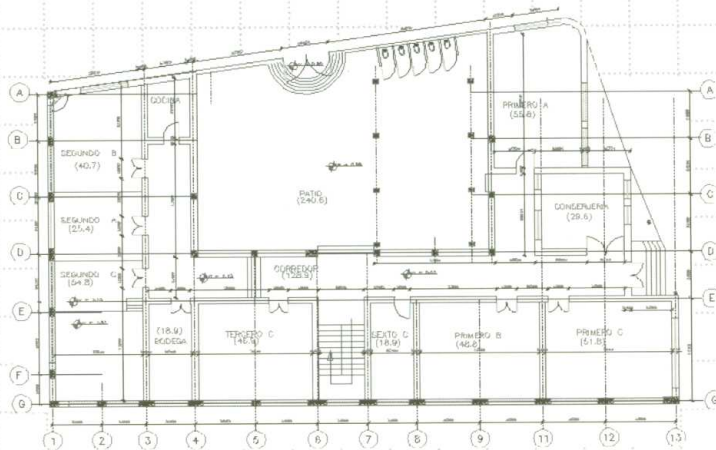
**Building Plan**

The interior and exterior unreinforced masonry bearing walls have openings that create, in effect, a hazardous short-column condition. The beam-wall connections are deficient. Since the wood beams and roof structure are supported by the walls, failure of the beam-wall connections during an earthquake would result in building collapse.

The wall openings will be modified to reduce the short-column effect. Better connections will be provided between intersecting walls. The in-plane rigidity of the floor and roof systems, as well as the connections with the supporting walls, will be improved.
