Location: Rocafuerte and Cumandá streets

The República de Chile elementary and high school consists of four reinforced concrete-frame buildings (Blocks 1 through 4) with unreinforced masonry infill walls. Blocks 1, 2, and 3, built in 1945, are two stories. Block 1 has a total floor area of 1,090 m² (11,730 ft²). Block 2, square-shaped in plan with a total floor area of 240 m² (2,580 ft²), is used for circulation between the other three blocks. Block 3 has an area of 600 m² (6,460 ft²) and is of construction similar to Block 1. Blocks 1, 2, and 3 have rectangular and cylindrical columns, some of which are dangerously slender. Piers of ciclópeo (large-aggregate) concrete support the columns, and stone footings support the walls. There are no tie beams between piers. Block 4, a one-story structure built in 1994, consists of concrete frames only in the transverse direction. It has a floor area of 200 m² (2,150 ft²).

The Río Amazonas high school consists of 12 two- and three-story reinforced concrete buildings and one steel-frame building, all constructed between 1978 and 1985. This project considered three reinforced concrete buildings constructed in 1978: the two-story, C-shaped mai

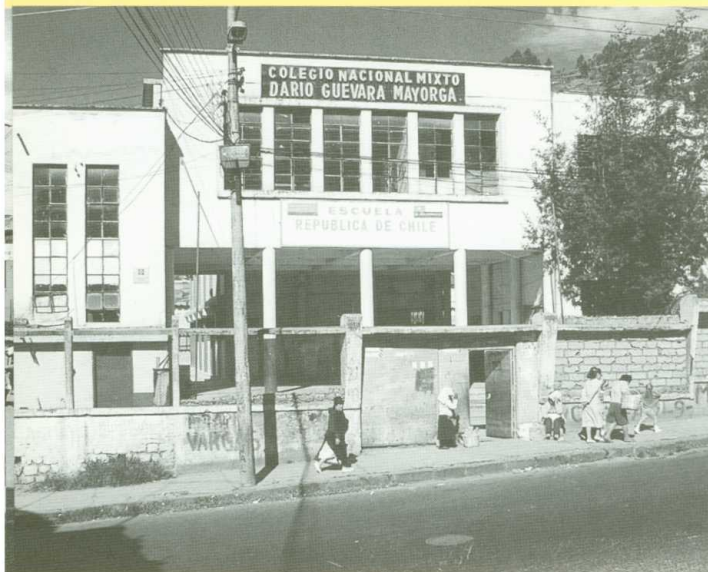
Retrofit Design Detail

The slab reinforcement and the reinforced concrete columns have deteriorated from exposure to water. In some areas the concrete contains soft aggregate or construction debris. The buildings contain short-column hazards, and the weak infill walls will likely crack and collapse during a strong earthquake. These buildings are not able to resist strong or long-duration earthquakes. Many ceilings contain unanchored clay tiles, which could fall during an earthquake.

The columns of Blocks 1, 2, and 3 contain smooth reinforcing steel. Slender cylindrical columns on the ground floor of Block 2 are not aligned with the corresponding columns on the second floor, resulting in a discontinuity between the columns and beams. Many beam spans are unusually long, and the beam distribution is inefficient. Block 4 lacks structural frames in the longitudinal direction, substantially diminishing the structure's ability to resist earthquake forces.

Because the República de Chile school was built without an earthquake-resistant structural system, the frames of Blocks 1, 3, and 4 will be completely redesigned. Due to the extremely poor design and condition of Block 2, it will be demolished and rebuilt. The ceiling tiles in all classrooms will be removed and replaced with lightweight, secured panels.

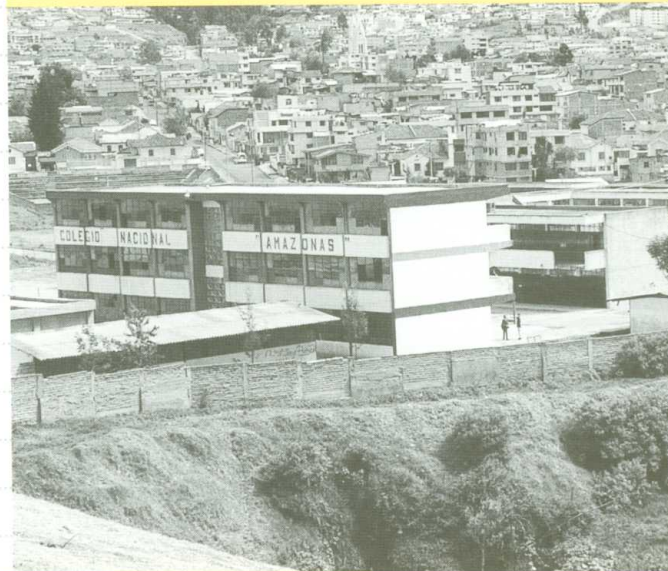
Retrofit Design Detail

The original building designs did not consider lateral forces. Inadequately connected portal frames in the longitudinal direction do not provide sufficient stiffness or strength to transfer properly lateral loads during an earthquake. Construction joint separations are too small and could permit pounding during an earthquake. Window and door openings and mid-height partition walls create short-column conditions. The staircase modules show excessive deflection.

Additional structural elements will be added to the buildings in order to increase their longitudinal stiffness. Two options are recommended: strengthening the unreinforced masonry infill walls by replacing them with reinforced masonry walls with proper connections to the concrete frames, or surface strengthening the existing walls with steel mesh and reinforced concrete. Separation joints will be added between walls and columns to mitigate short-column hazards. Supporting elements will be added to control deflection of the staircase modules.

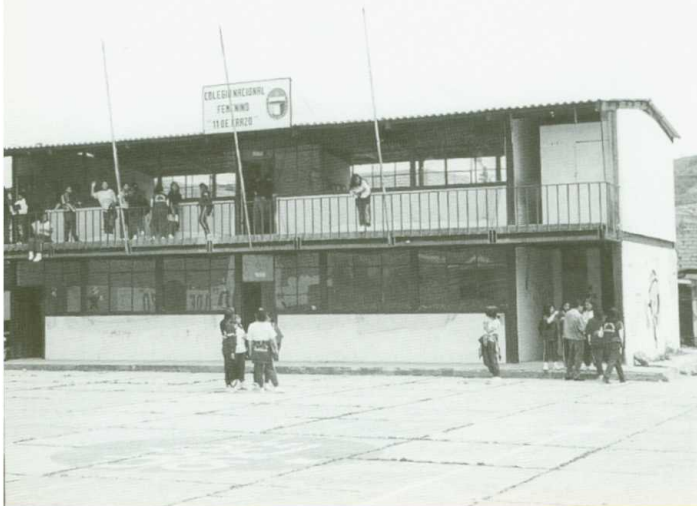
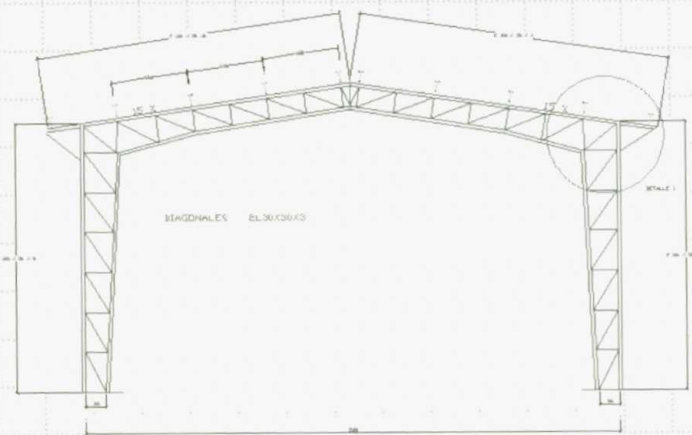
Retrofit Design Detail

Because the unreinforced masonry infill walls are much stiffer than the steel frames, the wall-frame interaction could result in major damage to the frame during strong ground shaking. The bending capacity of the first-floor beams is low, and the beam-column connections in the longitudinal frames are not sufficiently rigid, potentially resulting in sudden collapse of the structure during an earthquake. Several steel members are corroded.

Separation joints will be added between walls and columns. The bending capacity of the first-floor beams will be increased with proper reinforcement. Beam-column joints of the longitudinal frames will be reinforced to ensure continuity and proper frame action. Corrosion problems will be mitigated, and exposed steel members will be painted to prevent further corrosion.
