Fig. 48 PHOTOS ILLUSTRATING DAMAGE TO THE CPM BUILDING IN MEXICO CITY DURING THE 1985 MEXICO EQ

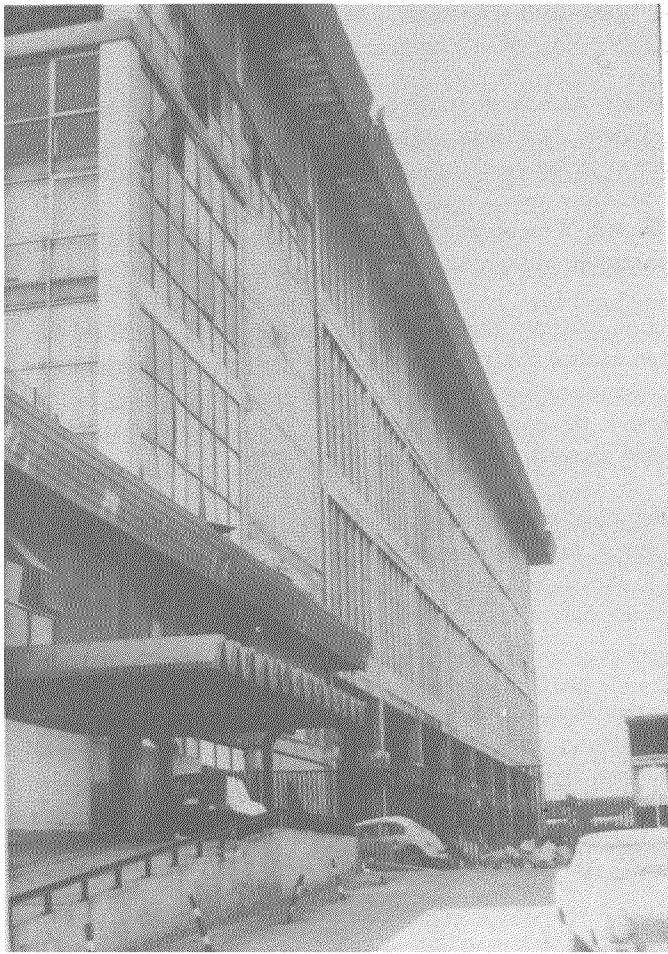
48 (a) Overview of building: the concrete awning in the back part of the building has been removed

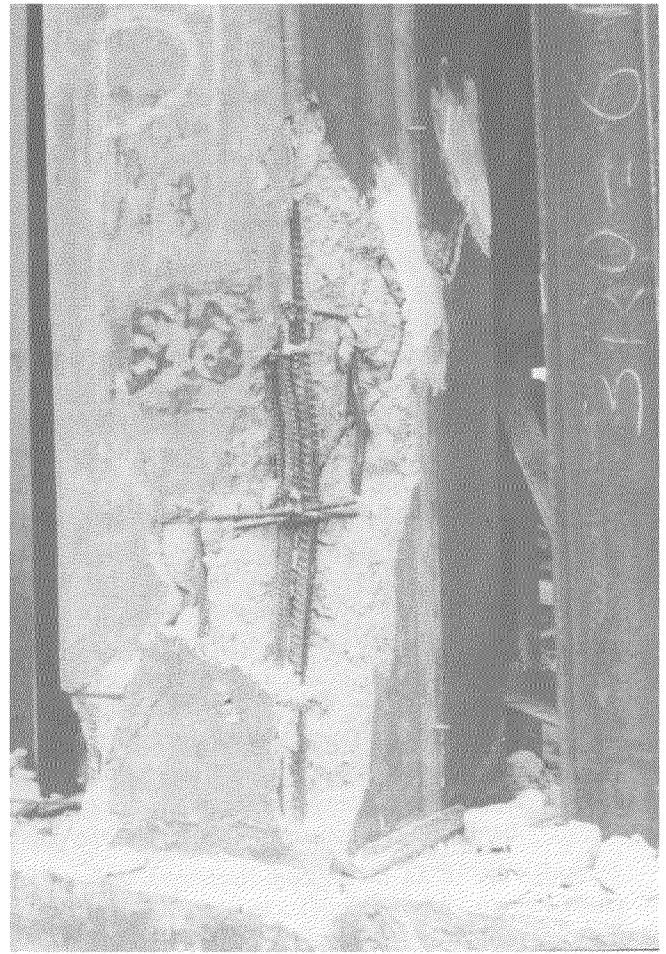
48 (b) Shear failure of the 1st-story column
