LESSONS LEARNED FROM RECENT CATASTROPHIC EARTHQUAKES

THE 3 MARCH 1985 CHILEAN EARTHQUAKE. This EQ, with an epicenter located in the Pacific Ocean near the coastal center of Chile, was reported to be of Richter magnitude 7.8. The EQGMs were measured by strong-motion instruments (accelerographs) at least 35 stations. From evaluation of these records, Saragoni and his associates [21] concluded that this event consisted of two successive shocks: the first of Richter magnitude 5.3, with a duration of strong motion of 10 seconds, and the second, which occurred 10 seconds later, of Richter magnitude 7.8, with a strong motion duration of about 30 seconds. The duration of recorded motion was in some cases 120 seconds.

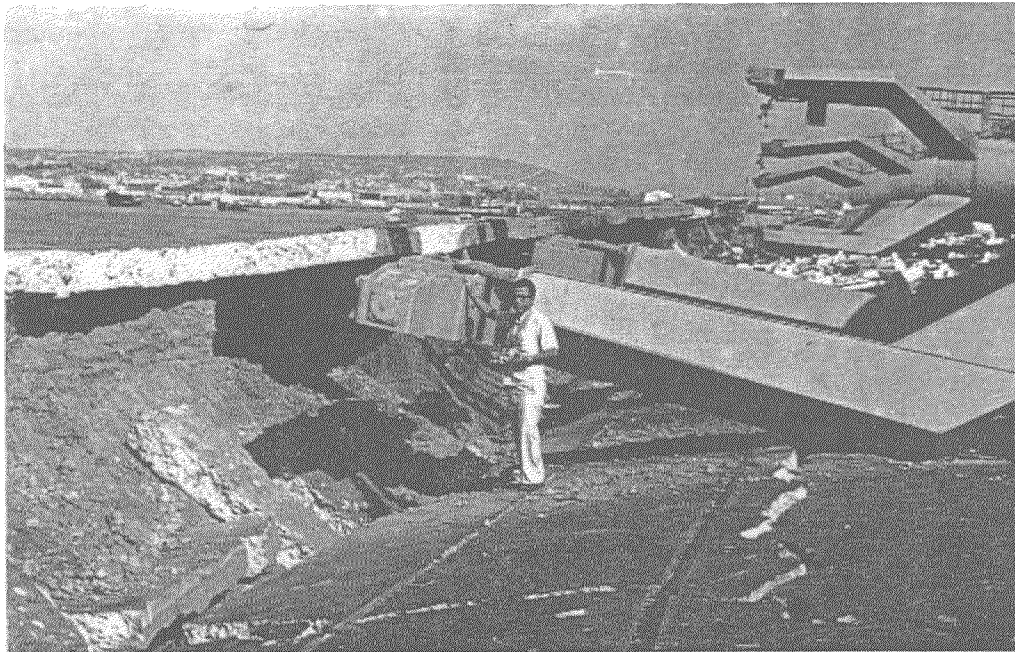
Geotechnical Effects. Important geotechnical failures were observed in many areas. The most spectacular failures were the liquefaction failures of portions of a seawall in San Antonio (Fig. 16) and in Valparaíso. Large settlements were observed in buildings in downtown San Antonio. Slope instability was observed on the hill side of Renaca.

Fig. 16 COLLAPSE OF SHEAR WALL IN SAN ANTONIO HARBOR [21]

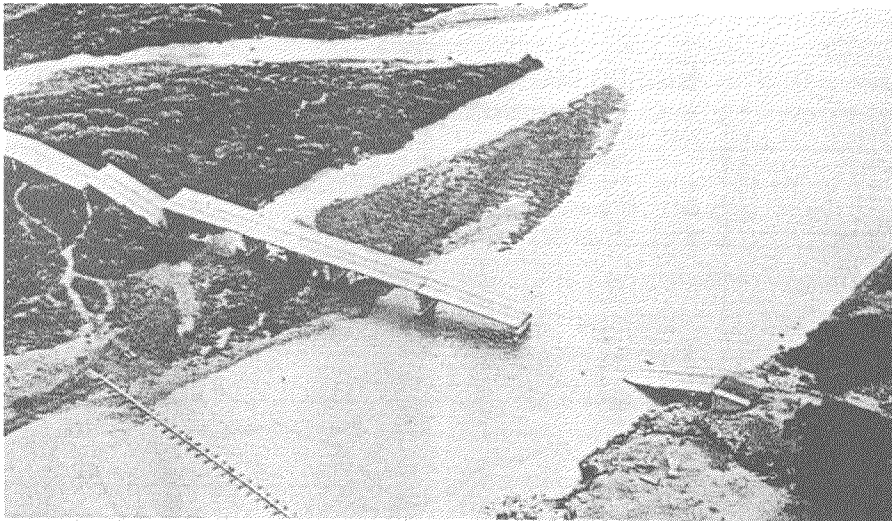
Several bridges sustained major damage as a result of movement of supporting piers. Figure 17 shows a photo of the bridge over the Maipo River between Llolelo and Rocas de Santo Domingo. Four spans fell down.

Fig. 17 COLLAPSE OF THE LO-GALLARDO BRIDGE DURING THE 1985 CHILE EQ [21]
