**Fig. 23 1985 MEXICO EQ: PHOTOS ILLUSTRATING THE COLLAPSE OF A BUILDING  
DUE TO FOUNDATION FAILURE**

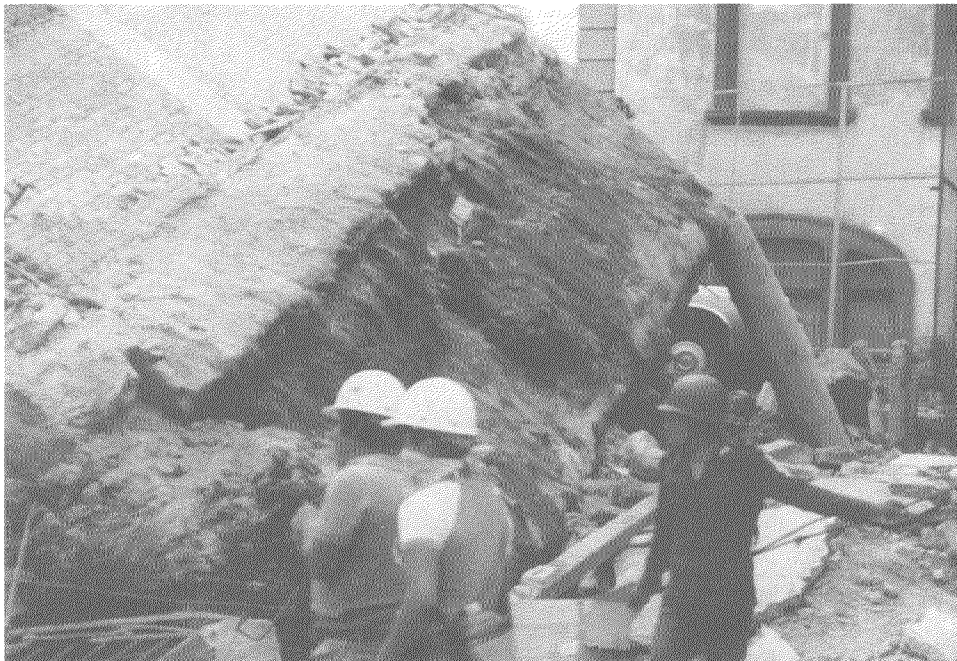
**Fig. 23 (b) Close-up showing pullout of friction pile**

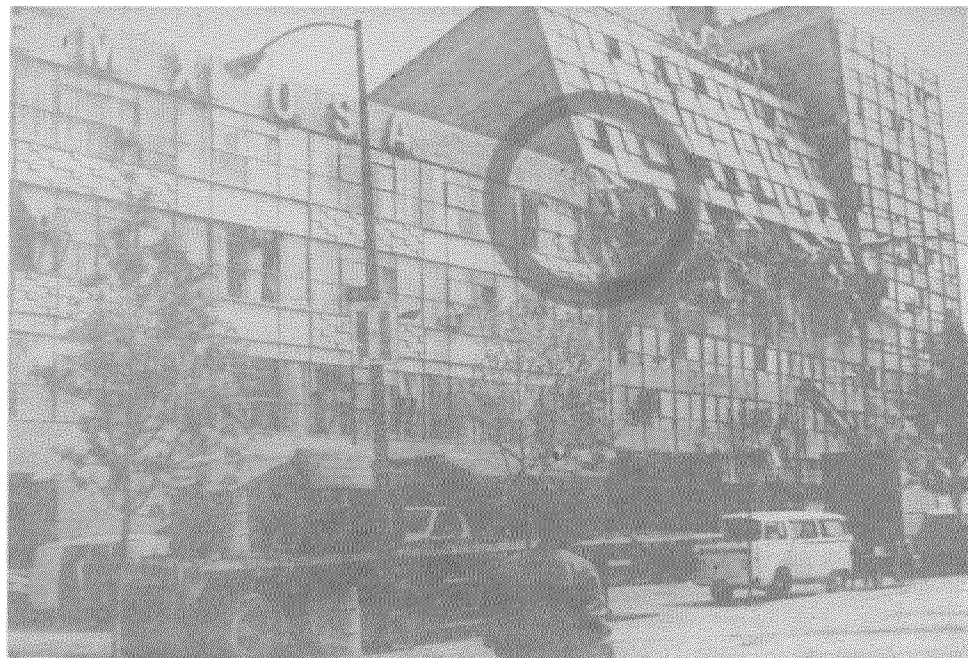
**Separation of Adjacent Buildings [25].** Many buildings in Mexico suffered serious damage (Fig. 24) owing to the hammering of adjacent buildings because of lack of proper separation, despite the significantly stricter requirement of the 1976 Mexican Code compared to that of the 1982 UBC interstory drift index, IDI, which computed through an elastic analysis considering the specified seismic forces. The building separations recommended by the UBC are inadequate. This has been confirmed by the significant damage that occurred due to hammering during the 1989 Loma Prieta EQ. The ATC has already recognized this inadequacy, and has recommended that the lateral deflection induced by the specified design seismic forces, which are determined through elastic analysis which considers the building to be fixed at the base, be increased by multiplying these seismic forces by a deflection amplification factor  $C_d$ . Although the 1988 SEAOC and the 1988 UBC specify a story drift index limitation similar to that of the 1982 UBC ( $\leq 0.04/R_w$  or  $\leq 0.005$ ), it is further recommended that separations between adjacent buildings should allow for  $(3/8)R_w$  times the displacement due to the design seismic forces. The rationale for this choice of amplification factor is not clear, since it appears that structures designed just to comply with the limitation of  $0.04/R_w$  under specified design seismic forces will undergo deflections larger than  $(3/8)R_w$  times the displacement under the specified design forces when subjected to major EQ ground-shaking.

**Fig. 24 COLLAPSE OF TWO INTERMEDIATE STORIES DUE TO HAMMERING OF ADJACENT BUILDINGS**

A revision of UBC regulations regarding acceptable IDI and building separation is urgently needed. To avoid the effects of the hammering of adjacent tall buildings, the separation that would be required could lead to serious problems in the economical use of usually very expensive real estate. Thus, it appears that in order to avoid damage between adjacent buildings it will be necessary to develop other regulations or requirements besides just the specification of adequate separation, such as the inclusion in the design and detailing of adjacent buildings of the possibility of such hammering. One such regulation should be that for two adjacent buildings with inadequate separation, the floor systems of the two buildings should be at the same level.

The problems of identifying realistically acceptable values of IDI at different limit states and defining proper separation between adjacent buildings urgently require a better solution than those offered in our current codes. Economical solutions for retrofitting existing adjacent buildings which do not have adequate separation should be researched immediately.
