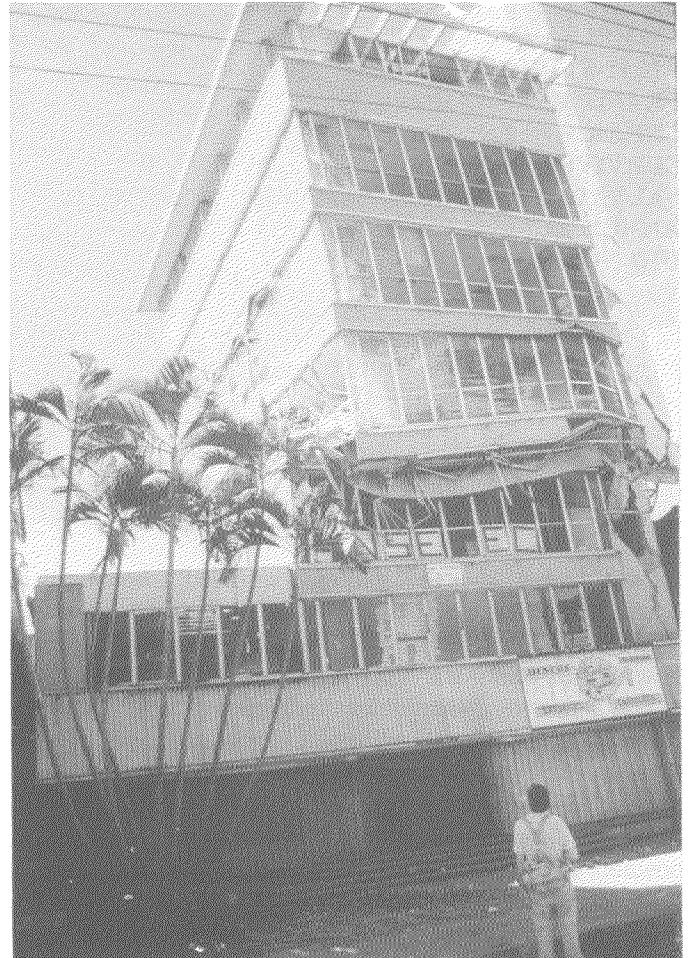
- Faulty construction, consisting of poor quality control of material, poor workmanship, and deficiencies in detailing and placement of reinforcement, was the common cause of severe damages.
- It is important to consider the probable predominant period of the EQGMs in the design of a building, and to try to prevent the response of the building from entering into resonance with the EQGMs.
- It is necessary to avoid torsional effects as much as possible (Fig. 26).

**Fig. 26 PHOTO  
ILLUSTRATING COLLAPSE  
OF ONE STORY DUE  
TO TORSIONAL EFFECTS**

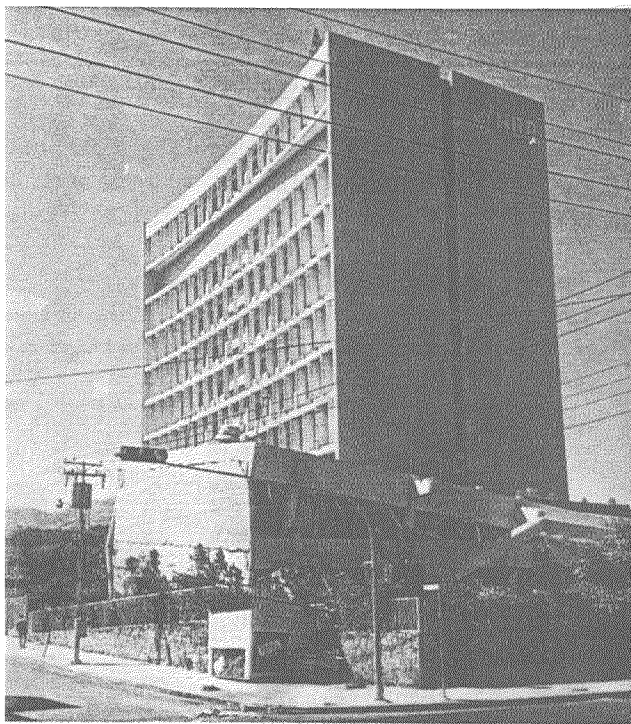
- Buildings with structural systems based on the use of shear walls behave better than buildings which use MRSF systems (Fig. 27).
- It is important to avoid creating short-column conditions in MRSFs by avoiding the use of partial-height infill masonry panels.
- It is necessary either to upgrade or demolish buildings that have been condemned because of poor performance in previous EQs.

**Fig. 27 VIEW OF A HOSPITAL COMPLEX CONSISTING OF AN 11-STORY TOWER (RC FRAME WITH COUPLED SHEAR WALLS), WHICH SURVIVED THE 1986 SAN SALVADOR EQ, AND A 3-STORY ANNEX (RC FRAME) WHICH DID NOT [26].**
