THE ARMENIAN EARTHQUAKE OF DECEMBER 7, 1988 [28, 29]. The main shock of this EQ, with a body wave magnitude M_b =6.3, corresponding to a surface wave magnitude M_s =6.8 and an estimated moment magnitude M_w =6.8, occurred at 11:41 am local time near the relatively new town of Spitak (population about 20,000), which is located midway between the cities of Leninakan (population about 290,000) and Kirovakan, 60 km east of Leninakan (population about 170,000). This main shock, with a focus (hypocenter) estimated at 15 km and with strong motion lasting nearly 30 seconds, caused catastrophic damage and was followed four minutes later by an aftershock with M_b =5.9, causing significant additional damage. Although the exact number of people killed is not known, official reports placed it at about 28,000 (ranging from 25,000 to 35,000) and unofficial reports gave a death toll ranging from 45,000 to 60,000. It has been estimated that about 130,000 people were injured, of which 18,000 required hospital care. The mortality among the injured was also high, particularly among those who remained buried alive for long periods of time. The number of people left homeless was estimated at between 500

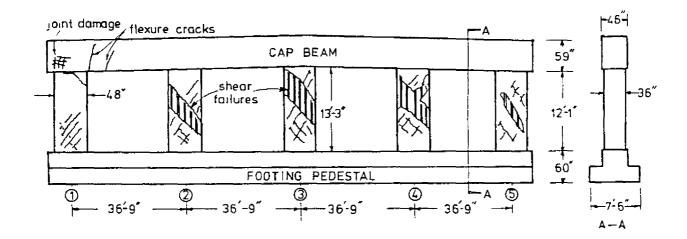
Priestley concluded that the damage was very extensive, and emphasized the need for detailed studies of the performance of this bridge in order to assess the need for column retrofits to other complex bridges. The importance of the observed damage and Priestley's recommendations will be discussed later in the context of the discussion of lessons learned, in particular in discussion of the damage to highway structures during the 1989 Loma Prieta EQ.

Fig. 30 ILLUSTRATION OF THE DIMENSIONS OF AND DAMAGE TO BENT 6 OF A MAJOR FREEWAY OVERPASS (PRIESTLEY [27])

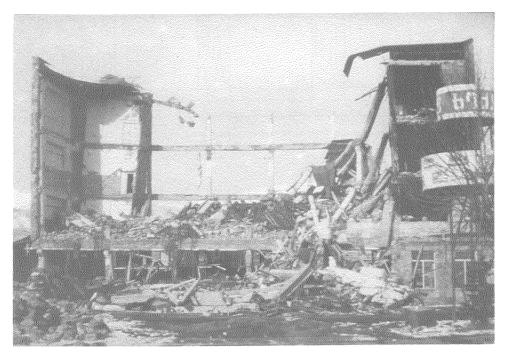
Performance of Structures. As indicated earlier, one of the most important features of this EQ was the catastrophic collapse of relatively modern multistory residential buildings (Figs. 6 and 32). A very large percentage of composite-frame stone buildings with four and five stories suffered heavy damage. In Spitak, 87% of the structures collapsed or suffered such heavy damage that they had to be demolished. In Leninkan, about 30% of the engineered structures suffered severe damage: 72 modern 9-story precast concrete frame buildings collapsed, and about 60 more have to be demolished. From analysis of the statistics available regarding the structures that collapsed

or suffered heavy damage [28], the following conclusions were drawn: (1) precast-panel buildings performed well; (2) precast-frame buildings performed poorly. Of the total number of precast-frame buildings in Leninkan (133), 95% collapsed or had to be demolished. A large number of these buildings were nine to 12 stories. These buildings lacked ductile details and the quality of the field workmanship was poor (Fig. 6). Except for a 9-story hotel and a couple of high-rise buildings that were under construction, no buildings of more than five stories survived the EQ. On the other hand, in Kirovakan, out of total of 108 RC precast-frame buildings of which the majority have 5 or fewer stories, none collapsed or had to be demolished.

Fig. 32 COLLAPSE OF A FIVE-STORY PRECAST FRAME BUILDING IN SPITAK [28]

Comparing the behavior of the RC precast-panel with that of the RC precast-frame, and considering that in both of these two types of construction the quality of the connections was very poor, it becomes clear that the seismic response of the frame structure is more sensitive to the behavior of the connections than the all-precast-walls system.
