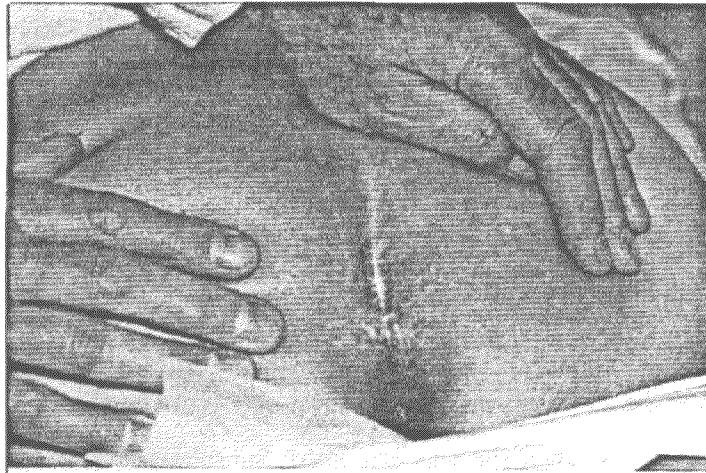
*Image 5. Breakdown of the skin in gluteal folds due to overexposure.*

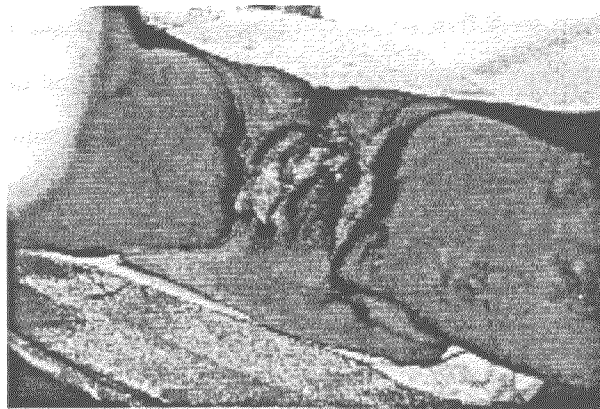
*Image 6. Severe non-healing ulceration (Grade 3 necrosis) of the vulva due to overexposure. The actual dose was about 30 Gy in two fractions of 15 Gy each.*

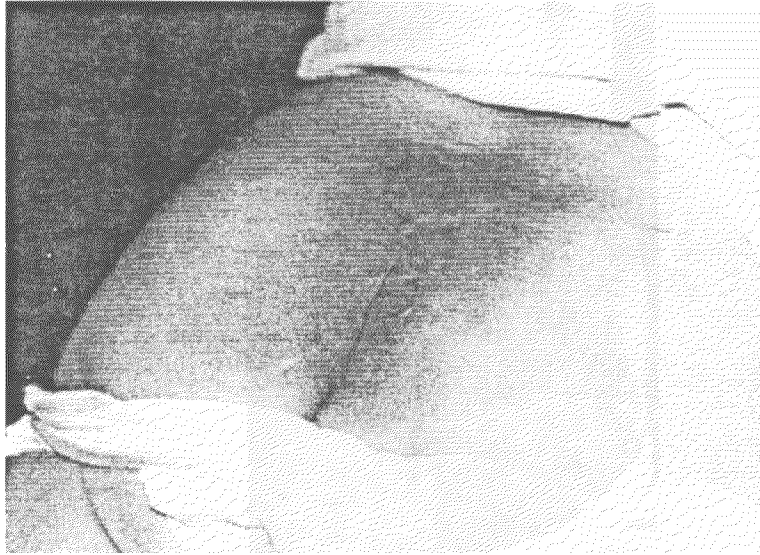
With megavoltage radiotherapy techniques, the most common indication that skin tolerance has been exceeded is subcutaneous fibrosis. This is usually a hard plaque below the pigmented skin surface (Image 7) and it is most pronounced where there is a layer of subcutaneous fat (Images 8, 9). The incidence of skin reactions is greatly influenced by the number of treatment fractions and the volume irradiated. As an example, severe fibrosis will develop in 20% of post-mastectomy patients who received 46 Gy (1.9 Gy per fraction) using the standard 5 fraction per week treatment scheme and in 80% of those who received 52 Gy (2.1 Gy per fraction). These figures can be compared against the data for two weekly fractions, where 20% of the patients developed severe fibrosis at 37 Gy (3.7 Gy per fraction) and 80% at 41 Gy (4.1 Gy per fraction).

*Image 7 Severe pigmentation, atrophy and skin fibrosis over the sacrum. Such skin is easily broken down with minimal trauma and is difficult to heal. Most such patients also had sacral plexus nerve and bowel complaints.*

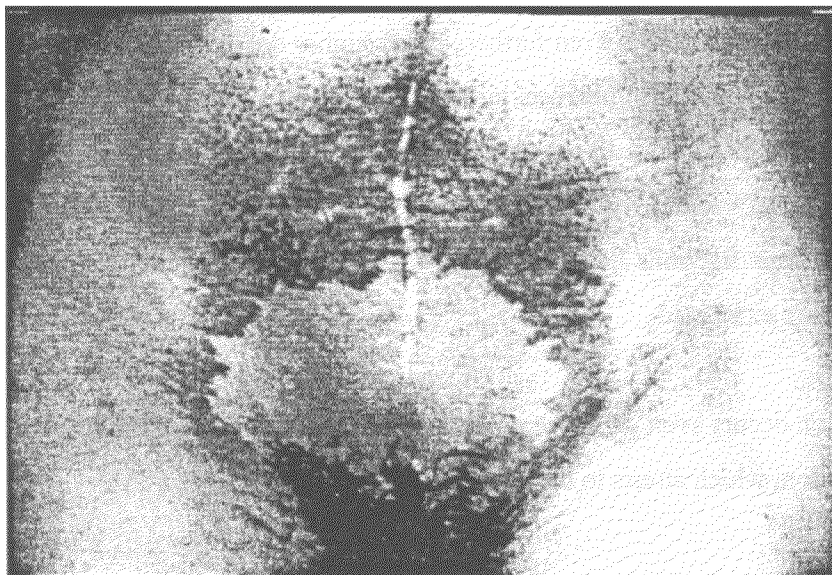
*Image 8. Deep pigmentation with central scarring of the skin. Overexposure of to the underlying sensitive bowel has caused significant problems, including persistent bloody diarrhoea, bowel obstruction and anaemia.*
