# BULLETIN OF EARTHQUAKE RESISTANT STRUCTURE RESEARCH CENTER

# Report of the Damage caused by the Mid-North Iwate Earthquake of September 3, 1998

Kazuo KONAGAI, Atsushi MIKAMI, Toshihiko KATAGIRI, Raquib AHSAN  
and Daisuke MARUYAMA

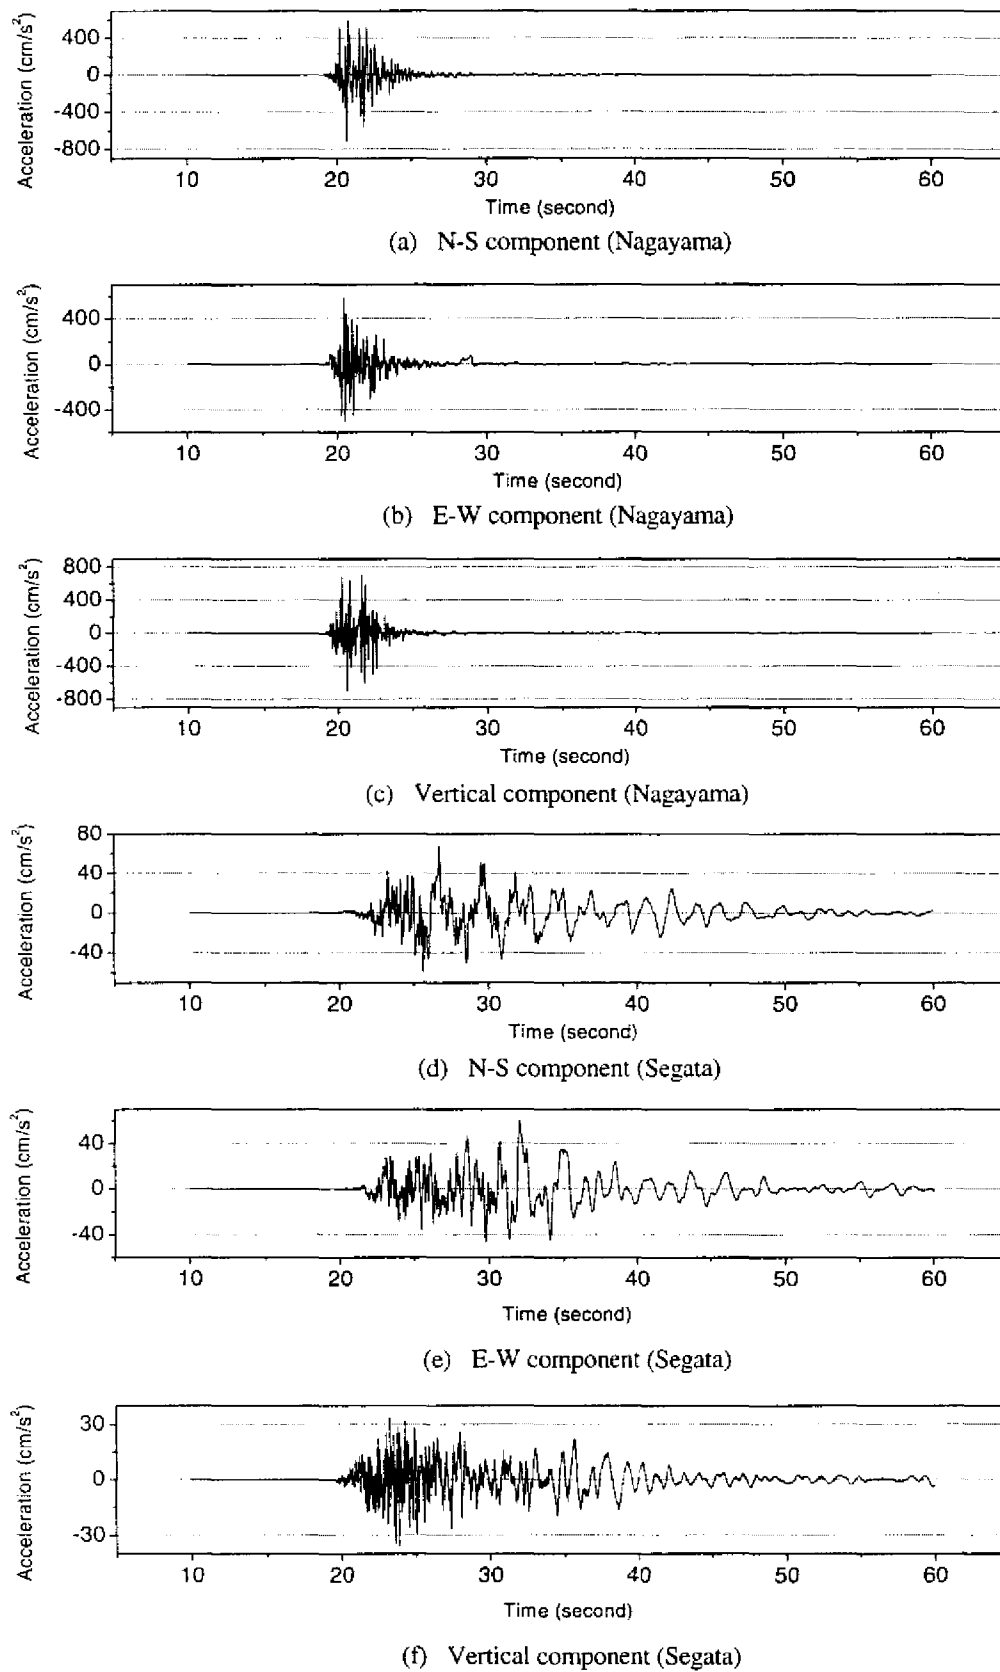
**Figs 3(a)-(c) and Figs. 3(d)-(f)** show the recorded strong ground motions at Amihari spa and the municipal office of Shizukuishi town, respectively. Peak acceleration of  $714 \text{ cm/s}^2$  was reached at Amihari spa about 3 km north-east of the epicenter, whereas the peak acceleration reached at Segata in Shizukuishi town, 10-15 km south of the epicenter, was  $68 \text{ cm/s}^2$ . This remarkable attenuation is seemingly consistent with the fact that no serious damage was reportedly found in downtown Shizukuishi.

Fig.3 Acceleration-time histories in Shizukuishi (16:58, Sept. 3, 1998)

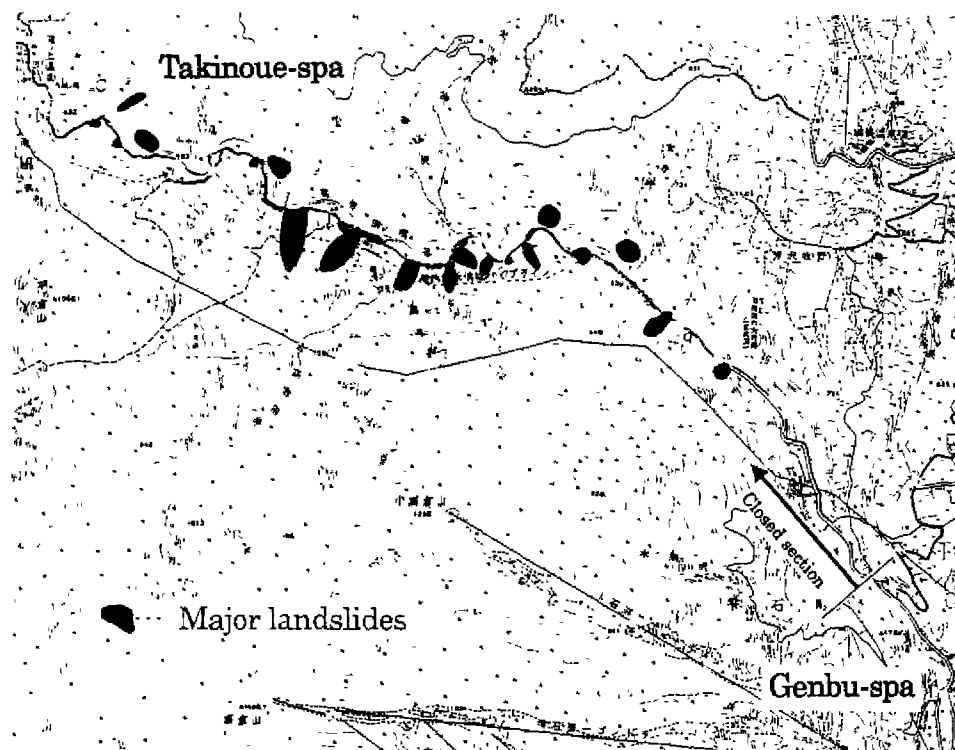
Traffic on the prefectural route 100, called Nishiyama-Obonai Line, was suspended by a number of earthquake-induced landslides along the Kakkonda glen, causing about 100 people at Takinoue Spa to be held up for a night. Total 55 landslides took place between Takinoue and Genbu spas. Locations of major landslides are shown in **Fig. 4** along with a pair of photographs of a typical slide (**Photo 6**). When the photographs are viewed side by side through a stereoscope, they are perceived as a single image in three-dimensional space. When used to focusing both eyes on these photographs, these separate perceptions of the two eyes can be combined and interpreted in terms of depth even without a stereoscope. On the visualized 3D

Fig.4 Location of major landslides

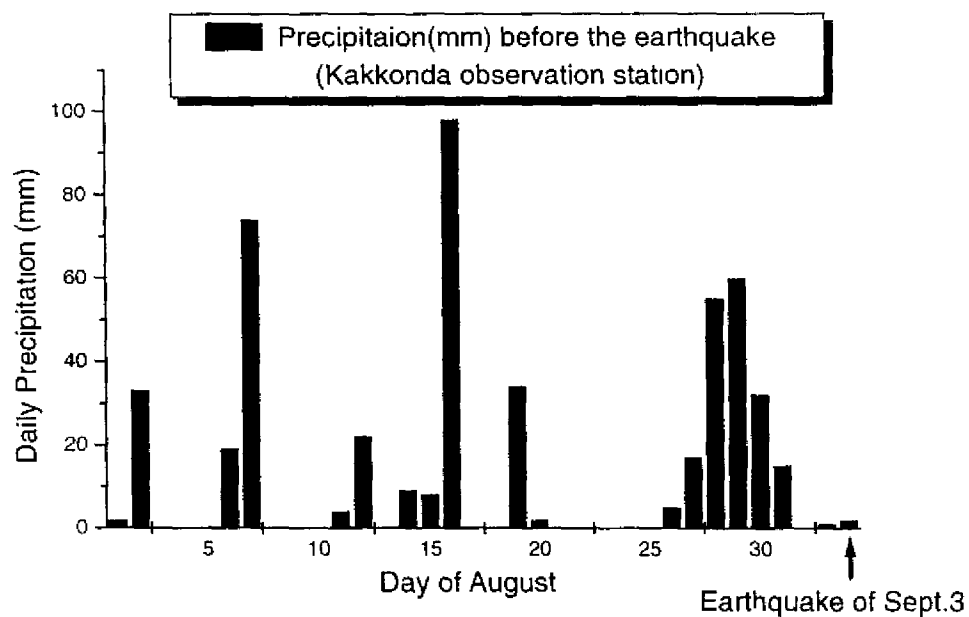
Needless to say, slope failures and precipitation closely correlate to each other. **Fig. 5** shows the precipitation record at Kakkonda meteorological observatory, which is very close to the dislocated fault planes. It is clear from this figure that a spell of 6 days rain was followed by the earthquake of Sept. 3. **Fig. 6** shows the number of tremors observed at the Mt. Iwate observation station of JMA. A great number of volcanism-related tremors preceded the earthquake of Sept. 3, and thus might have been another cause of making the loamy soils loose

Fig.5 Precipitation record (Kakkonda meteorological observatory)

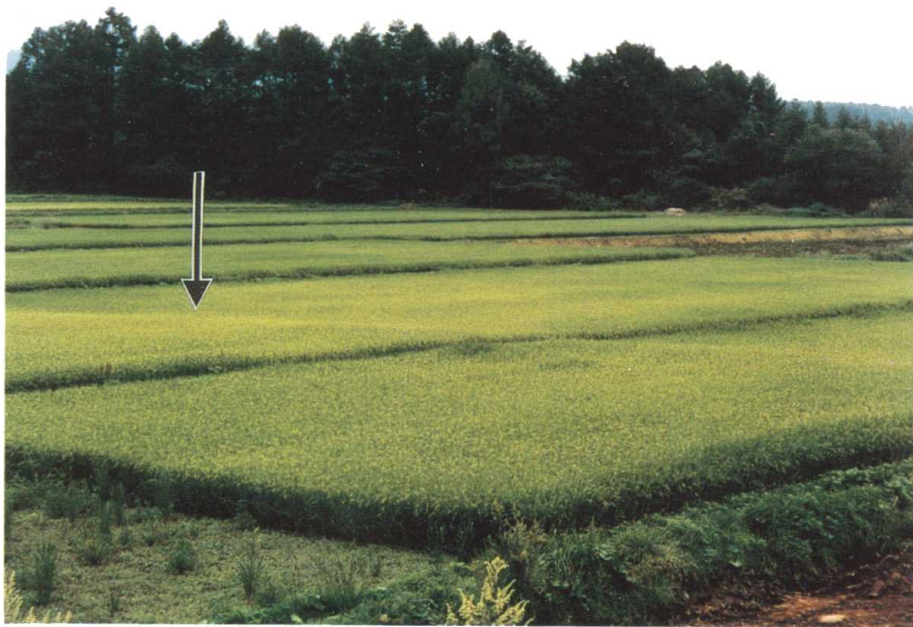
The activated fault planes were found roughly lined up at random intervals near a scarp formed along the Kakkonda glen. One of the faults which appeared in a paddy field was a straight raised mark extending a couple of hundred meters' distance, clearly showing a compressional dip-slip movement of this fault (**Photo 1**). The averaged upward movement of the soil caused by the reverse faulting reached or exceeded ten centimeters in this paddy field. This movement of the fault caused concrete walls covering up a drain to be cracked and dislocated (**Photo 2**). A fault plane branching off the lined major fault planes crossed the Kakkonda river and buckled the pavement of the prefectural route 100 (**Photo 3**).

Photo 1 Fault that appeared in paddy field

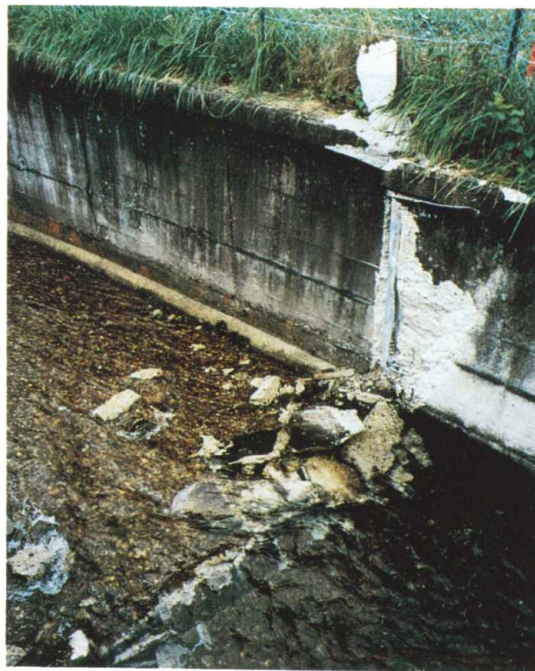
Photo 2 Damaged concrete wall of drain
