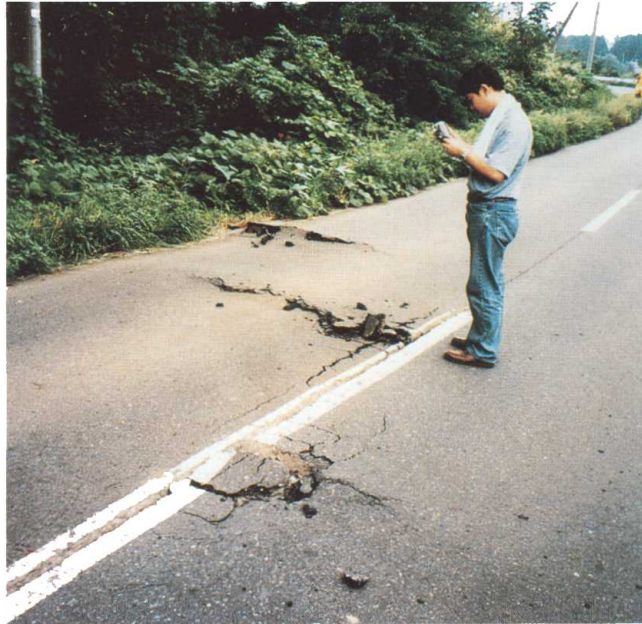
Photo 3 Buckled pavement

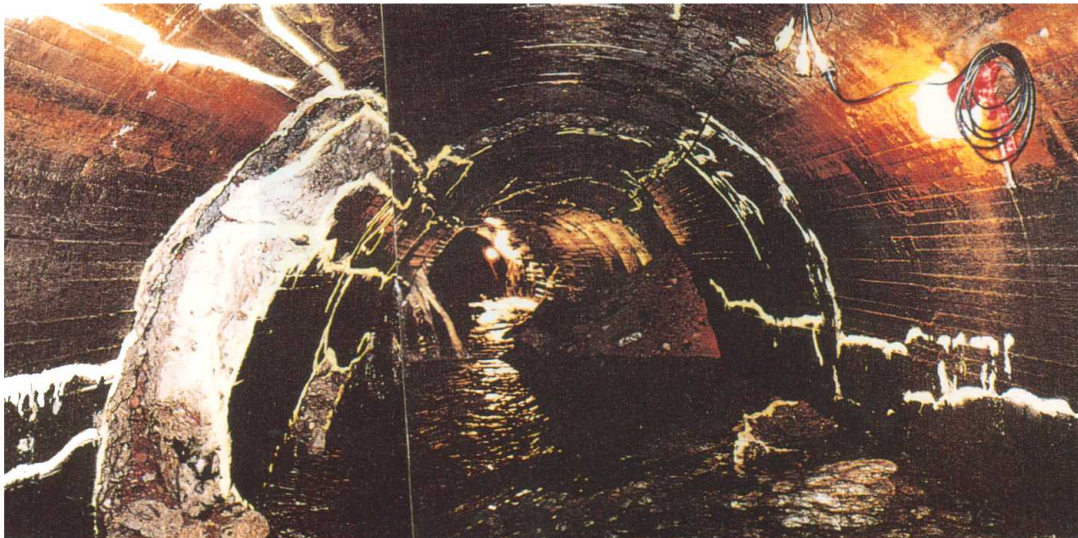
Photo 4 Damage to outlet tunnel (provided by Tohoku Electric Power Company)

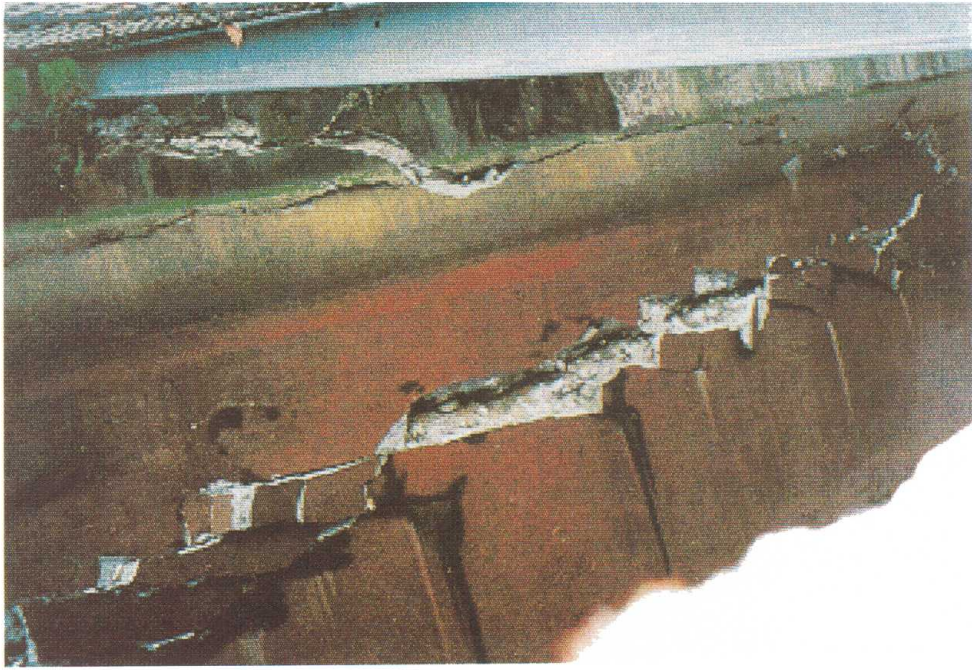
Photo 5 Damage to open aqueduct

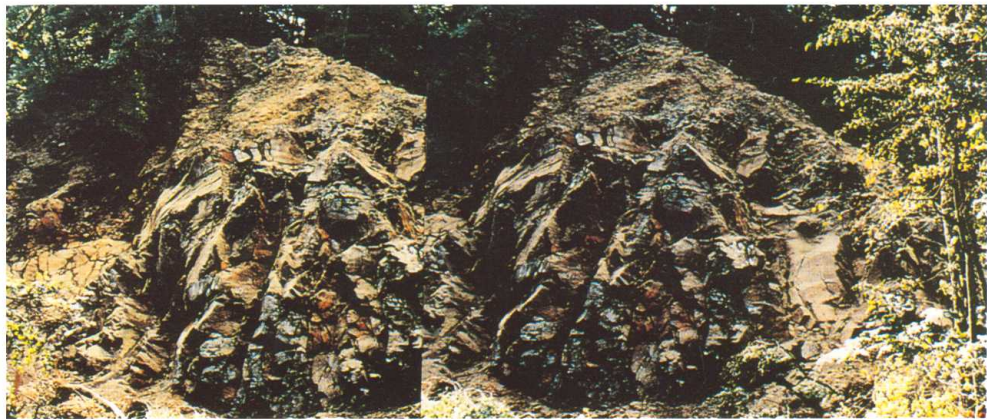
Photo 6 Basalt rock that appeared on a failure surface

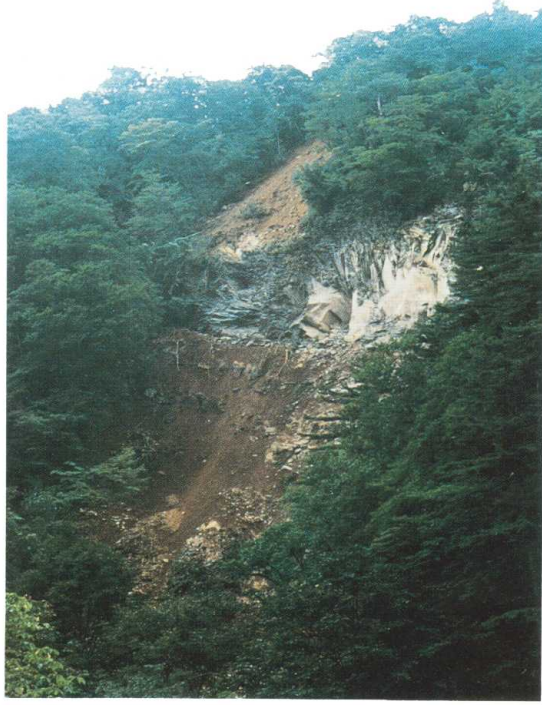
Photo 7 Basalt rock layer sandwiched in between loamy soils
