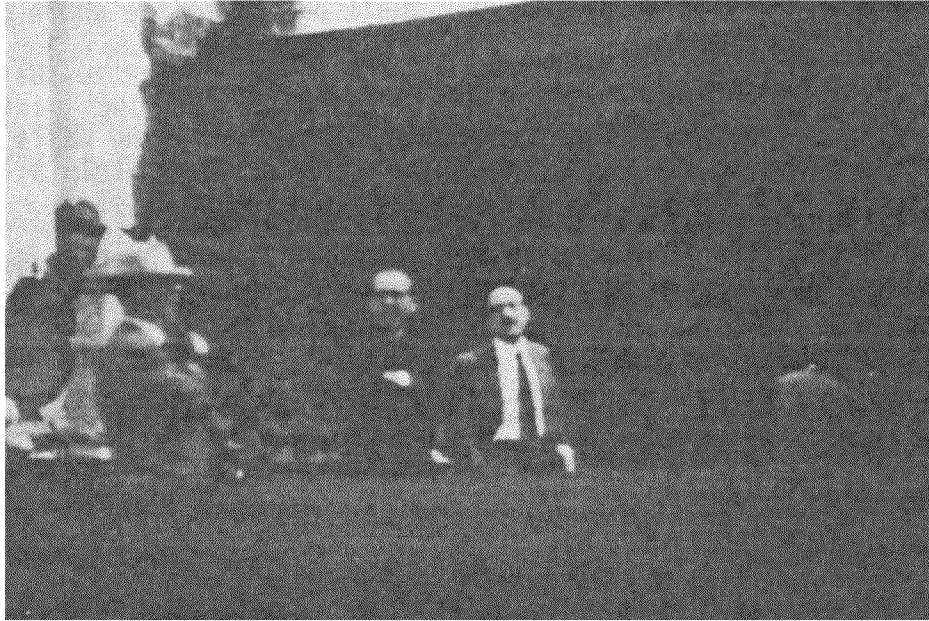
FIG. 3

Damage Due to Inadequate Embedment of Beams of Choir Loft

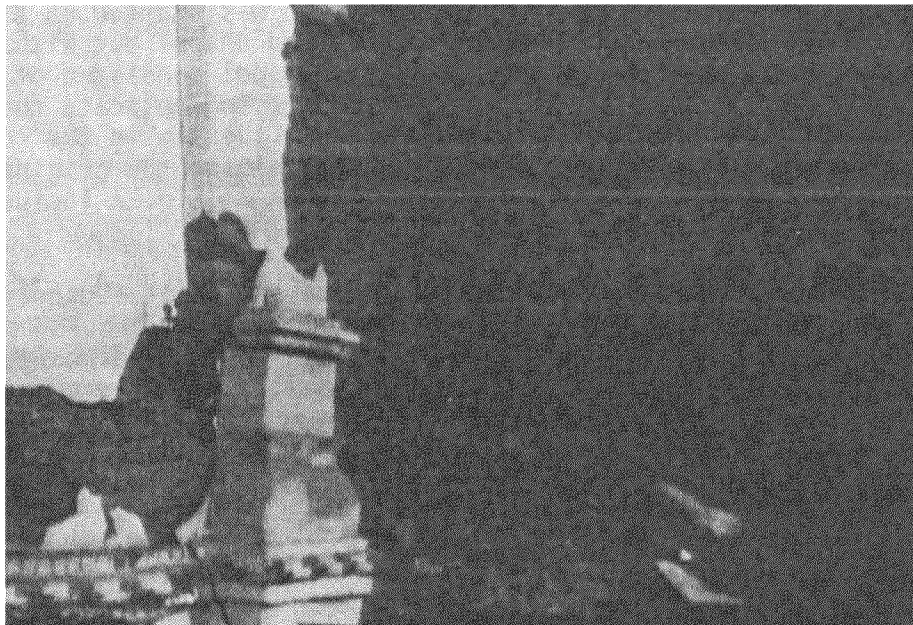
FIG. 4

Adobe Brick Collapse at Choir Loft
