Performance Under Weathering

Performance During Earthquakes

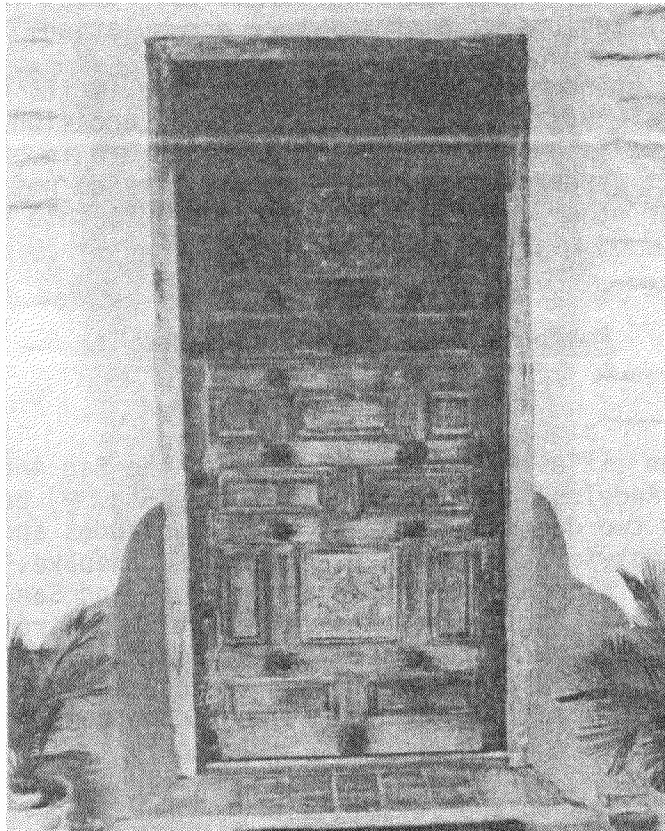
FIG. 12
Typical Handmade Doors and Hinges

Most doors, both interior and exterior, were hand-carved utilizing aesthetic features common to the Mexican-Indians. The door hinges were made from malleable iron rods and shaped according to the colonial Spanish and Indian traditions as illustrated in Fig. 12. The hardware on all doors was handmade.
