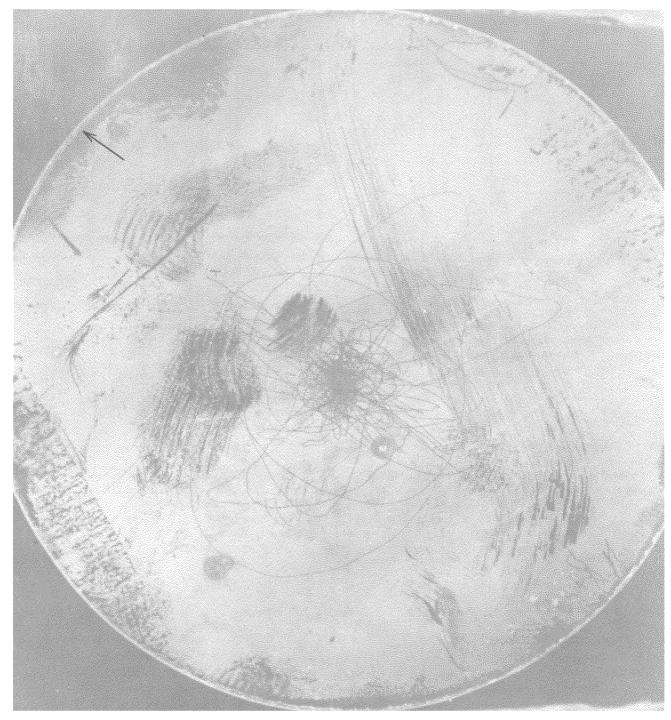
FIGURE 17—Seismoscope plate of main event located on a ground-floor instrument at the administration building of the Universidad de San Carlos, Guatemala City. Instrument was about 30 km south of Motagua fault surface breakage. Arrow indicates north. The plate is scratched all over. Recording of main event is shown in middle part of plate.

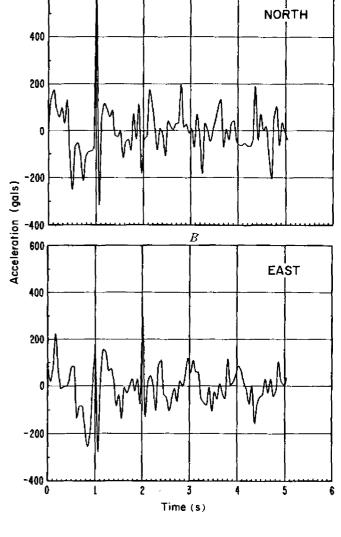
FIGURE 19.—Deconvolved 5-s section of seismoscope of the main event. Acceleration as a function of time. These 5 s of recordings are later than those shown in figure 18. A. North component; B, east component.

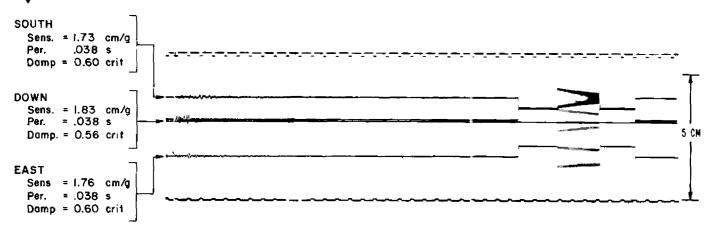
Several aftershocks have been recorded on the accelerographs located at Zacapa, the Observatorio Nacional, and at the IBM building stations. These aftershocks have a Richter magnitude less than 4.0 and are not considered significant. An aftershock was recorded at the IBM building on February 18, 1976, at 03:59 local time. The accelerogram in figure 20 shows a vertical motion of approximately 0.1 g during the first second.
