GEOLOGIC EFFECTS

By GEORGE PLAFKER, MANUEL G. BONILLA, and SAMUEL B. BONIS¹

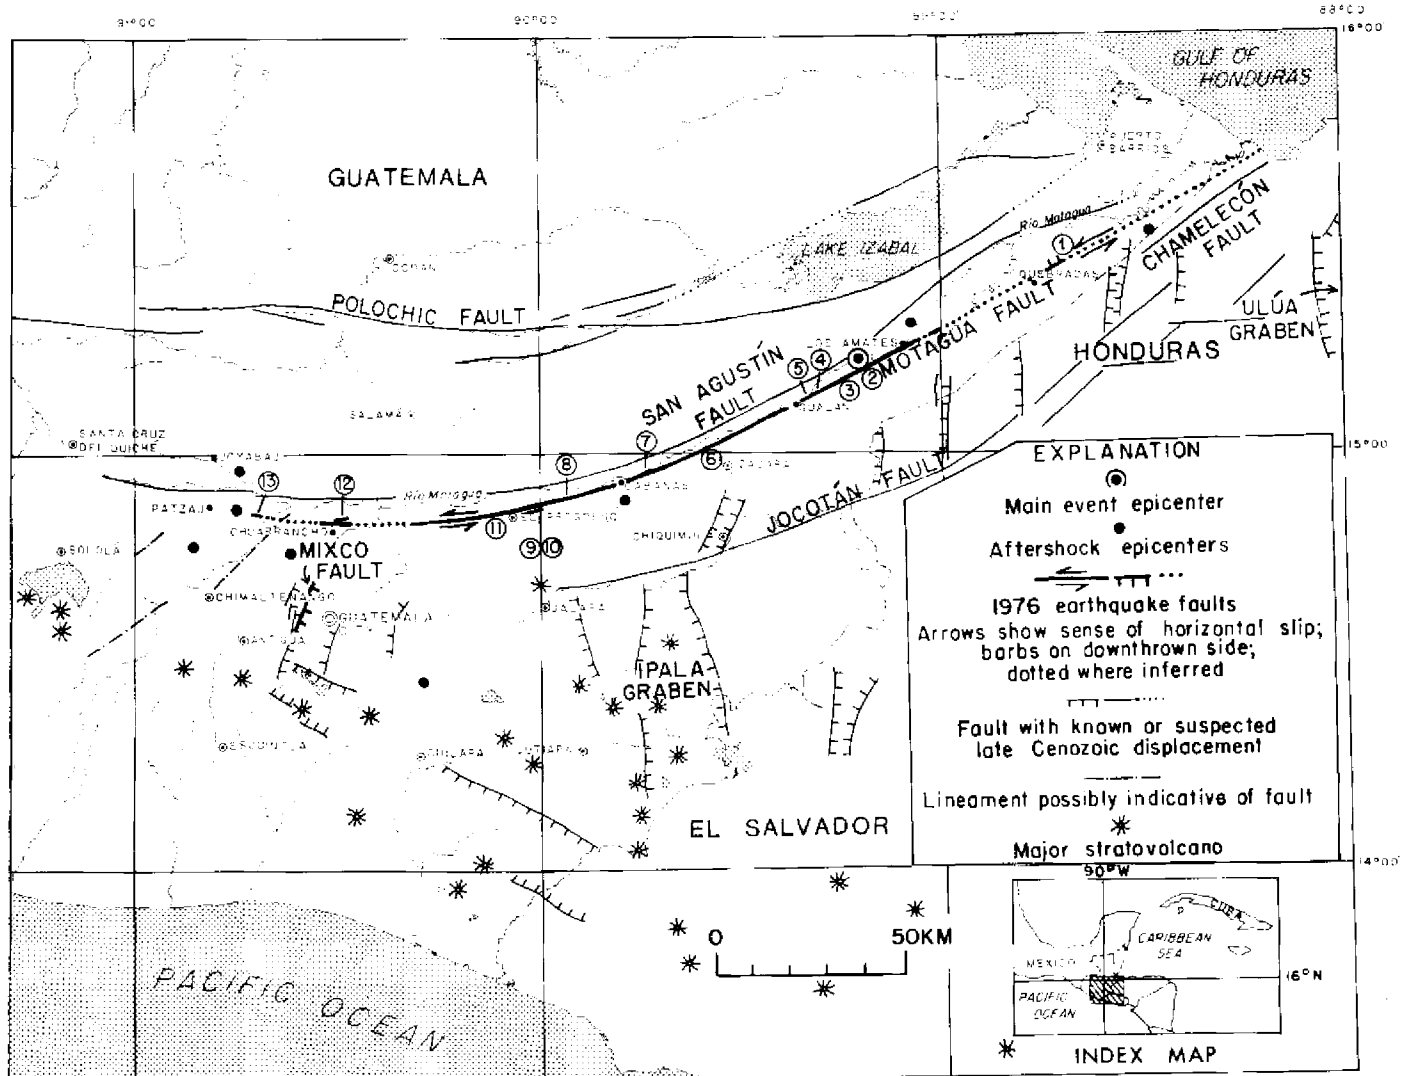
The main fault along which the destructive main event ($M_s=7.5$) occurred was identified for 240 km in the Motagua Valley and the mountainous area west of the valley² (fig. 23). This fault is of special interest because it is the most extensive surface rupture in the Northern Hemisphere since the 1906 San Francisco earthquake. Identification of this fault permits evaluation of damage relative to the earthquake source and provides critical new information on the present mode of deformation to a major tectonic belt of Central America. The eastern part of this major fault, within the Motagua Valley, has been named the Motagua fault (Dengo and Bohnenberger, 1969; Instituto Geográfico Nacional, Chiquimula 1:250,000 sheet, 1969), and this name is herein applied to all the fault that slipped during the earthquake.

FIGURE 23.—Relationship of the Motagua and Mixco faults to the main-event epicenter, the epicenters of large aftershocks, and major structural and volcanic features in northern Central America. Numerals along the Motagua fault refer to localities listed in table 7. Epicenters are from data of the NEIS and Person, Spence, and Dewey (this report); faults and volcanoes are modified from Dengo (1968) and Bonis, Bohnenberger, and Dengo (1970).

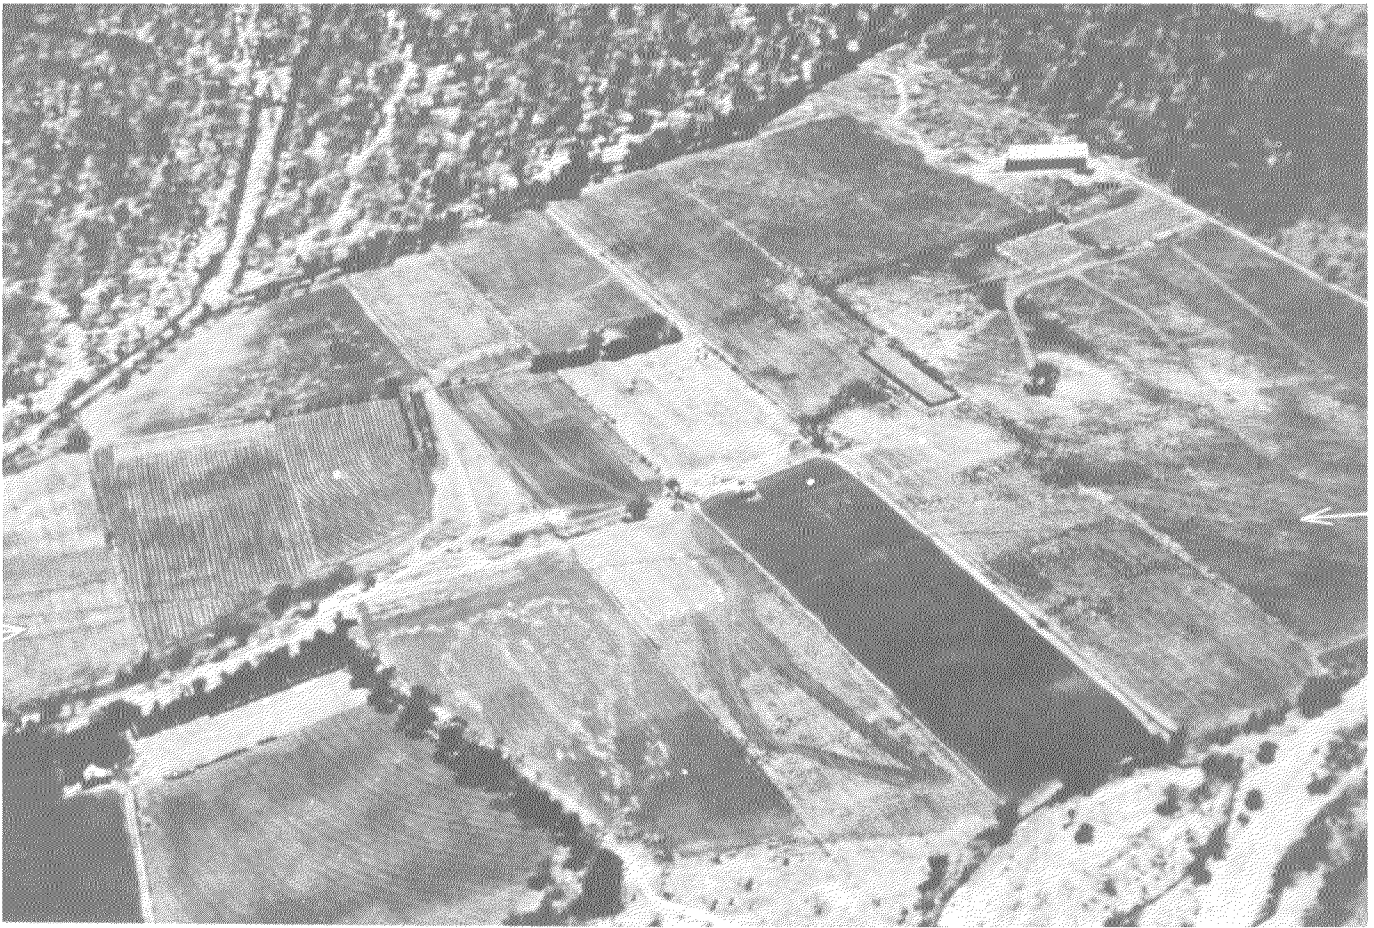
FIGURE 24.—Oblique aerial view looking south towards linear trace of the Motagua fault (arrows) in farmland west of Cabañas. Furrows with sinistral offset may be seen in the field at left. See figure 23 for location of Cabañas.
