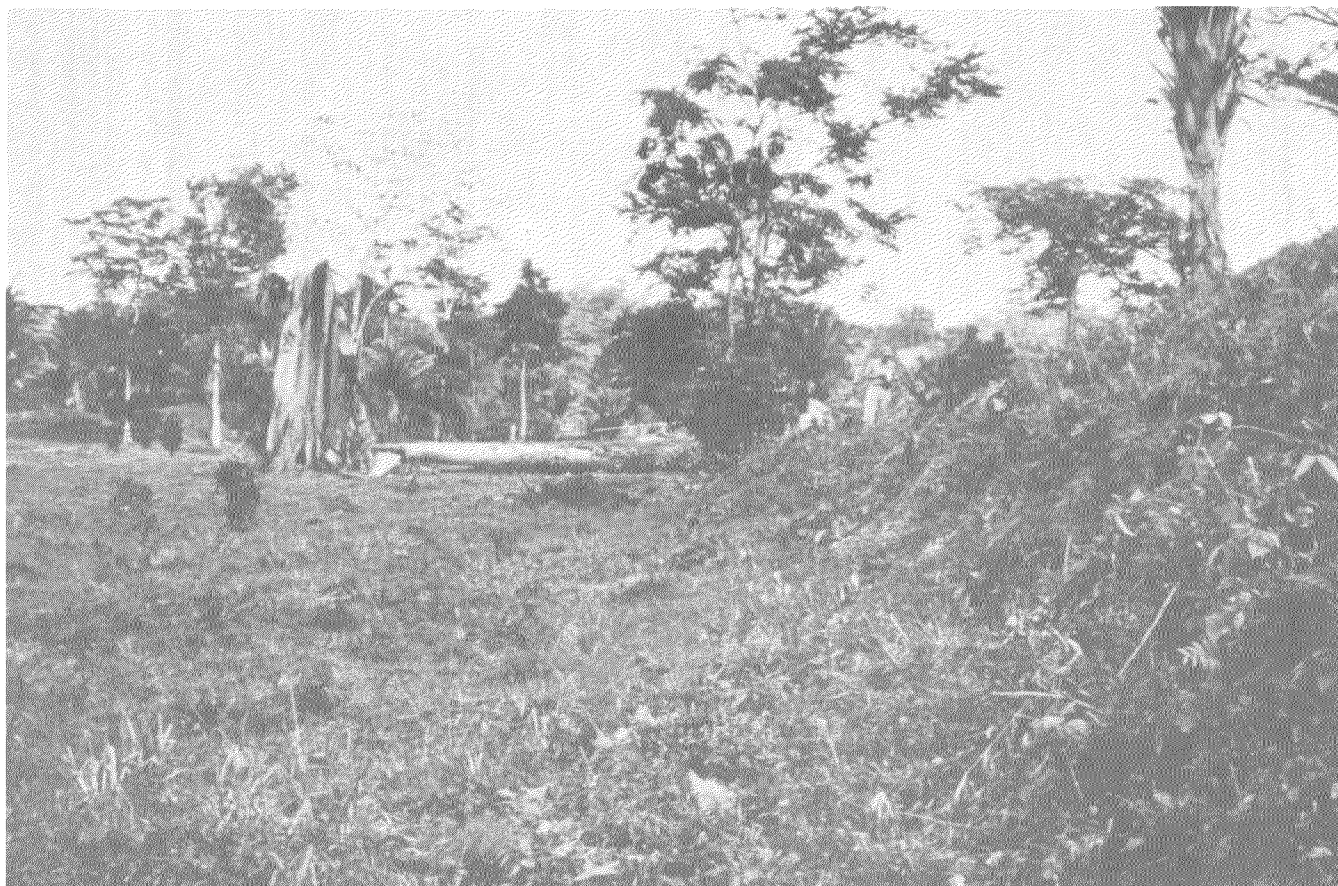
FIGURE 27.—View looking east along fault trace at the most easterly locality visited on the ground (station 1, table 7). Fault trace trends along base of 5-m-high scarp in foreground and through the fallen tree in the distance, which has a base diameter of more than 5 m. The tree was split and toppled by fault movement of about 72-cm sinistral displacement and 37-cm displacement down to the north. The north-facing steep scarp was probably formed by many repeated earlier movements along this same trace
