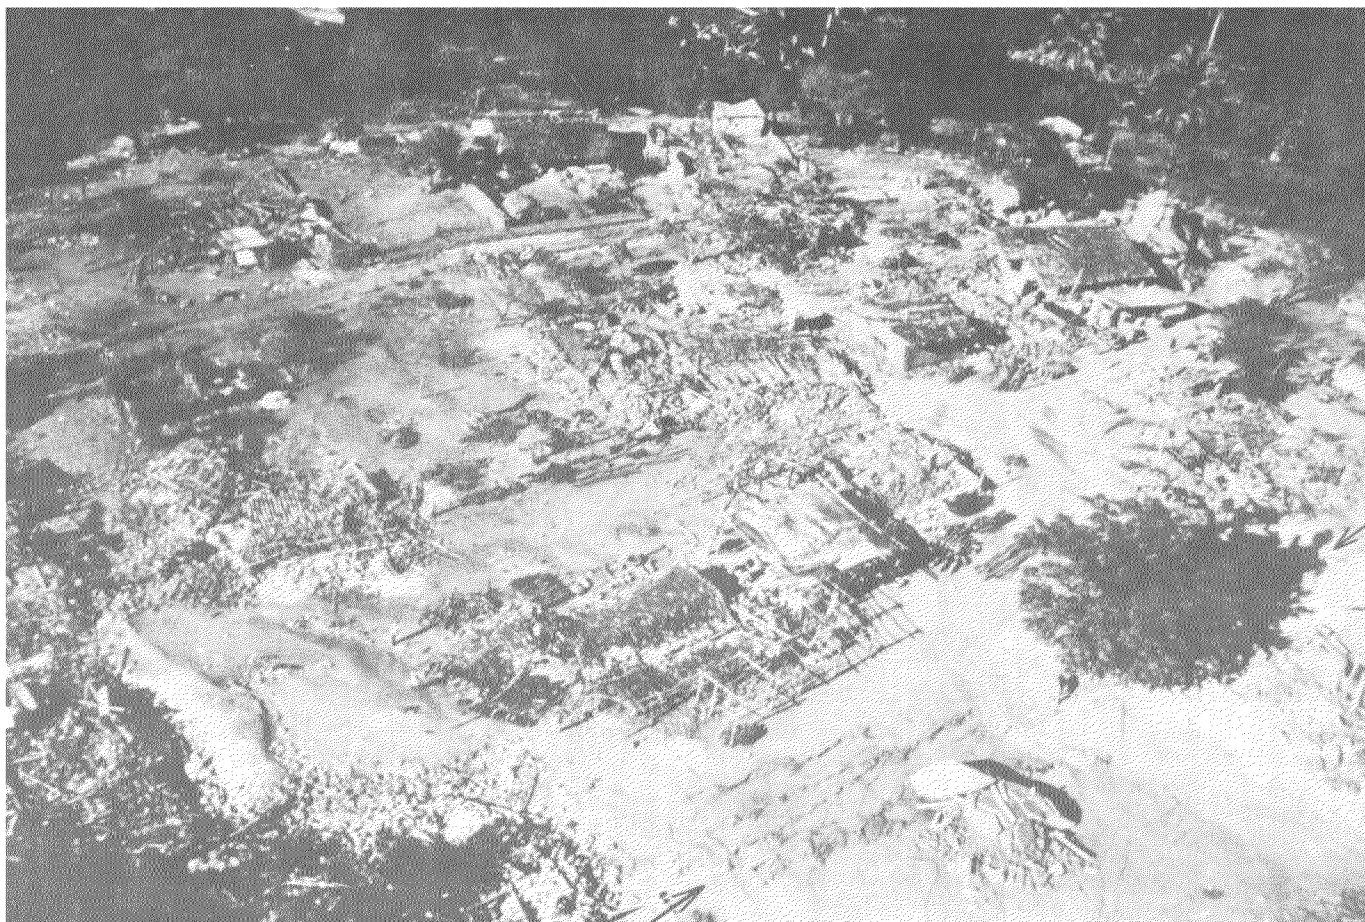
FIGURE 28.—Part of the village of Subinal, 7 km west of El Progreso, showing the destruction of adobe structures near the Motagua fault trace. The fault is a broad zone of ground cracks that cuts diagonally across the lower right corner of the photograph (arrows).
