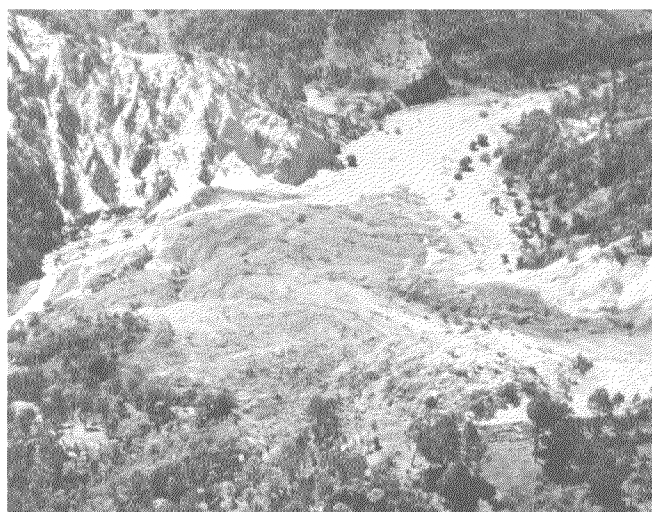
FIGURE 37.—Landslide-dammed lake along Río Pixcayá. The toe of the dam had been breached by the river by the time this photograph was taken on February 13.

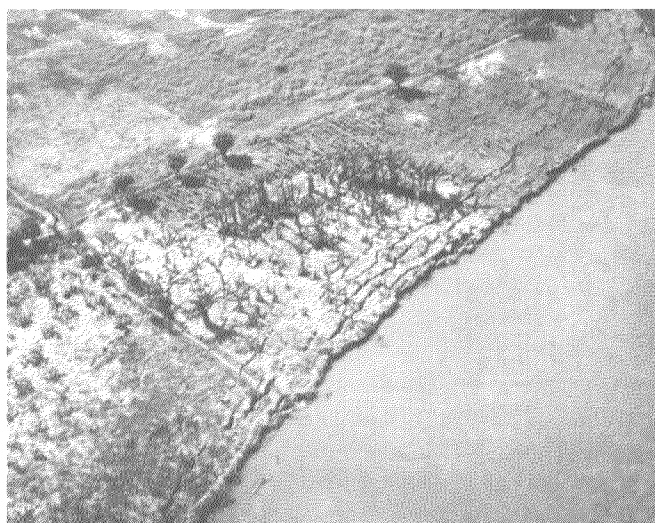
FIGURE 38.—Aerial view of ground cracks and sand mounds (white patches) in unconsolidated alluvial deposits along the Motagua River north of Quebradas in the lower Motagua Valley. Ground cracks are believed to result from liquefaction of water-saturated sediments and spreading towards the river channel.

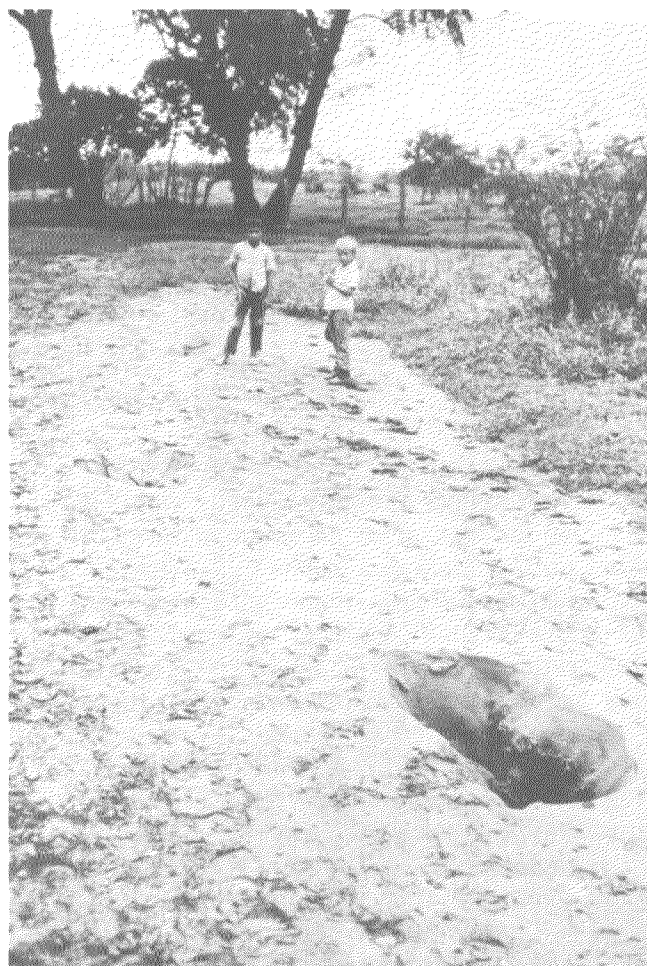
FIGURE 39.—View of linear sand mounds and circular to elliptical craters in area of water-saturated unconsolidated deposits along the Motagua River.
