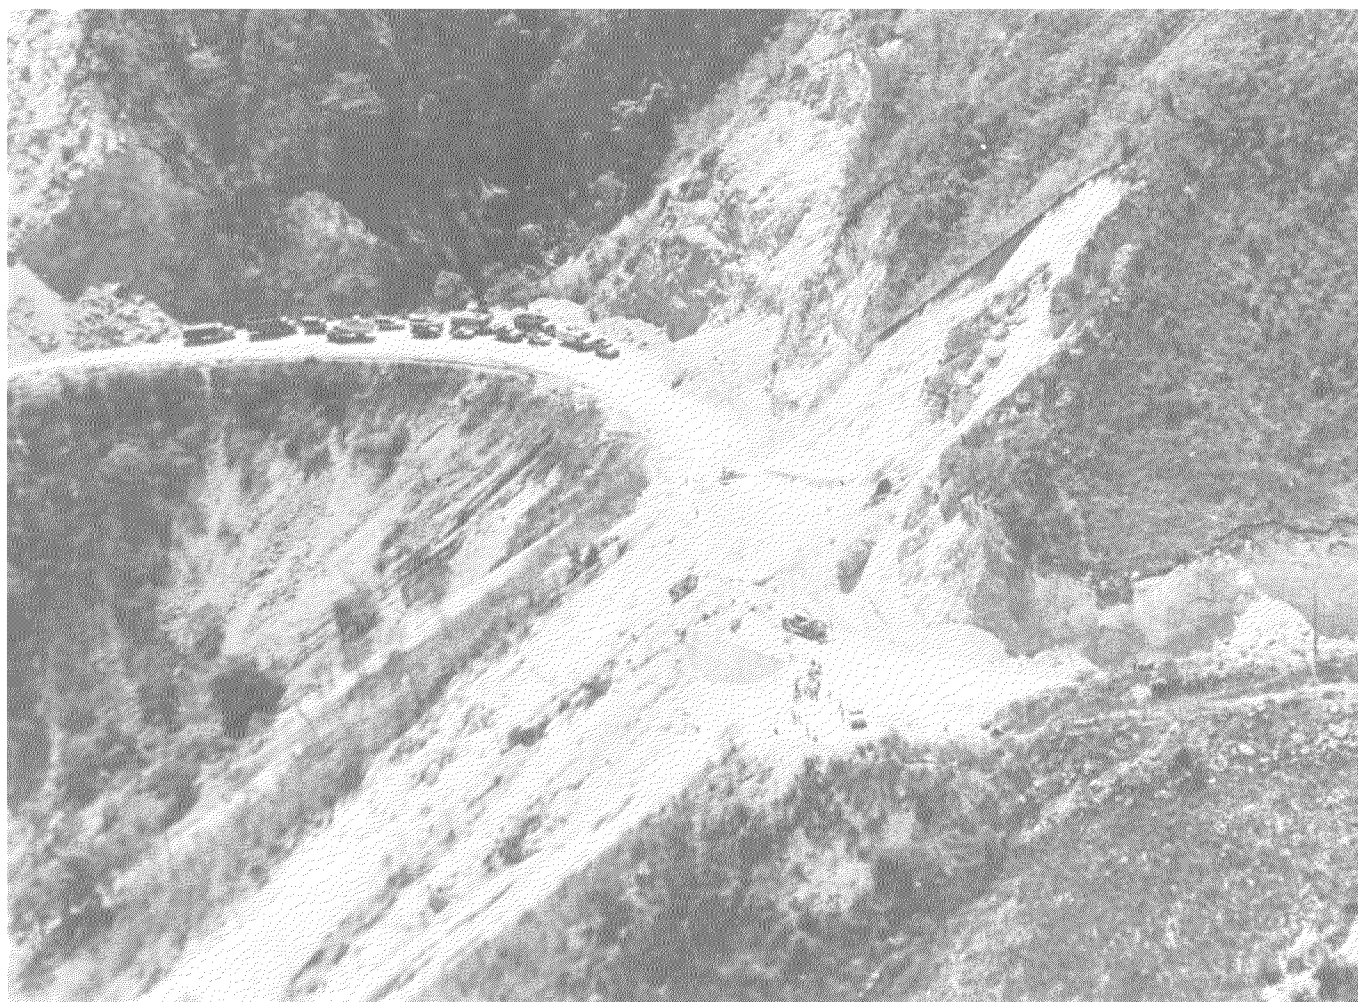
FIGURE 41.—One of the many landslides obstructing the main highway from Guatemala City toward El Progreso.
